Front Shock Absorber With Coil Spring Reassembly

Service Category Suspension

Section Front Suspension

YEAR(S)	MODEL(S)	ADDITIONAL INFORMATION
2005 - 2015	Tacoma	VDS(s): JX4CN, NX22N, NX4CN, TU22N, TU4CN, TX22N, TX4CN

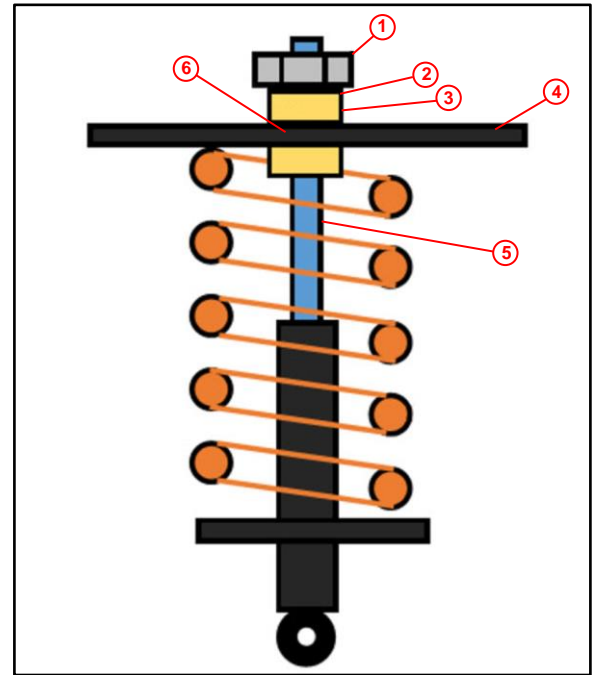
Figure 1.

1	Shock Absorber Rod Nut
2	Shock Absorber Cushion Retainer
3	Shock Absorber Cushion No. 1
4	Suspension Support Sub-assembly
5	Shock Absorber Rod
6	Inner Rubber Sleeve Location

5. Remove the shock absorber rod nut, front shock absorber cushion retainer, and front shock absorber cushion No. 1 to expose the top of the front suspension support sub-assembly.
6. Visually inspect the inner rubber sleeve of the front suspension support sub-assembly. The inner rubber sleeve of the front suspension support sub-assembly will likely be deformed as shown in Figure 2.

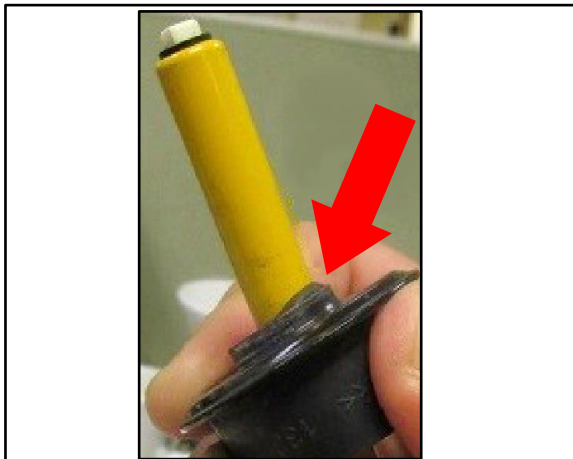
Figure 2. Deformed Inner Rubber Sleeve

9. Push the inner rubber sleeve down into the front suspension support sub-assembly and make sure it is as flush as possible.

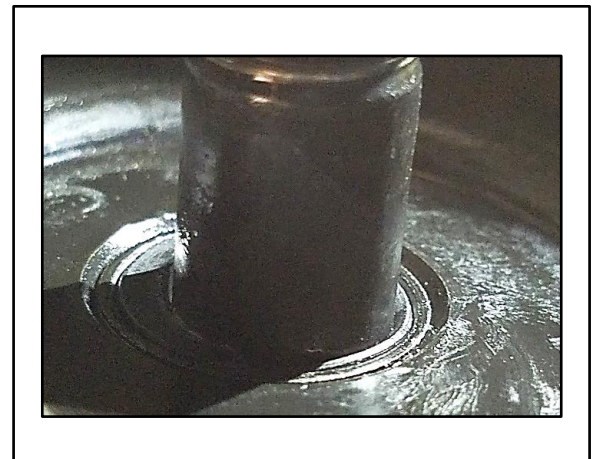
Figure 3. Normal Inner Rubber Sleeve

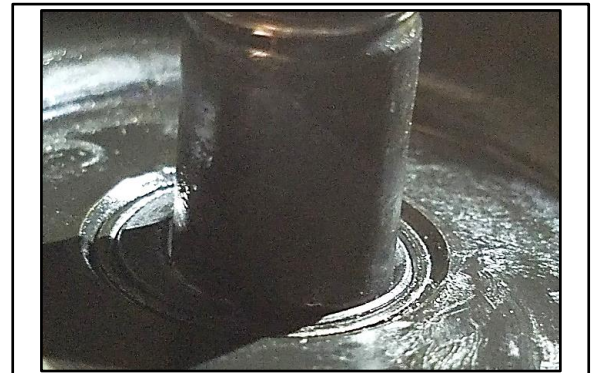
Perform a “fingernail test” to confirm proper fit. There should be minimal difference in height between the inner rubber sleeve and front suspension support sub-assembly.

Figure 4. Ideal Condition
