FLA COE  
FLB COE  
FLD Conventional  
Business Class  
FLC 112 Conventional

Freightliner  
Service Bulletin

## Primary Air System Leak Test

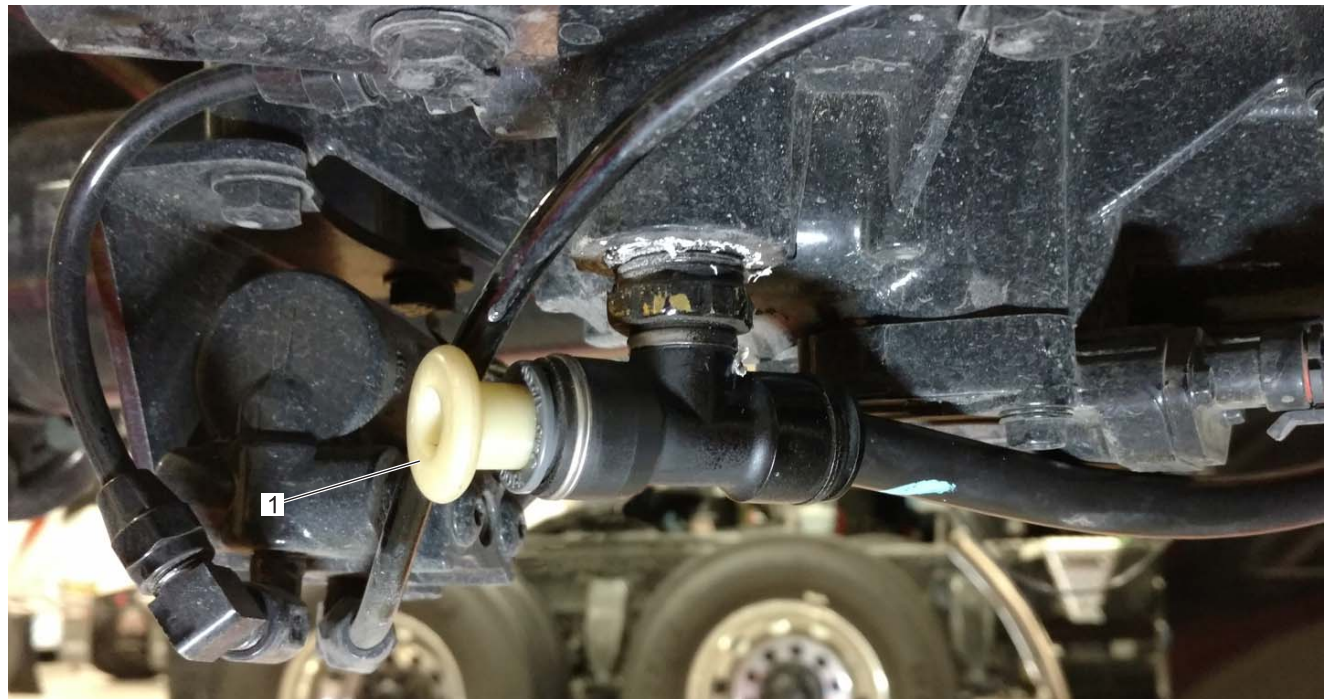
**Fig. 1, Air Dryer Fill Port**

1. Air Dryer Fill Port Plug

1. The vehicle air tanks must be drained before starting this procedure. Pump the brakes repeatedly to drain the air tanks.
2. Once the air tanks are drained, remove the air dryer fill port plug shown in [Fig. 1](#), and connect a DDE TLZ00100 Cal Tester to the air dryer fill port. See [Fig. 2](#) and [Fig. 3](#). Ensure that the cutoff valve is closed.
