Business Class M2  
Cascadia  
108SD/114SD  
> New Cascadia

**Freightliner  
Service Bulletin**

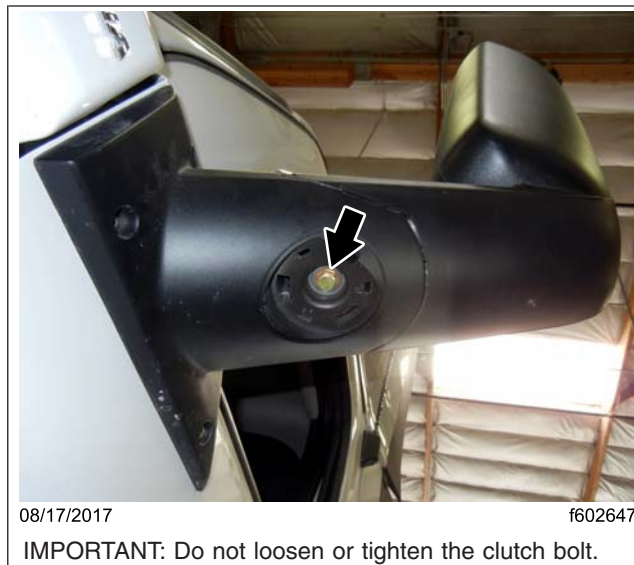
**Fig. 1, Mirror-Arm Pivot Clutch Bolt**

The mirror-arm pivot joint on the New Cascadia primary door-mounted mirror assembly is not serviceable. If the clutch bolt (see [Fig. 1](#)) is turned with a wrench, the mirror-arm pivot joint will be compromised, possibly allowing the joint to loosen over time. If a mirror-arm pivot is damaged or defective, the entire mirror assembly must be replaced. For mirror assembly replacement, refer to *New Cascadia Workshop Manual*, **Section 60.03, Subject 100**.
