**Countries:** CANADA, UNITED STATES **Document ID:** IK1600243  
**Availability:** ISIS, FleetSIS, NotSIR **Revision:** 0  
**Major System:** CAB / SLEEPER / HOOD **Created:** 2/22/2018  
**Current Language:** English **Last Modified:** 5/15/2018  
**Other Languages:** NONE **Author:** Jeff Novak  
**Viewed:** 66

**Title:** ProStar Battery Access Door Magnetic Latch Update

**Applies To:** ProStar

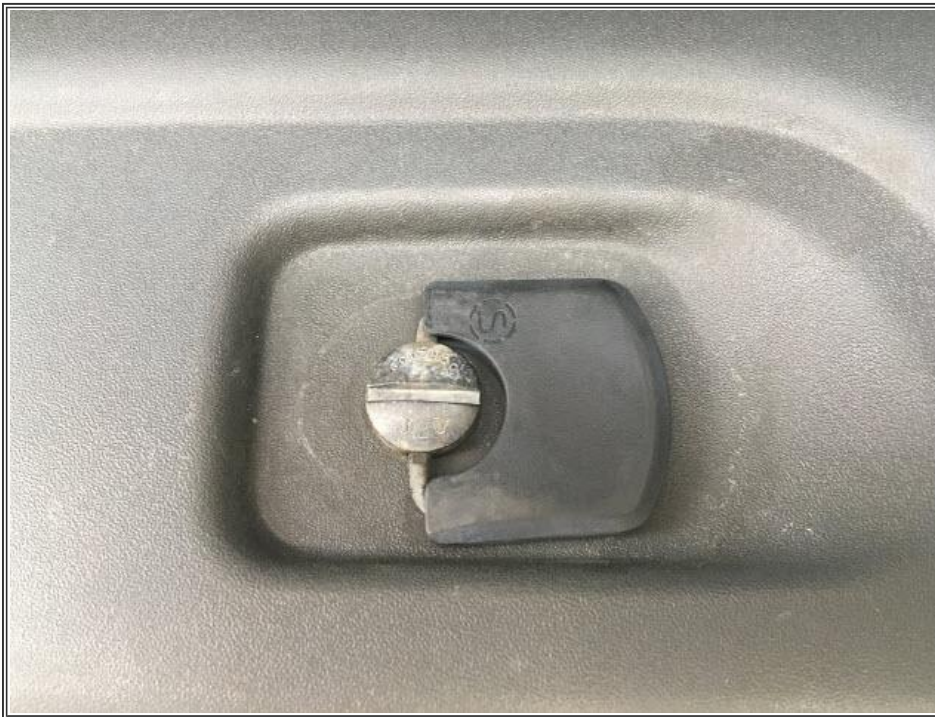
**Figure # 1**

Step #1: Remove both 1/4 turn assemblies from the battery access door cover (Figure #1)

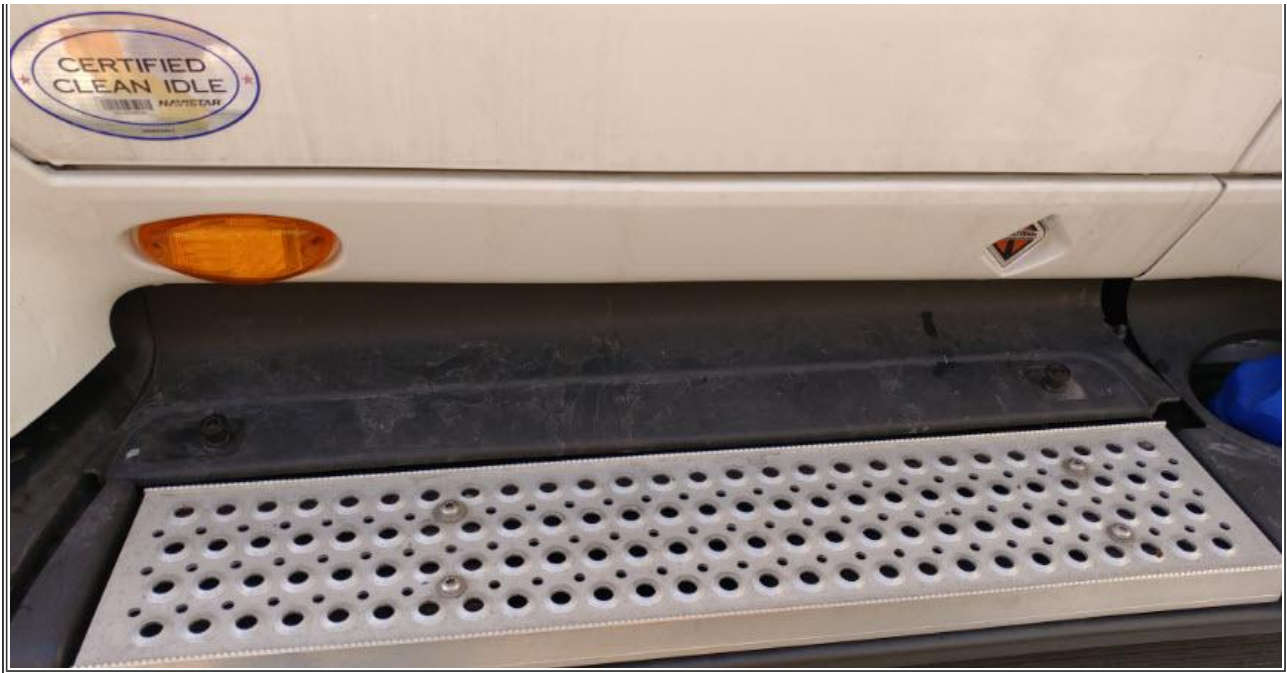
Figure #4

Step #4: Verify the battery access door closes and magnetic latches engage the tabs on the battery tray.
