SERVICE PROCEDURE

18505
May, 2018

SUBJECT: SAFETY RECALL
Seat Belt Shoulder D-Ring Bolt on certain IC Bus[®] HC Series models and International[®] HV[™] Series, MV[™] Series, RH[™] Series, LT[®] Series, DuraStar[®], LoneStar[®], ProStar[®], TranStar[®], and WorkStar[®] models built 18 September 2017 thru 23 March 2018 with seat belt assemblies supplied by Shield.

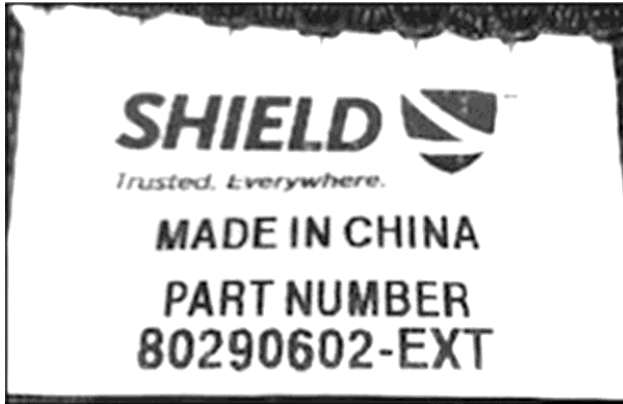
Figure 1. Seat Belt Label

6. Locate and identify seat belt label (Figure 1) on webbing of belt near anchor bracket on all 3-point seat belts equipped in vehicle.
7. Identify location of seat belt manufacturing.
 - a. If seat belt label does not state “Made in China”, repeat Steps 6 and 7 on passenger-side as well as any other 3-point seat belts equipped in vehicle.
 - b. If label states “Made in China”, proceed to Step 8.

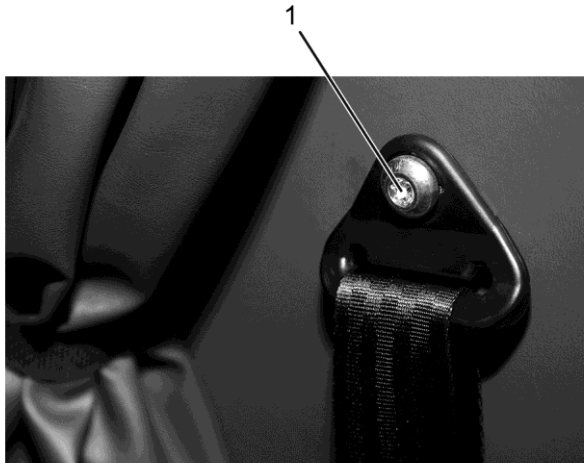
Figure 2. Bolt Marking

1. White dot

NOTE: Certain vehicles may have a yellow / green marking on the bolt head. The ONLY marking relating to this recall is a WHITE marking in the center of the bolt, all other marks may be ignored.

8. For all belt labels that state “Made in China” inspect D-ring bolt for white dot (Figure 2, Item 1).
 - a. If bolt has a white dot, bolt does not need to be replaced; check remaining affected bolts.
 - b. If bolt does not have a white dot, proceed to next step.

9. Remove and discard top seat belt mounting bolt and retaining washer from B pillar. If bolt breaks, proceed to Broken Bolt Removal Procedure.

NOTE: The retaining washer is not required with new bolt.

10. Install new bolt through D-loop and into B pillar.
11. Using a torque wrench, tighten bolt to 35 lb-ft (47 N•m).
12. Pull seat belt out and let it retract, confirm belt is not twisted.
13. Repeat Steps 7 through 12 for passenger-side and all other 3-point seat belts equipped in vehicle.
14. Remove wheel chocks.
