REFERENCE:	Nova Bus Manuals
SECTION:	02: Doors and Mechanism
RS N°:	MQR 7621-1165
EFFECTIVE IN PROD.:	N/A

SUBJECT:	Front door - Upper brush cover seal
JUSTIFICATION:	Automatic Passenger Counter may report erroneous data due to dust or water intrusion on optical front door sensor lens.

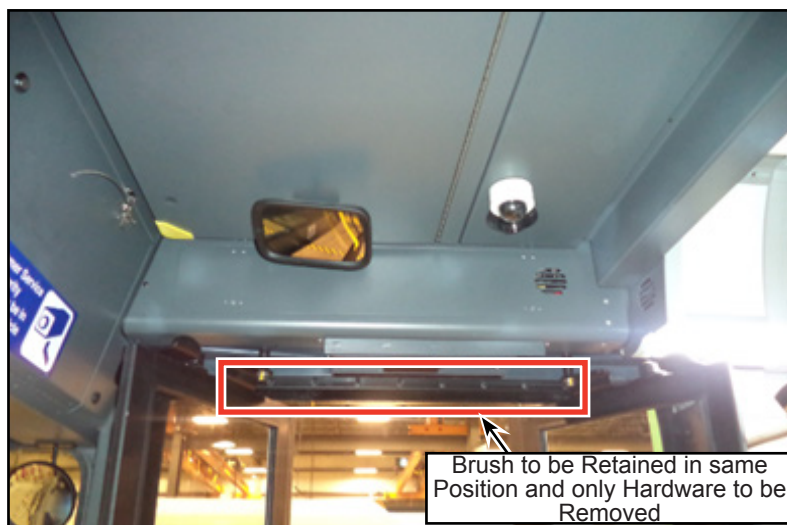
Figure 2 - Typical Location of Upper Door Brush

- 1.4. Locate the upper door brush of the front door (see Figure 2).

- 1.5. Remove the hardware holding the upper door brush and retain the brush in its original position.

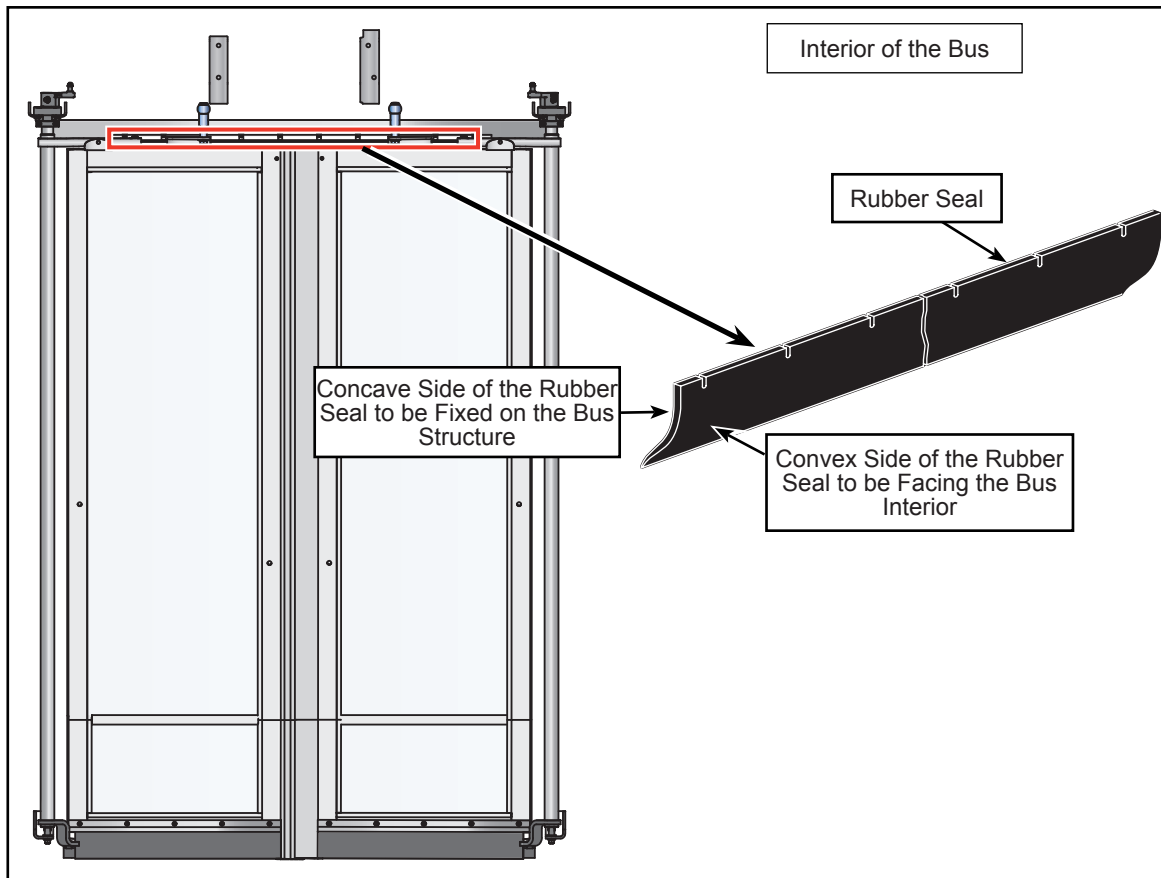
Figure 3 - Alignment of Rubber Seal

The rubber seal must be installed correctly. Its positioning is determined by the curve in the rubber seal. The rubber seal must curve toward the door.

- 1.6. Align the holes of rubber seal (N91377) with the pre-existing holes on the door structure (see Figure 3).

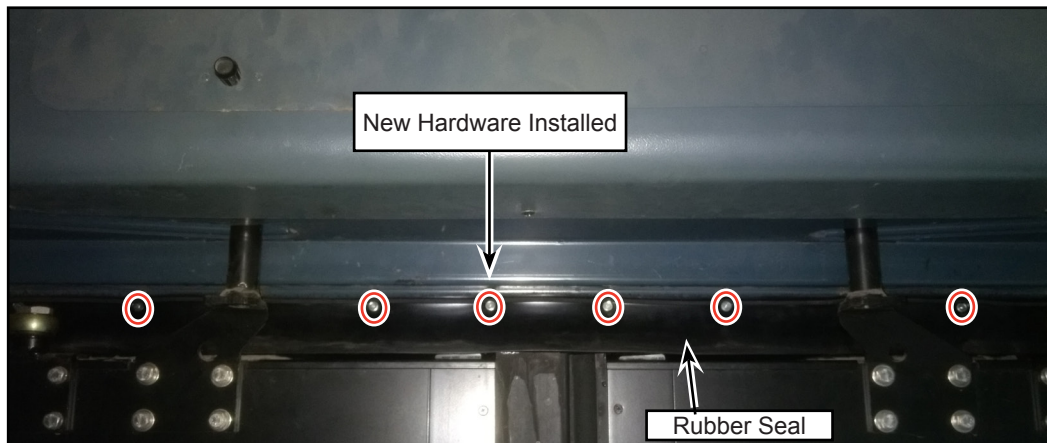
Figure 4 - Installation of Rubber Seal

- 1.7. Secure the rubber seal and upper door brush with the new screws (N20265) and washers (N8906932) (see Figure 4).

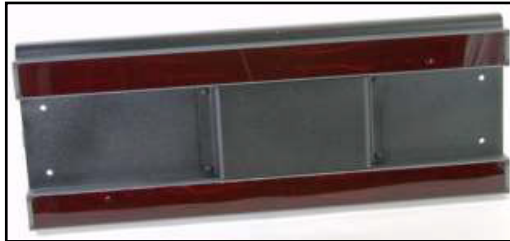
1.13.1. UTA's overhead diffuse sensor assembly (see Figure 5 and Figure 6), used on SEPTA Nova buses is identical in function to the retroreflective sensor, but differs in operation. The overhead sensor "strips" each contain a series of infrared emitter LED's and a series of infrared receivers. When emitted infrared light is detected, by reflecting back from an object (passenger) below, the output of the sensor is triggered and a signal sent to the Smart Sensor.

The sensitivity of each sensor "strip" is adjustable by a small potentiometer which can be seen and accessed through a small hole in the sensor lens. Turning the potentiometer clockwise with a small straight-blade screwdriver will increase the detection range of the sensor. Turning the screw counterclockwise will decrease the detection range.

*Figure 5 - Typical View of Overhead Sensor Assembly*

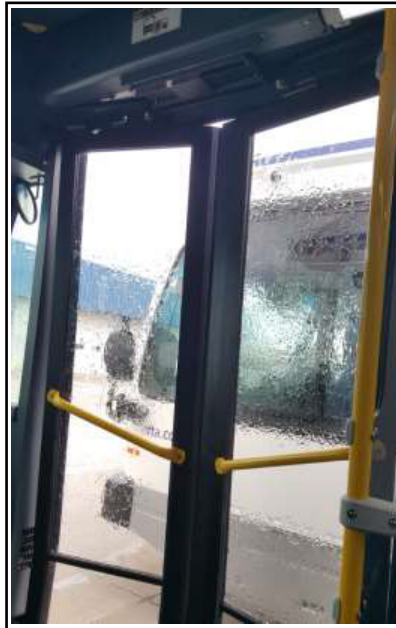
Any sensor mounted to the underside of the door header, near the outside of a bus is subject to accumulation of water/dirt/air system oil, etc., which may penetrate the door seal or drip from the door motor area above. UTA's sensor assemblies are no exception to this, and cleaning of the sensors may be required.

As with any optical situation (car windshield, eyeglasses, camera lenses, etc) this accumulation of dirt or residue will restrict the light passing through the lens. In the case of APC infrared sensors, accumulation of dirt will restrict the emitted infrared light AND the light returned from the reflection from the passenger below. This has the same effect as "shortening" the detection range of the sensor by the adjustment potentiometer.

*Figure 6 - Typical Location of Overhead Sensor Assembly mounted over Novabus Doorway*

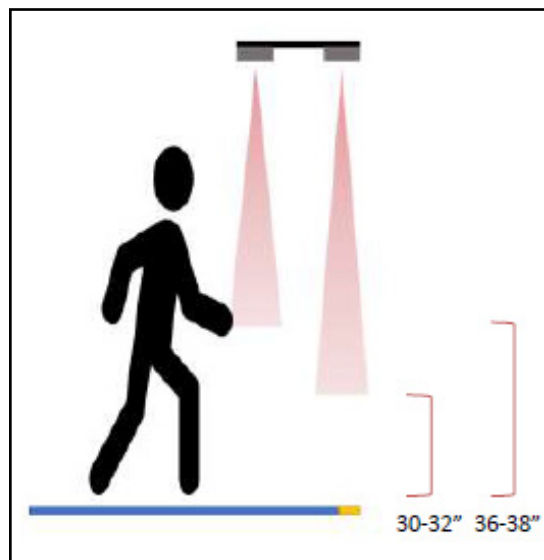
- 1.13.2. The detection range of the overhead sensors is adjustable to accommodate different mounting heights. In the case of SEPTA's Novabus fleet, the detection range should be set to:  
Outboard Sensor – 30-32"  
Inboard Sensor – 36-38"

Below is an illustration of the sensor adjustment/detection range (see Figure 7). Note the outboard sensor is adjusted several inches lower than the inboard. This is to enhance the separation between the detection point of the two sensors, and to aid in detecting passengers stepping up into the bus from the ground (or down, when exiting).

Figure 7 - Typical View of the Sensor Adjustment/Detection Range
