Reference	SSM73861
Models	F-PACE / X761
Title	Windscreen Cracks
Category	Body
Last modified	25-Apr-2018 00:00:00
Symptom	102000 Window/Glass
Attachments	Screen Crack1.pdf

Windscreen cracked

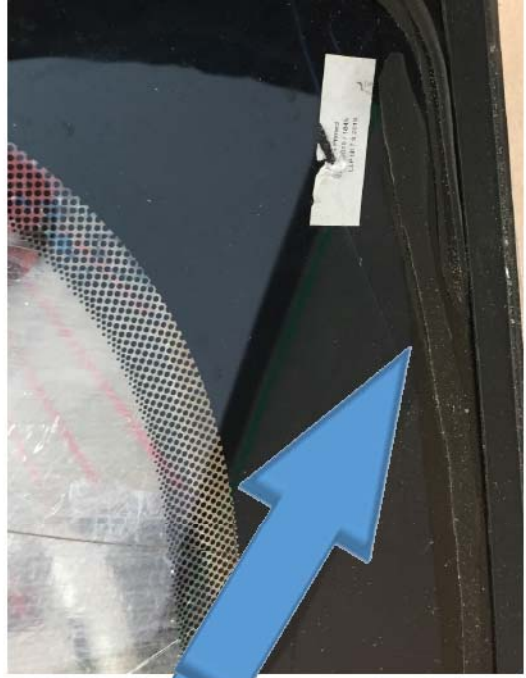
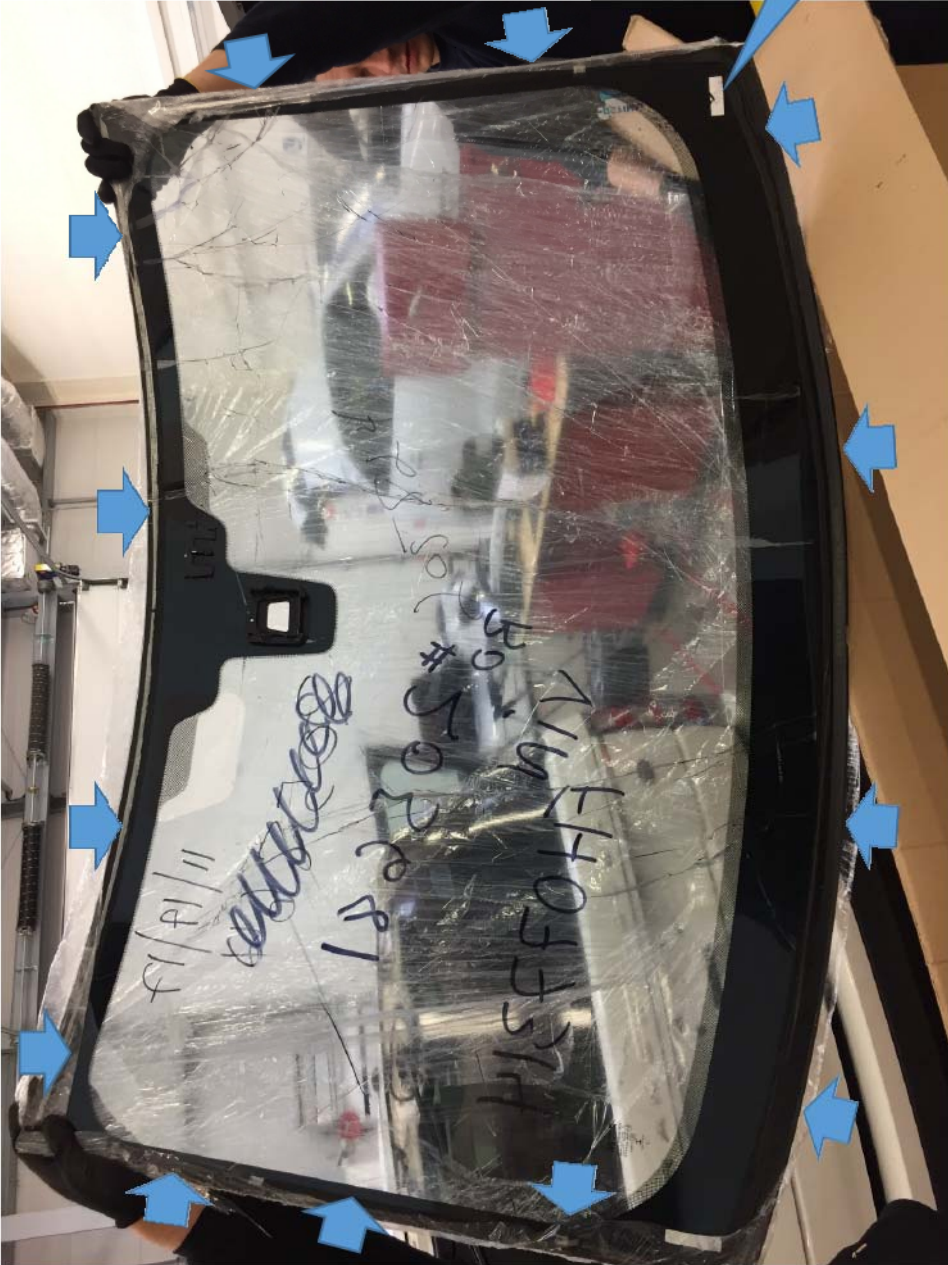
Fig 5

A picture of the sealant inside on the periphery of the removed windscreen, if there are any gaps or missing sealant please take an additional zoom picture of the area (Fig 5)
