REFERENCE:	Nova Bus Manuals
SECTION:	05: Rear Suspension
RS N°:	N/A
EFFECTIVE IN PROD.:	N/A

SUBJECT:	ZF service bulletin 80-17 for wheel bearing assembly - ZF axles (Type A/AV/AVN - Middle/Rear axle)
JUSTIFICATION:	Inner slotted nuts may mislocate the wheel bearing assembly.

# ANNEX - CHECKING OF SLOTTED NUT-HUB BOLT CONNECTION ON A 132, AV 110/132/133, AV 132

### Checking of slotted nut-hub bolt connection on A 132, AV 110/132/133, AVN 132

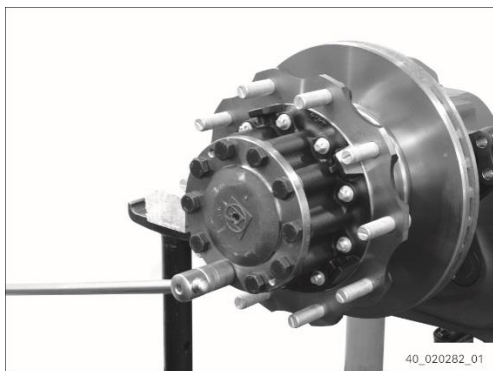
Figure 1

1. Fix hub by inserting the parking brake.
2. Loosen screws of the flange shaft.

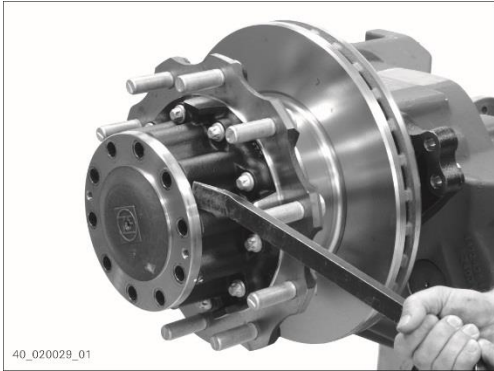
Figure 2

3. Observe safety instructions environment.  
Remove flange shaft and collect leaking oil.
4. Unlock outer slotted nut.

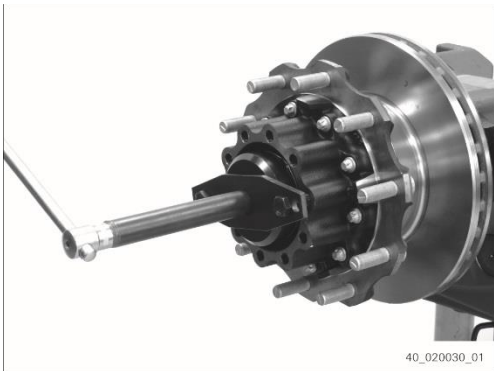
Figure 3

5. Loosen outer slotted nut with 5870.401.146 [slotted nut wrench].
6. Remove locking plate.
7. Loosen inner slotted nut with 5870.401.146 [slotted nut wrench].

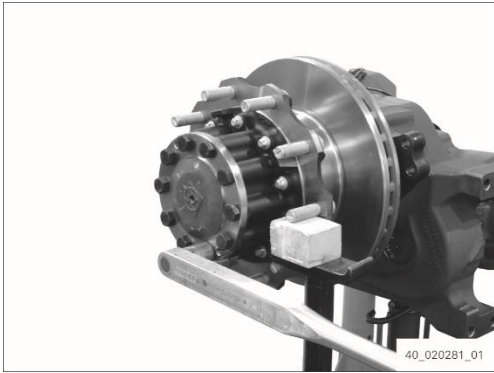
Figure 8

17. Fix hub by inserting the parking brake.
18. Turn in and tighten the screws.  
Tightening torque: **440 Nm**

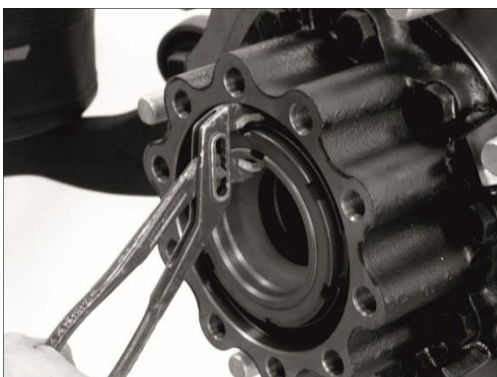
Figure 12

15. Secure outer slotted nut with locking plate.

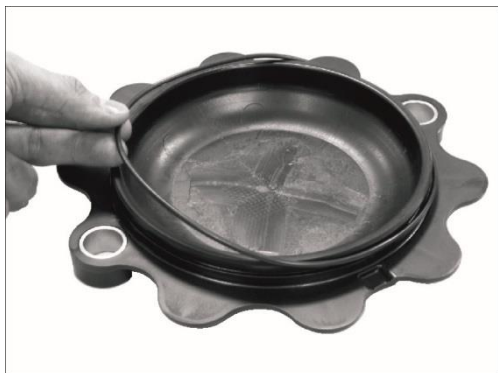
Figure 13

16. Grease **new** O-ring and insert it into the annular groove of the cover.

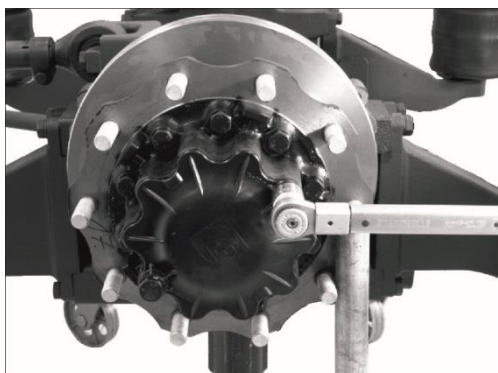
Figure 14

17. Insert cover until contact is obtained.
18. Fix hub by inserting the parking brake.
19. Turn in and tighten the screws.  
Tightening torque: **100 Nm**
