June 14, 2018

Buzzing Coming From the Driver's Door Mirror

AFFECTED VEHICLES

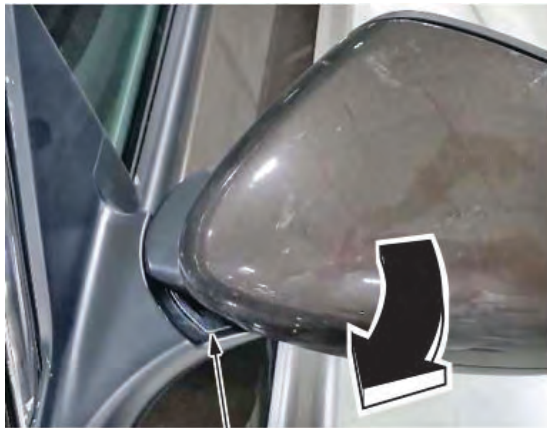
2. Push the mirror housing forward, and tape down the cutline seal to the base as shown.

CUTLINE SEAL

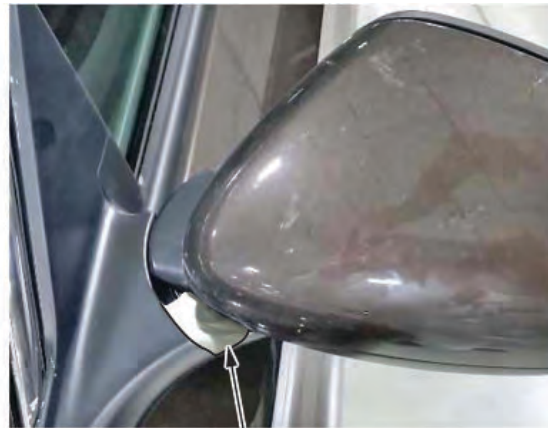
Tape over cutline seal.

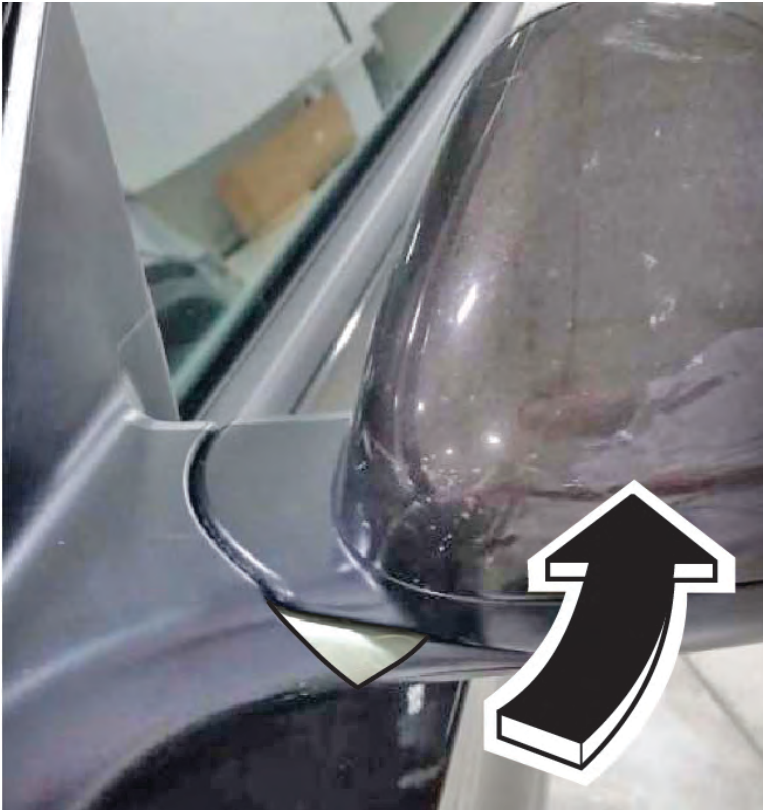
3. Return the mirror back to its normal position.

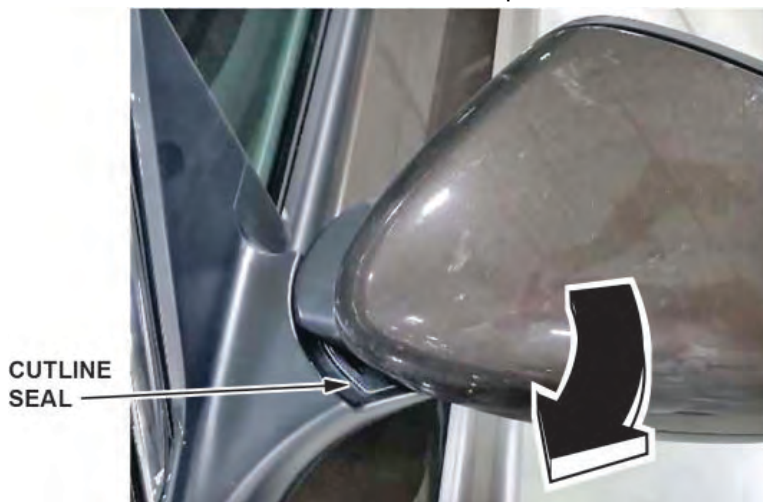
1. Push the driver's door mirror forward to expose the area of the cutline seal as shown.

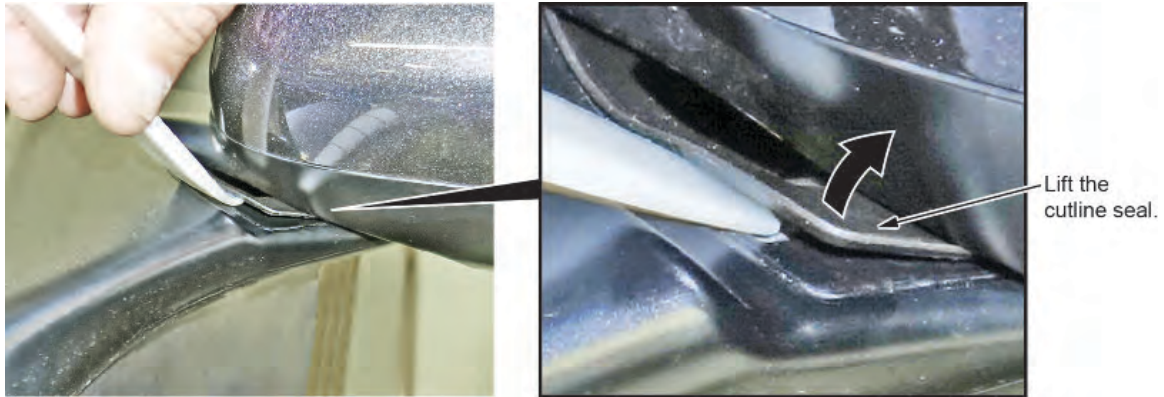
2. Lift up the corner of the cutline seal with the appropriate plastic trim tool.

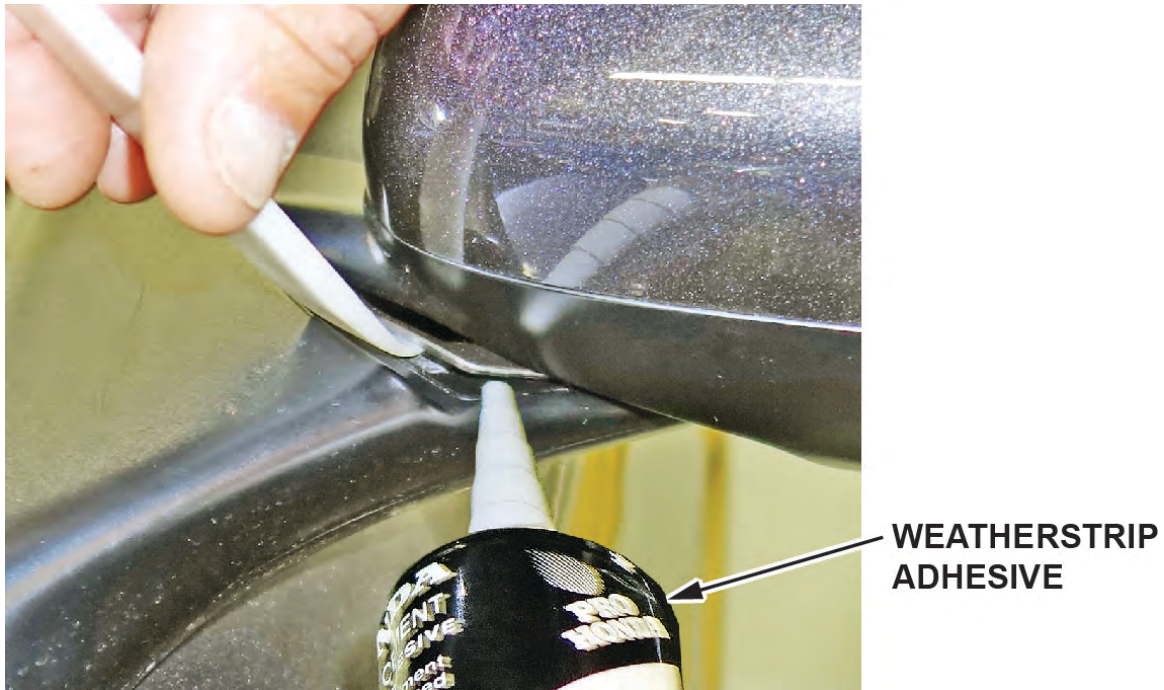
3. Apply a small bead of weatherstrip cement to the bottom of the seal as shown.

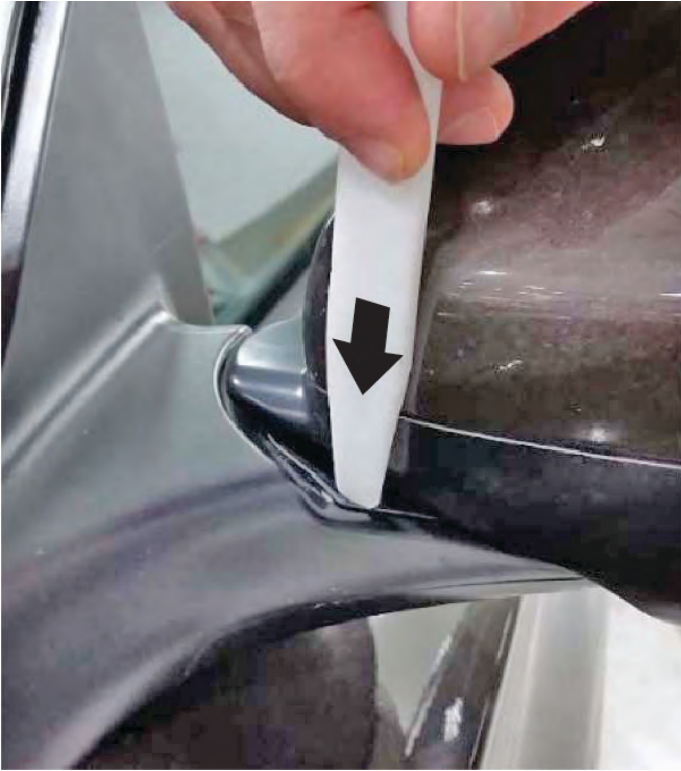
4. Line up the cutline seal with the mirror base, then using the plastic trim tool, press and hold down the seal to secure it in place. **Clean off any excess weatherstrip cement.**

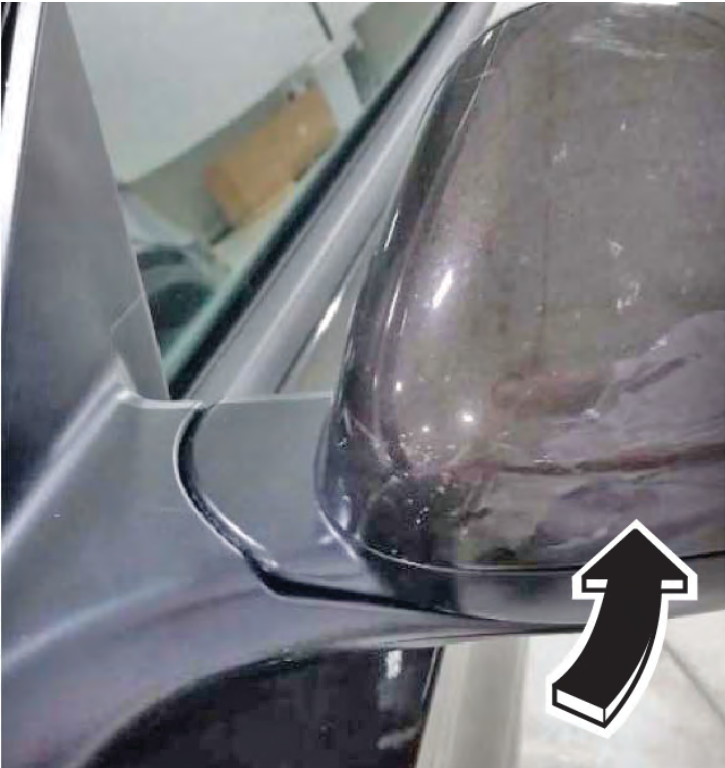
5. Return the mirror housing to its normal location.
