June 15, 2018

Warranty Extension: Customer Support For Front Passenger's Airbag Inflator for 2016-17 RDX, 2014-17 RLX, and 2014, 2016-17 RLX Sport Hybrid (Expires June 30, 2030)

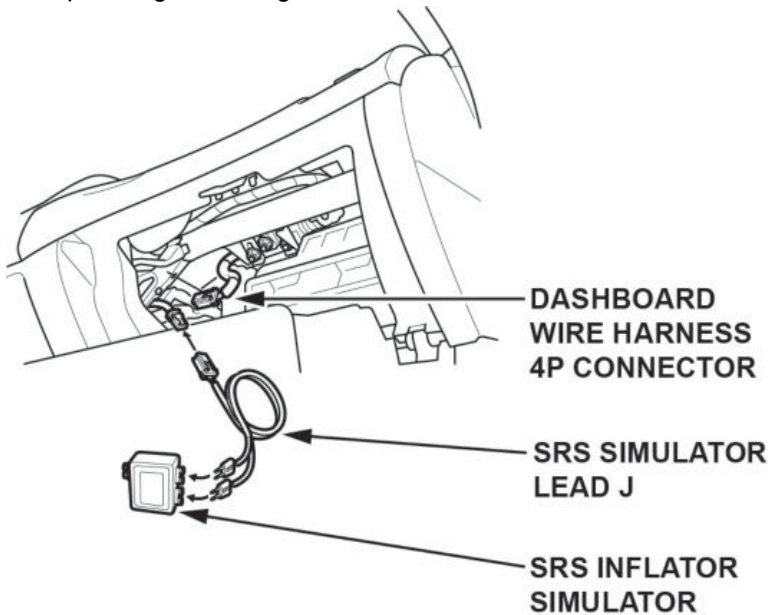
11. Access the front passenger's airbag, and disconnect the dashboard wire harness connector 4P connector from the front passenger's airbag 4P connector.

12. Connect the terminals of SRS simulator lead J to the SRS inflator simulator (2 Ω connectors), then connect SRS simulator lead J to the 4P connector as shown.
13. Reconnect the negative battery cable.
14. Turn the ignition to ON, not ACC, and wait 10 seconds.
15. Check if the SRS DTC listed in step 8 returns.
 - If the same SRS DTC returned, the inflator is OK. The Customer Support Program does not apply. Continue with normal troubleshooting.
 - If the same SRS DTC **did not** return, go to the REPAIR PROCEDURE.

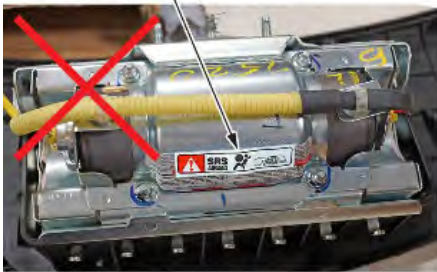
NON-STANDARD SAFETY LABEL

- If there are any unusual markings, like an incorrect label or a model year written in marker, the airbag module and inflator may not be the correct airbag module and/or inflator for the vehicle or it may be a counterfeit part. For more information about counterfeit airbags, you can refer to *safercar.gov*, enter keywords **MANAGING COUNTERFEIT**, and select **Recommended Dealer Guidance for Managing Counterfeit Air Bags** from the list. **If you suspect that the airbag module or inflator is counterfeit, do not continue this procedure.** Contact your DPSM for assistance.

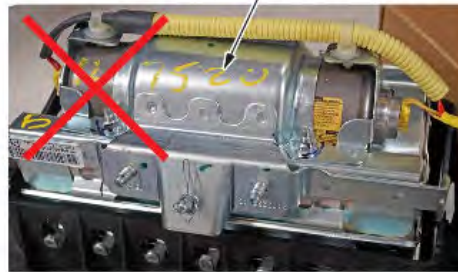
GREASE PENCIL OR PAINT MARKINGS

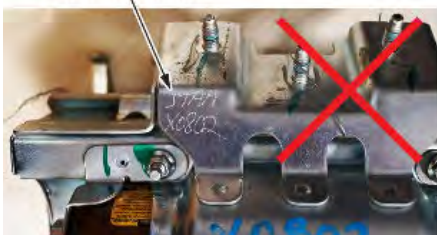
HAND ENGRAVING

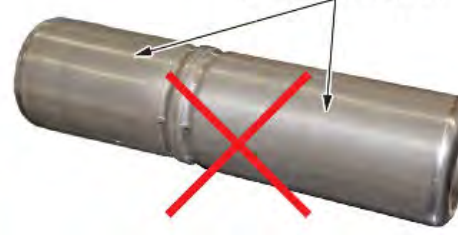
NO LABELS ON INFLATOR

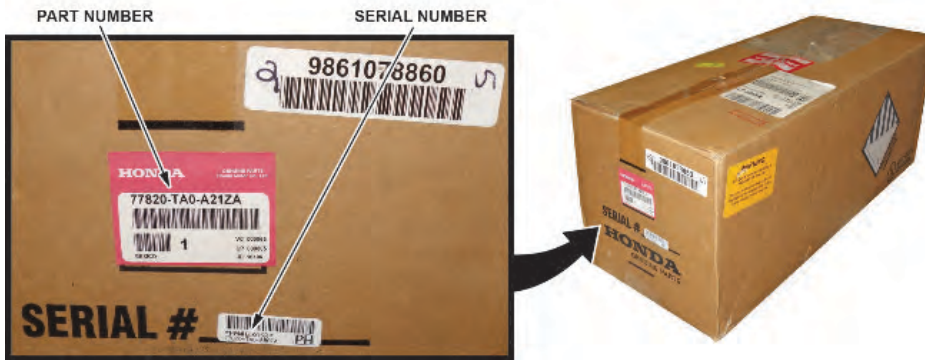
6. Write the serial number and part number from the outside of the airbag module box on the RO.

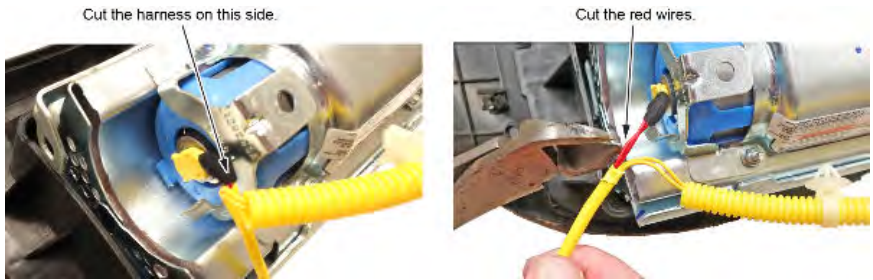
- 3.1. Cut the red wires about 2 inches from the inflator.

There may be some protective tube covering the wires that needs to be cut away to access the wires.

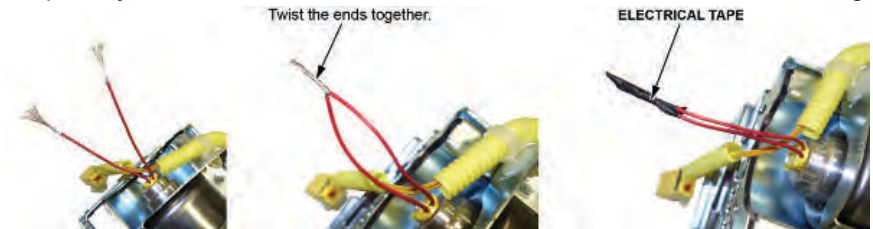
- 3.2. Strip away about 1 inch of the red wire insulation, then twist the wires together.

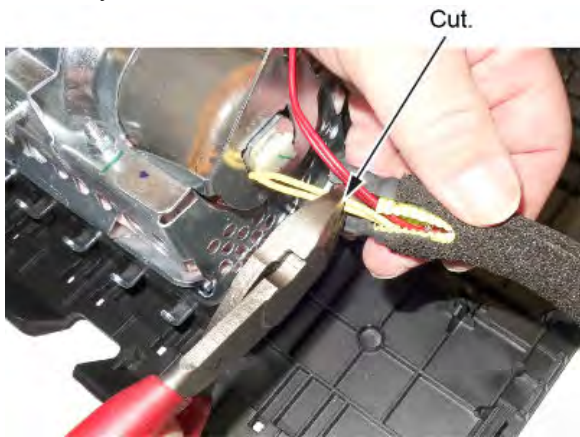
- 3.3. Tape the twisted ends with electrical tape.
- 3.4. Cut the yellow wires about 2 inches from the inflator.

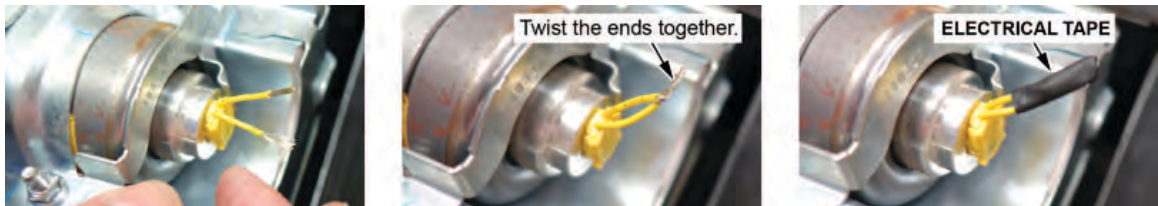
- 3.5. Strip away about 1 inch of the yellow wire insulation, then twist the wires together.

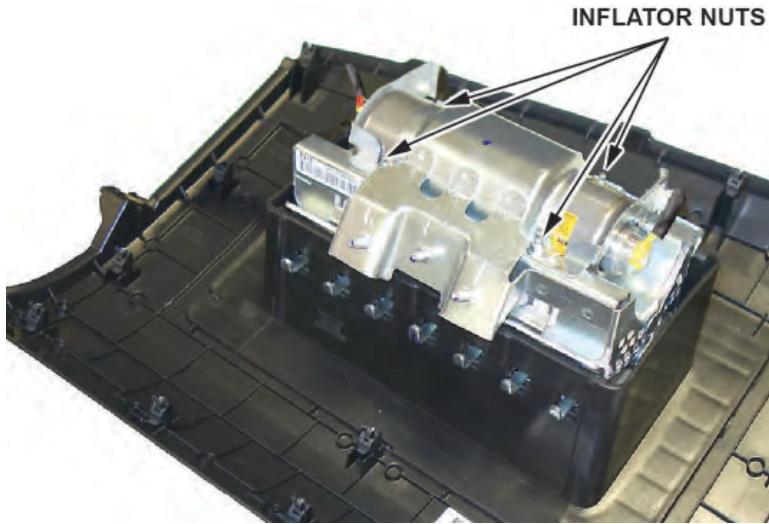
3.7. Remove the four inflator nuts.

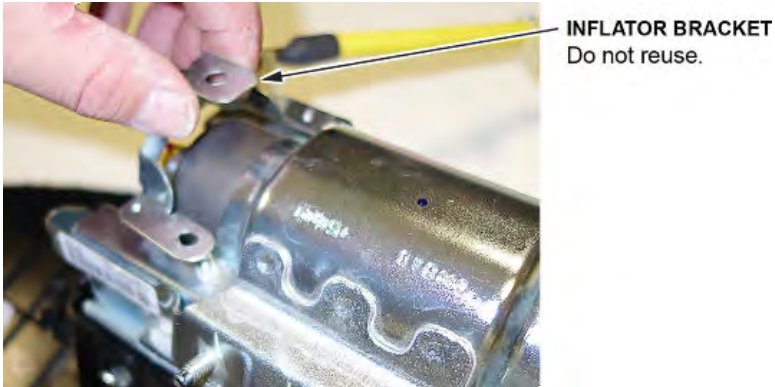
4. Remove the inflator bracket.

You can only remove one of the brackets, as the other is welded to the airbag housing.

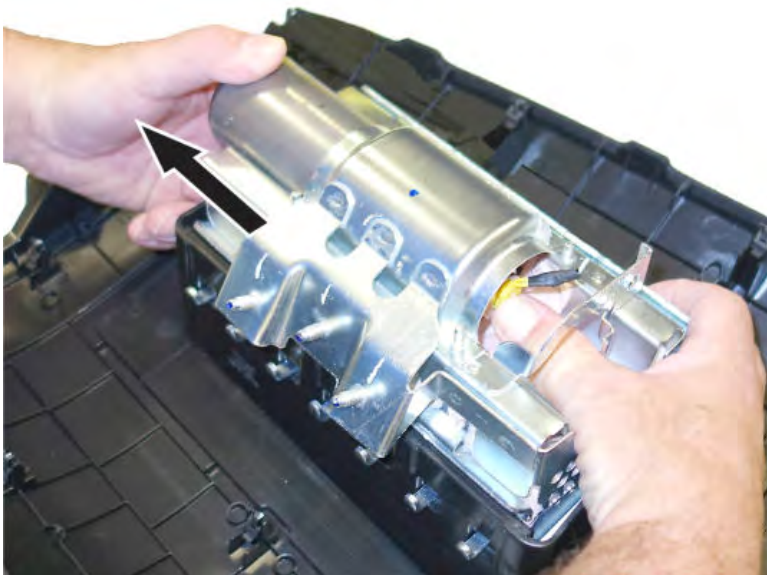
5. Remove the inflator by pulling it out.
