May 9, 2018

Version 2

Capless Shutter Set (Mis-Fuel Inhibit Device) Is Frozen

Supersedes 18-018, dated March 16, 2018, to revise the sections highlighted in **yellow**.

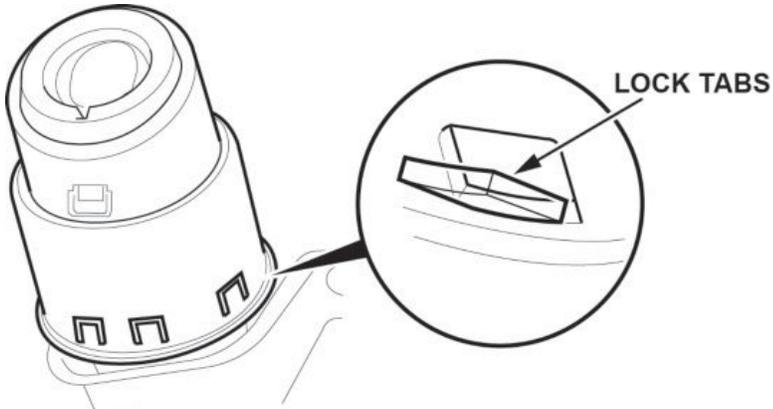
1. Remove the mis-fuel inhibit device by breaking the six lock tabs.

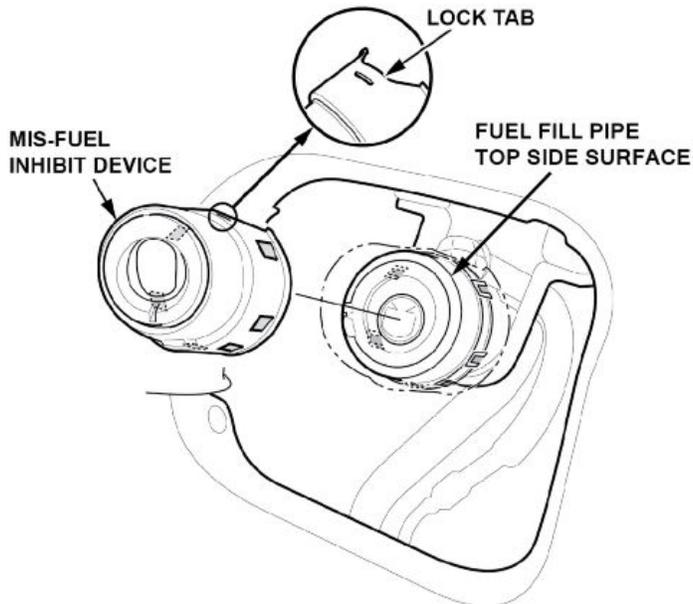
2. Pry up the lock tab, and remove the mis-fuel inhibit device.

Be careful not to damage the fuel fill pipe or the main flap unit (fuel fill pipe top side surface); they **do not** need to be replaced at this time.

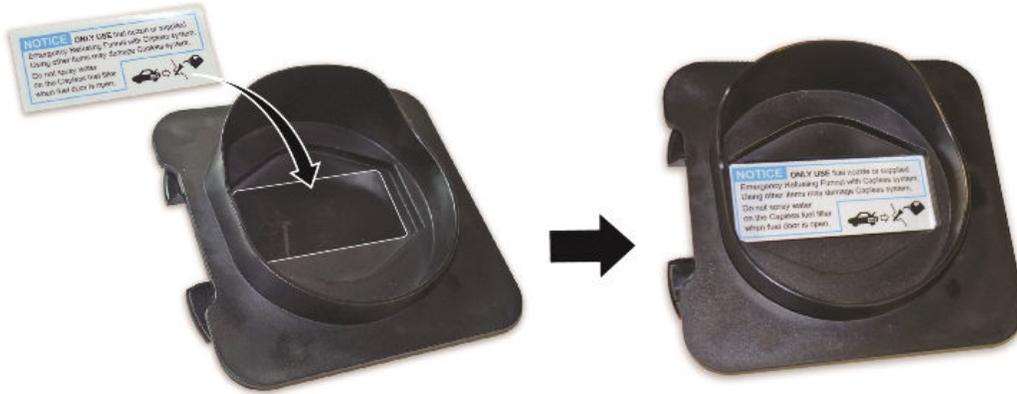
- Apply the fuel filler caution label to the new fuel filler lid cover as shown. Make sure the lid is clean and grease-free, especially on the surface where the label will be applied.

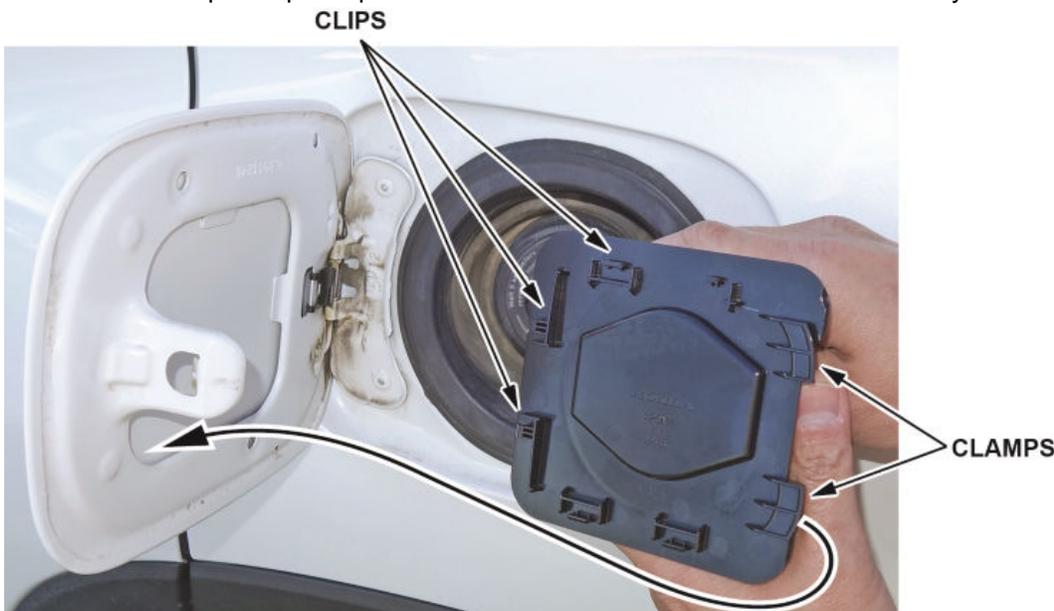
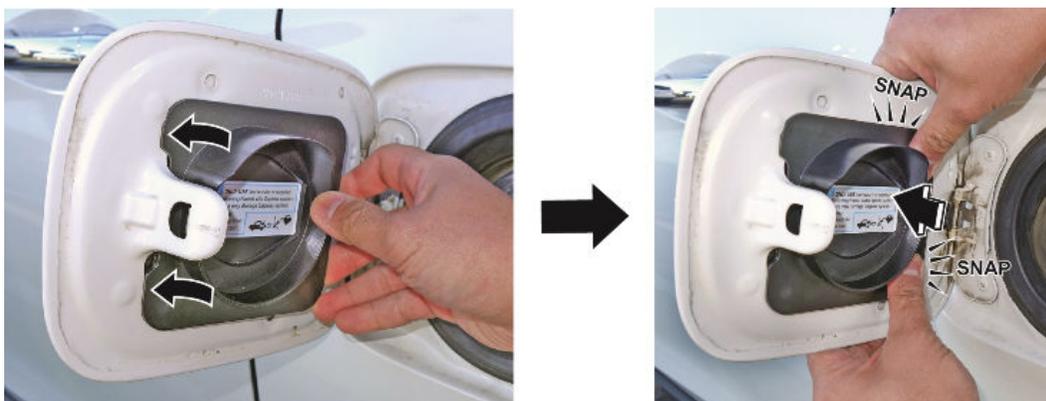
- Make sure the clamps engage the fuel fill door, then slide the lid cover away from the fuel fill door hinge. Press on the lid until the clips snap into place. This indicates the lid is secured and correctly installed.

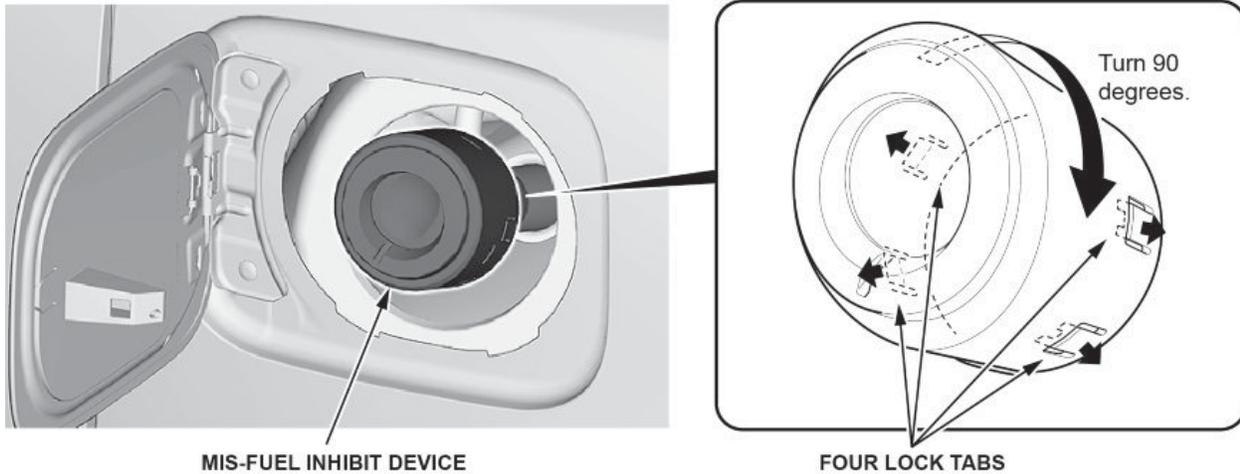
1. Remove the mis-fuel inhibit device by prying out the four lock tabs and turning the assembly 90 degrees.

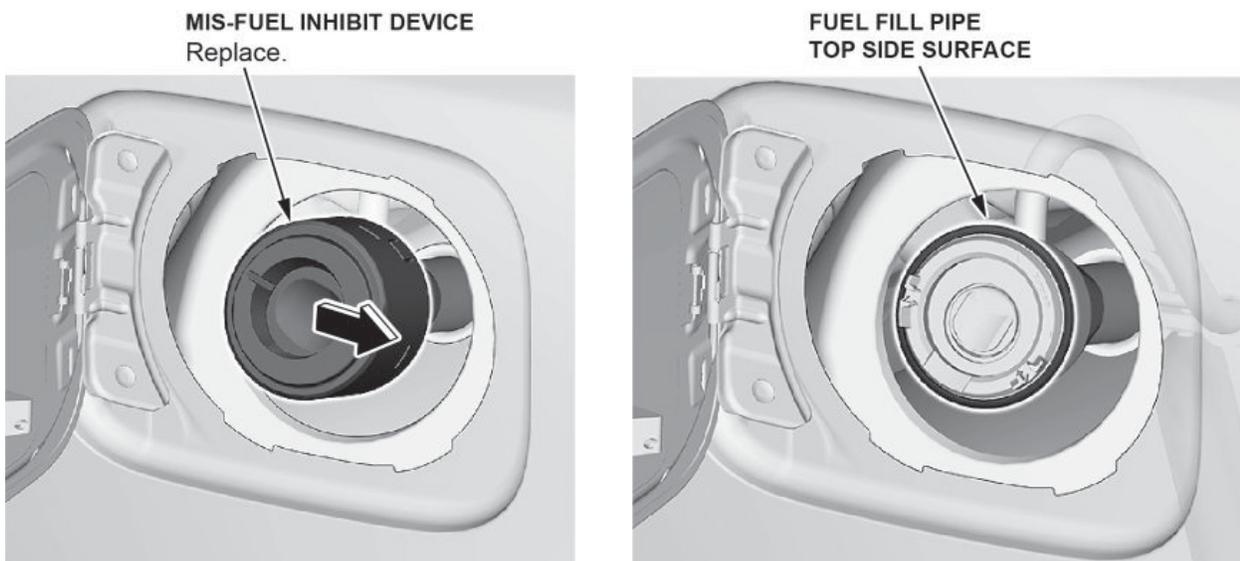
2. Tilt the mis-fuel inhibit device towards the rear of the vehicle to remove it from the fuel fill pipe.

Be careful not to damage the fuel fill pipe or the main flap unit (fuel fill pipe top side surface); they **do not** need to be replaced at this time.

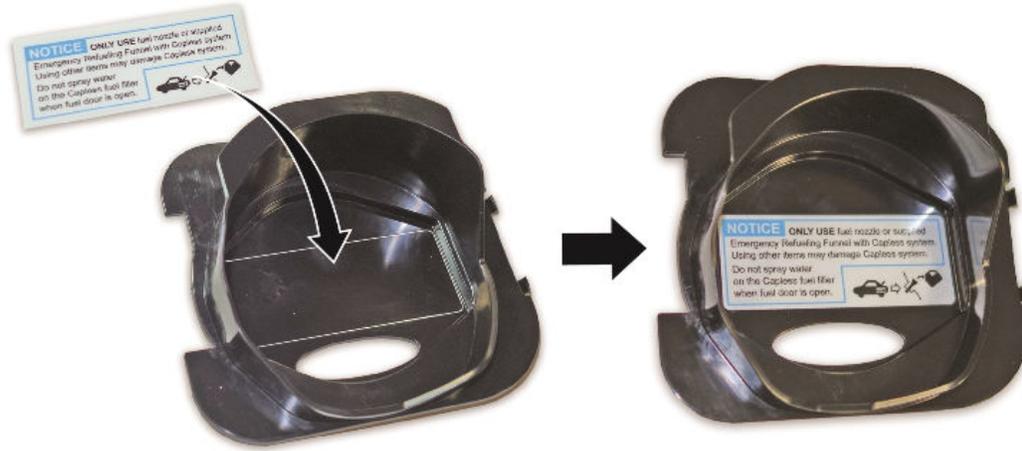
4. Apply the fuel filler caution label to the new fuel filler lid as shown. Make sure the new lid is clean and grease-free, especially on the surface where the label will be applied.

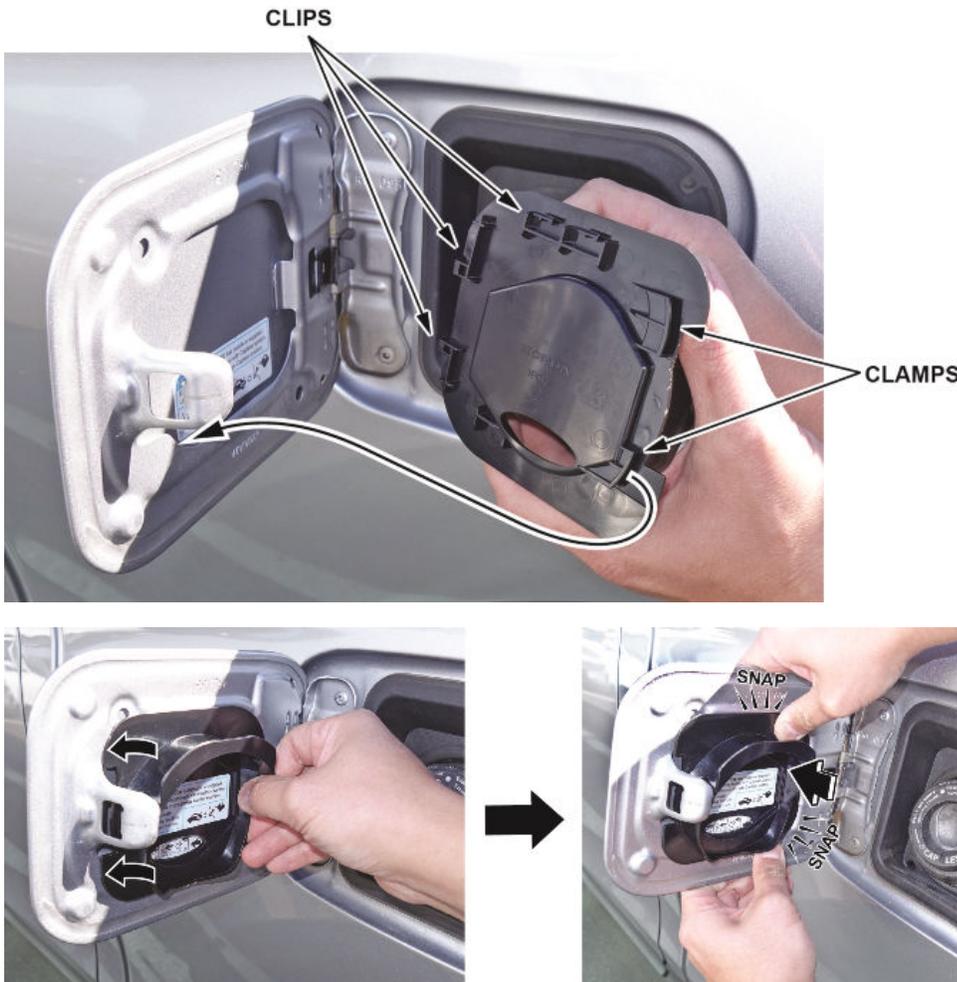
5. Make sure the clamps engage the fuel fill door, then slide the lid away from the fuel fill door hinge. Press on the lid until the clips snap into place. This indicates the lid is secured and correctly installed.

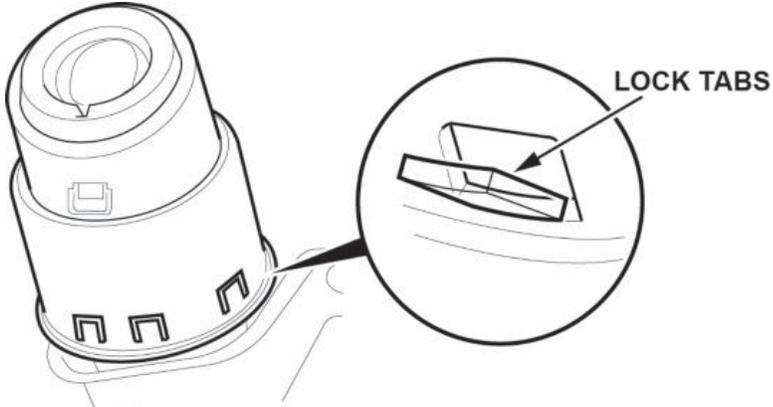
1. Remove the mis-fuel inhibit device by breaking the six lock tabs.

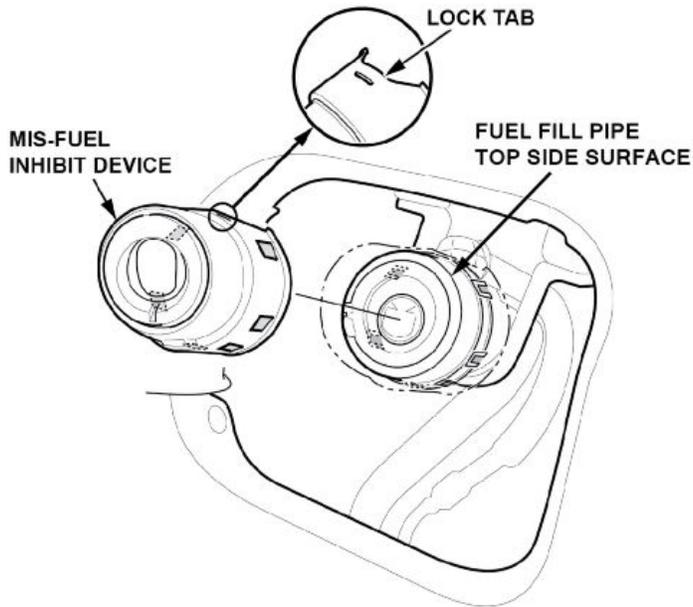
2. Pry up the lock tab, and remove the mis-fuel inhibit device.

Be careful not to damage the fuel fill pipe or the main flap unit (fuel fill pipe top side surface); they **do not** need to be replaced at this time.

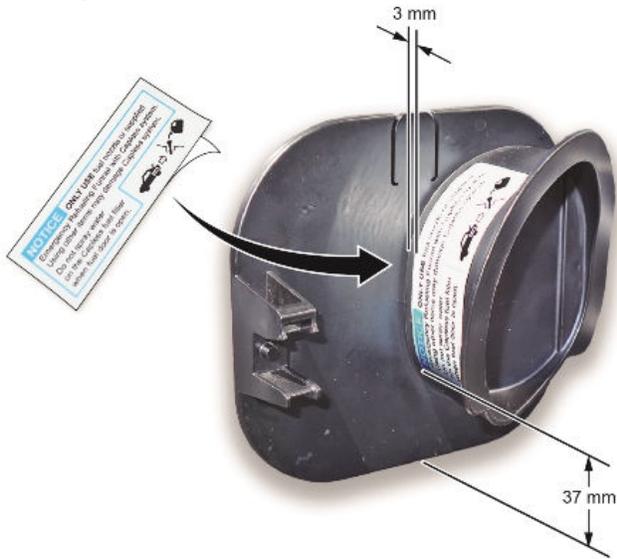
4. Apply the fuel filler caution label to the new fuel filler lid striker as shown. Make sure the lid is clean and grease-free, especially on the surface where the label will be applied.

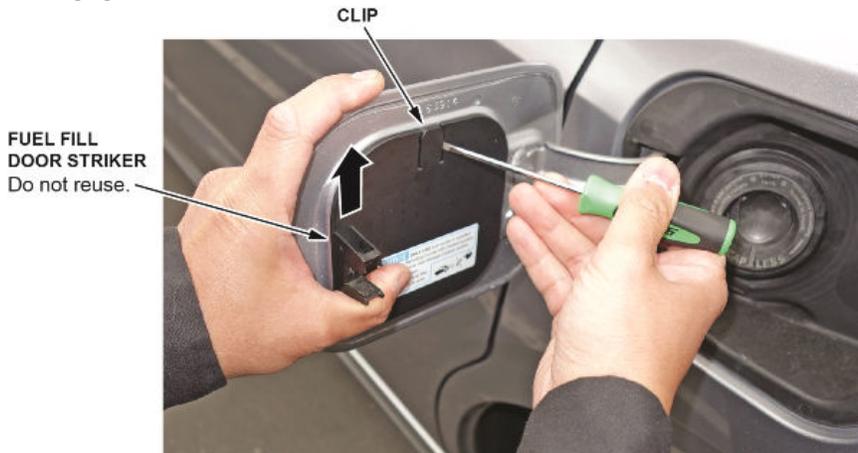
5. Remove the original fuel filler lid striker. Lift the fuel filler lid locking tab and slide the lid upwards until the tabs disengage from the slots in the fuel door.

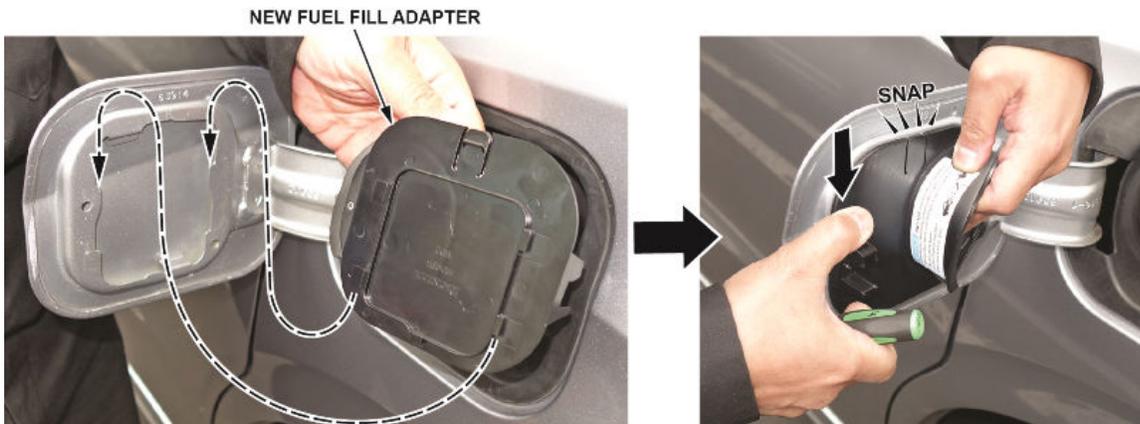
6. Installation of the fuel filler lid striker is the reverse of removal. Verify all the tabs are engaged, and slide the lid downwards until it clicks. This indicates the fuel filler lid striker is secured and correctly installed.

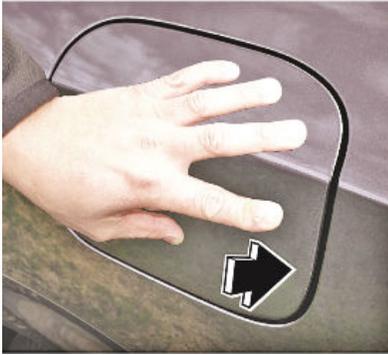
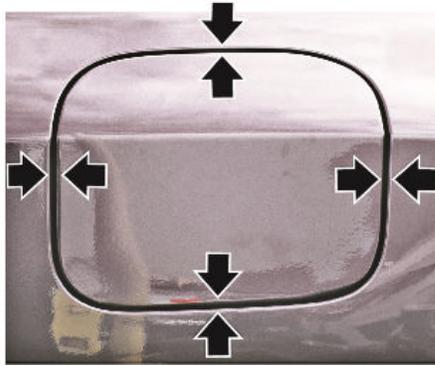
7. Make sure the fuel door closes and latches without contact or interference from the mis-fuel inhibit device and surrounding area. The gap between the door and the surrounding quarter panel should remain consistent.
