Requested Channel Not Available Message Covering SiriusXM® Preset Icons

Year	Model	Trim
2016-18	Civic	with SiriusXM Radio
2017-18	CR-V	with SiriusXM Radio

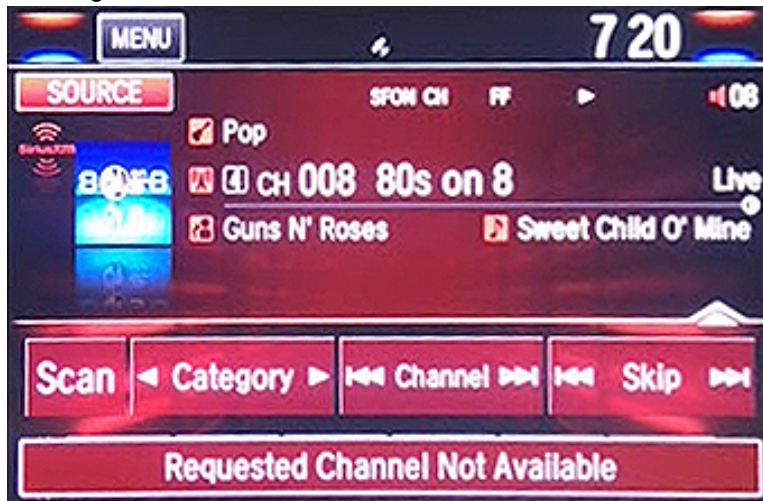
Got a vehicle with the message Requested Channel Not Available covering the SiriusXM preset icons? We're aware of this issue and have it under investigation.

This message only comes up when you select a SiriusXM station from the preset icons. When selected, the station starts playing, but the message covers those icons. This doesn't happen when using other means such as the Channel icons.

Until there's a solution to this issue, there's nothing you can do to fix it, so don't replace any parts. Instead, try this procedure. It should get rid of that message, but keep in mind this is just temporary, so the message may come back.

1. From the **SOURCE** screen, select **MENU, Setting, Multiple Channel Mix Preset**, then **ON**.
2. Select **OK**.
3. Select the **BACK** icon to go back to the audio source screen.
4. Using the **Channel** icons, select a different SiriusXM (music, no talk) station that's not already preset, and save it to one of the preset icons. You'll then see the message **Tunemix allows multiple channels to be combined on one preset. Would you like to combine this channel with the current preset or replace it?** Select **Combine**.
5. Select a different preset icon, and make sure the message doesn't come back.
