June 26, 2018

Product Update: 2017 Civic Type-R Turbocharger Control Solenoid Valve Circuit

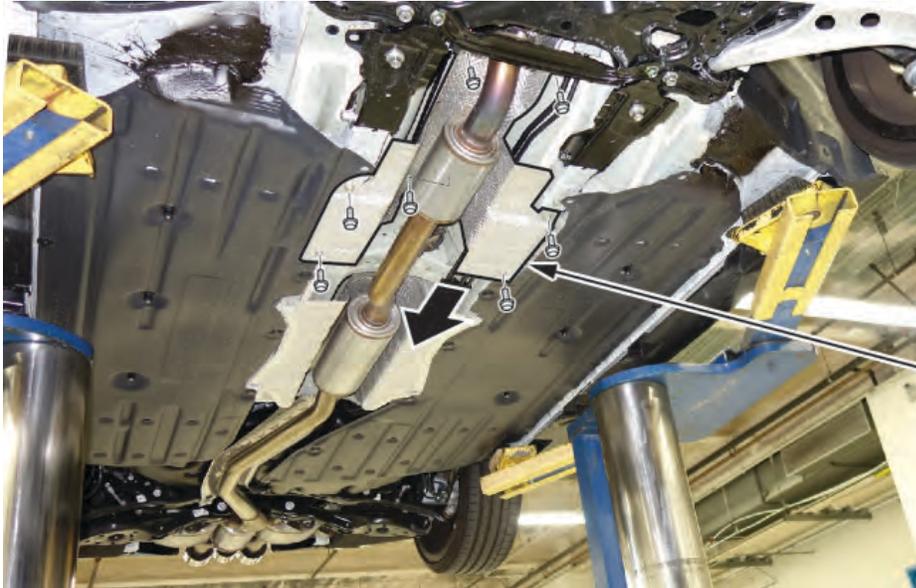
1. Disconnect the 12-volt battery. Refer to the service information.
2. Raise the vehicle on a lift.
3. Remove the following parts from underneath the vehicle. Refer to the service information.
 - Engine undercover
 - Unbolt and slide back the heat shield above exhaust pipe B

HEAT SHIELD
Slide rearward.

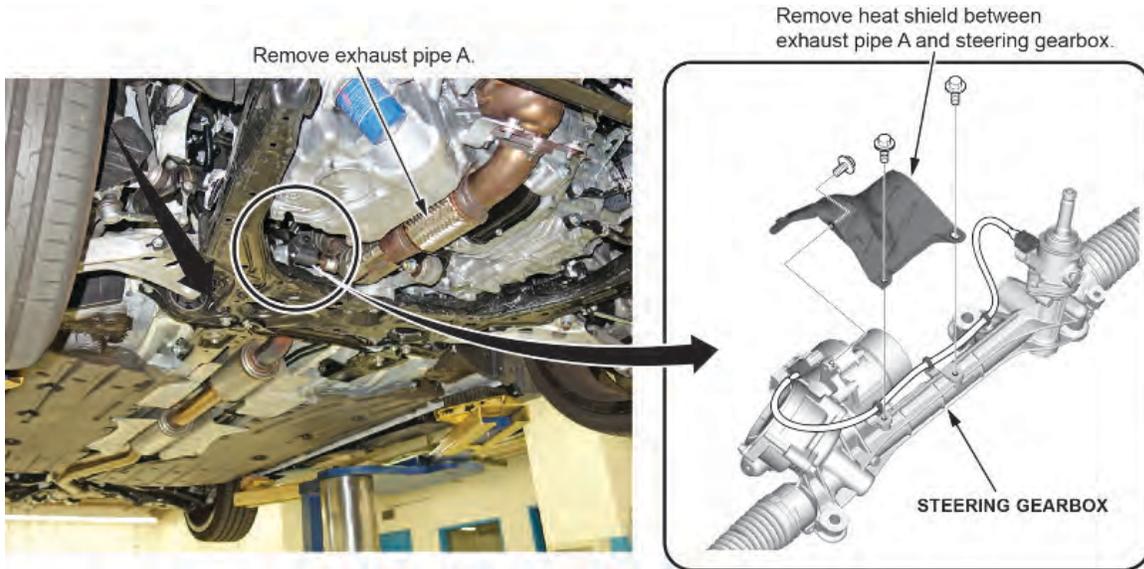
- Exhaust pipe A

- Power steering gearbox heat shield

Carefully remove exhaust pipe A to avoid damaging the steering gearbox heat shield.

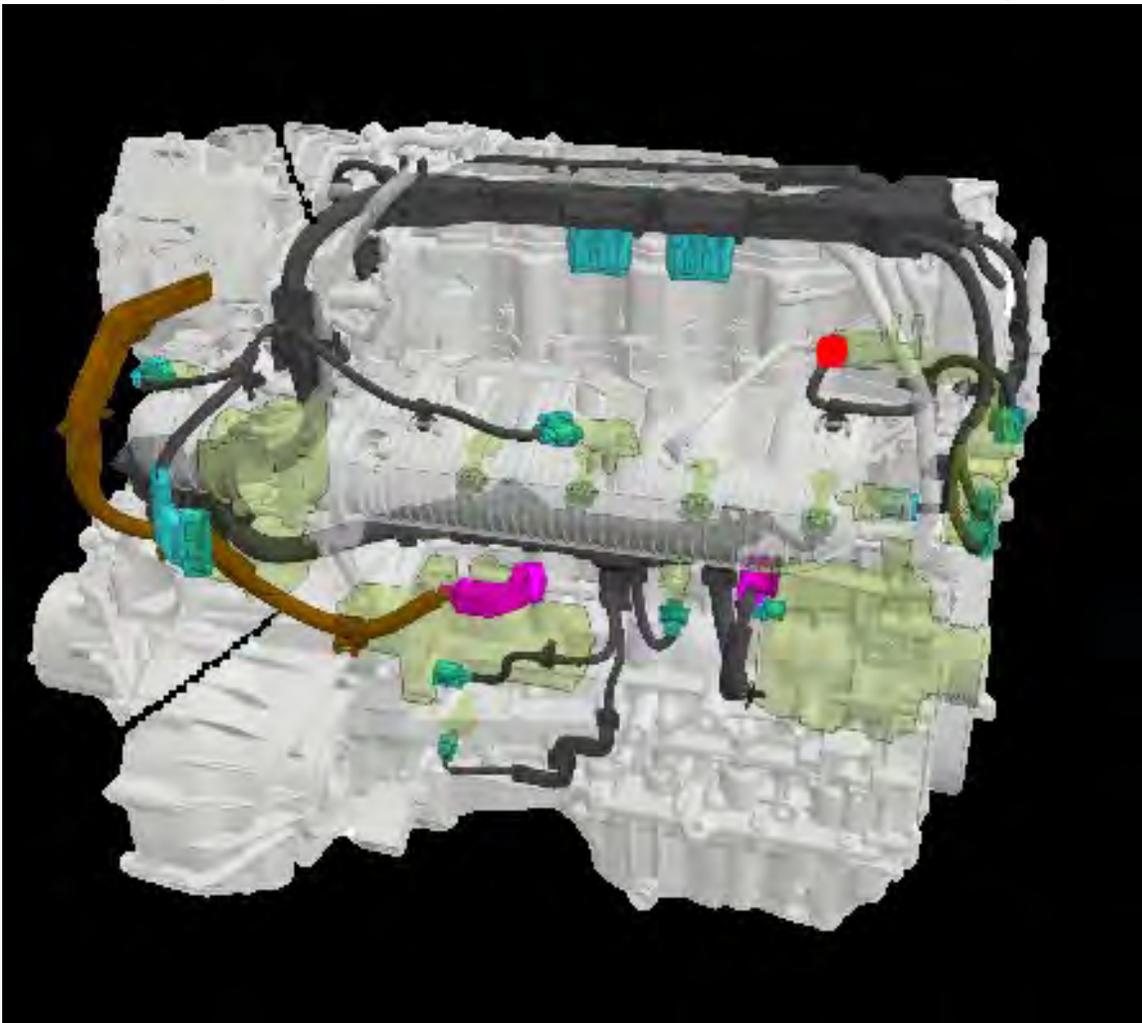
4. Disconnect the engine wire harness connectors underneath and at the back of the engine.

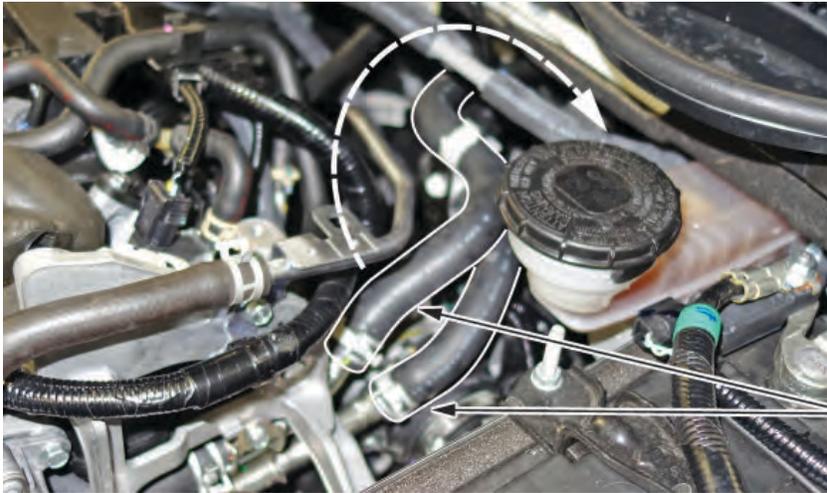
Carefully remove the heater hoses and cap off to avoid coolant loss.

HEATER HOSES
Disconnect and swing up
and out of the way.

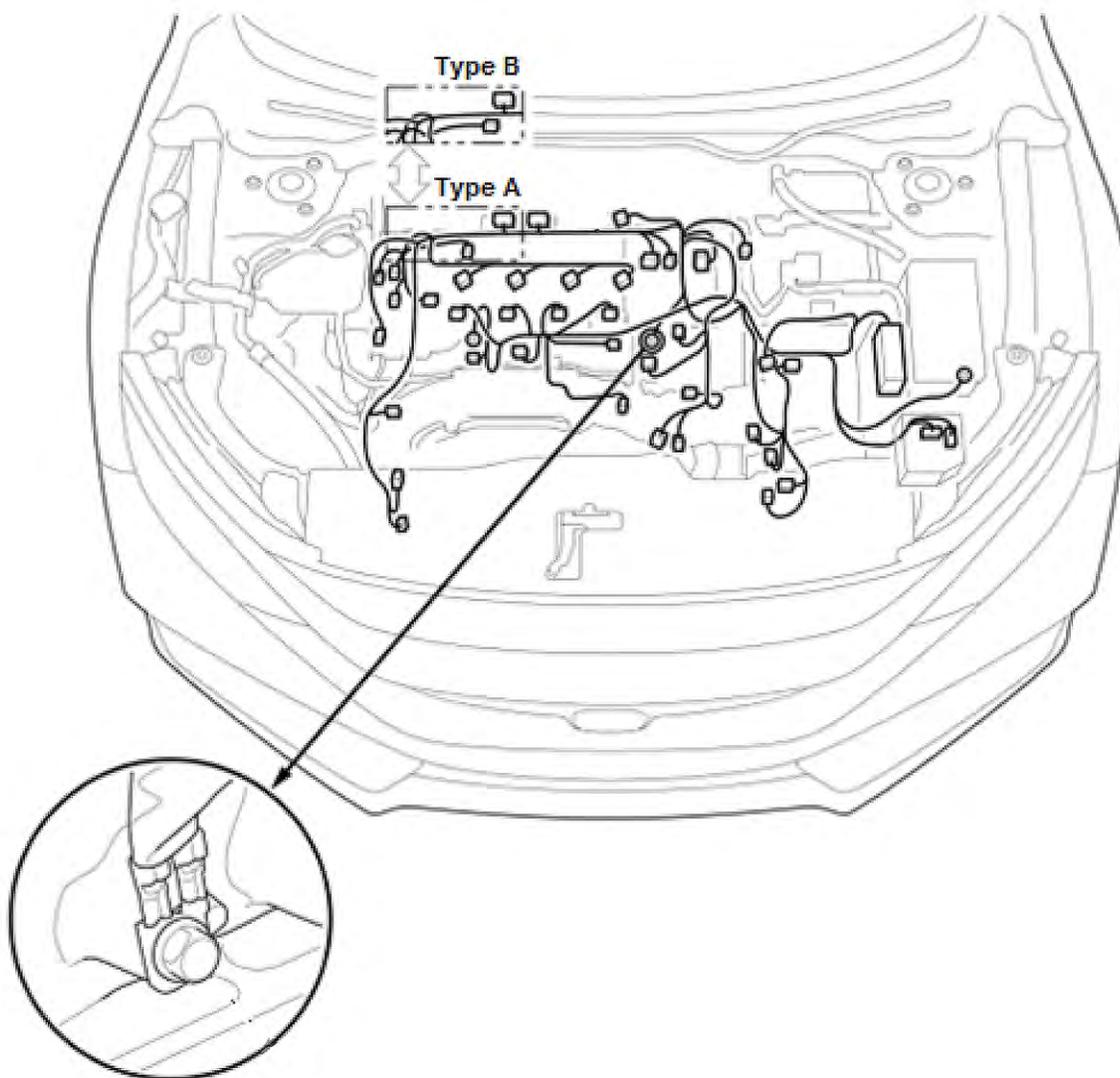
8. Disconnect the engine wire harness connectors, and unbolt the ground wires.

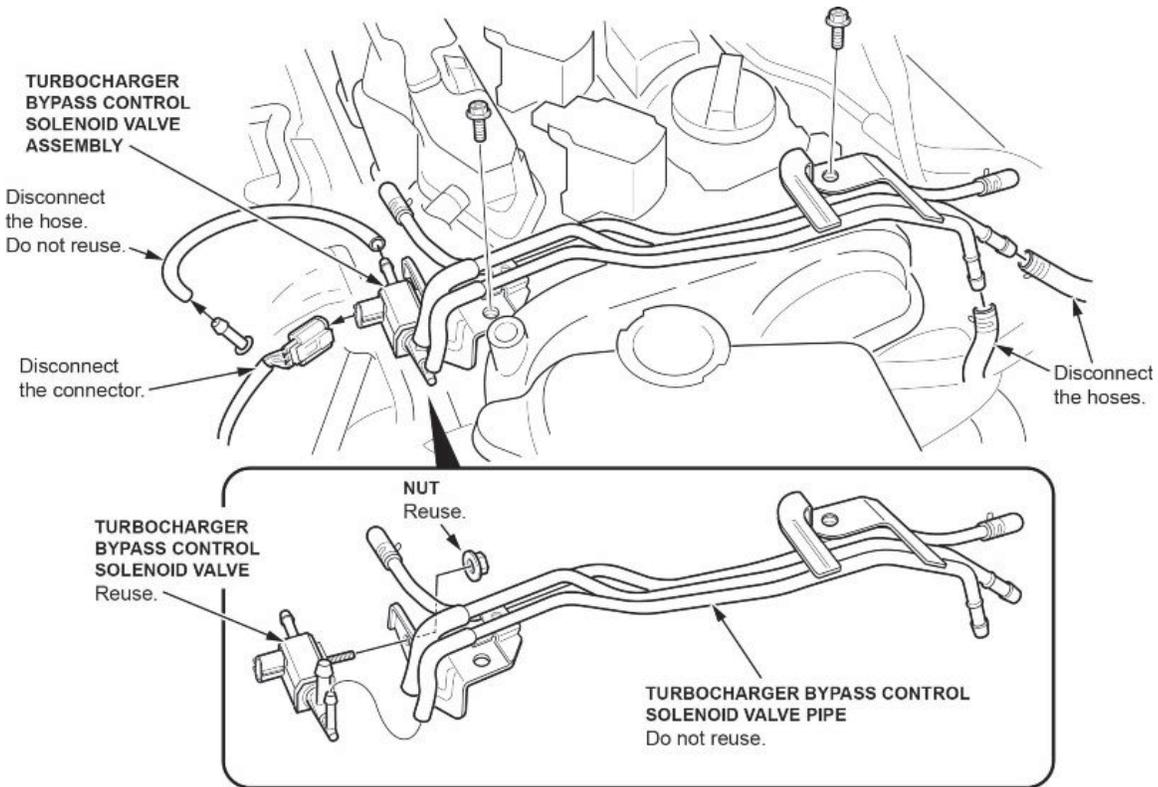
9. Remove the turbocharger bypass control solenoid valve and pipe as shown.

The turbocharger bypass control solenoid valve will be relocated and reused.

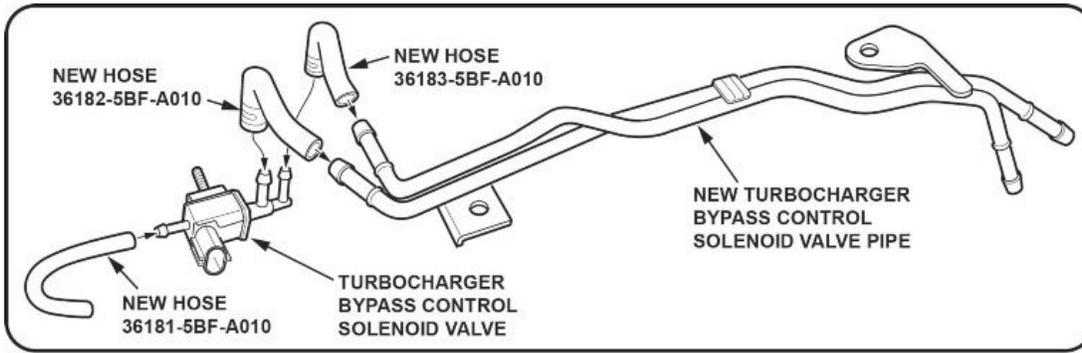
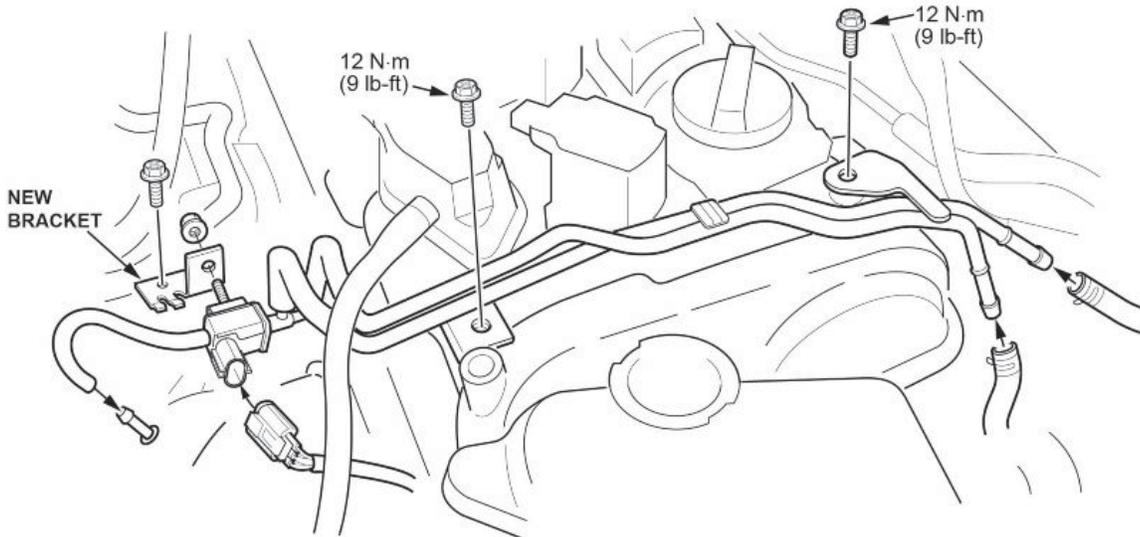
10. Remove the engine wire harness.
11. Install the new turbocharger bypass control solenoid valve pipe, connect the new hoses, and install the turbocharger bypass control solenoid valve as shown.

12. Install the new engine wire harness and related parts included in the kit.
13. Install all removed parts in the reverse order of removal. Refer to the service information.
14. Top off the coolant.
