June 26, 2018

ATF Leak from Transmission Case Bolt

Year	Model	Trim	VIN Range
2014	MDX	All with SH-AWD	5FRYD4H..EB030353 thru 5FRYD4H..EB041381

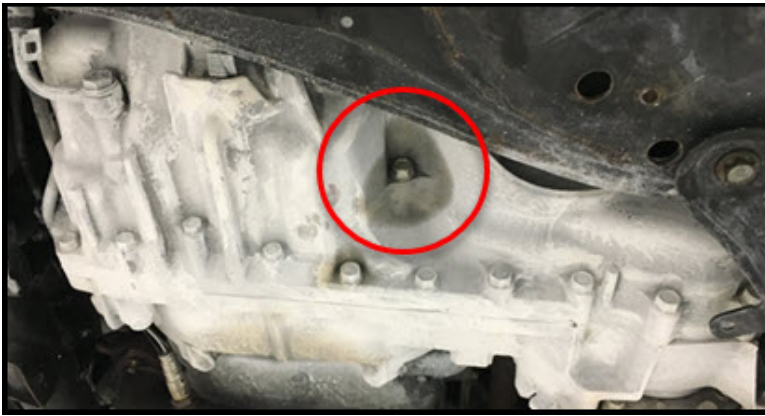
During assembly, a transmission case bolt was not properly torqued allowing ATF to leak.

Compare the leak location on the vehicle to this photo.

The transmission bolt in this location **only** applies to vehicles with SH-AWD. A 2WD vehicle has a **different** case allowing greater clearance for proper torque during assembly.

- If it is in the same location, go to REPAIR PROCEDURE.
- If the leak is not from this location, clean and add dye to isolate the leak.

1. Remove the lower transmission cover.
2. Remove the 10 x 95 mm flange bolt to the left of the drive shaft on the driver's side of the vehicle.
3. Clean the bolt and the transmission case. Install the bolt, and torque it to **45 N·m (33 ft-lb)**.

Use a 14 mm thin-walled socket to maintain clearance between the socket and the transmission case. **Do not** use an impact socket as it may contact the transmission case and not provide proper torque.
