# HYUNDAI

## Technical Service Bulletin

GROUP <b>FUEL SYSTEM</b>	NUMBER <b>18-FL-002</b>
DATE <b>JUNE, 2018</b>	MODEL <b>ACCENT (RB)</b>

**SUBJECT:** CCV AND AIR DRAIN CASE INSPECTION/REPLACEMENT

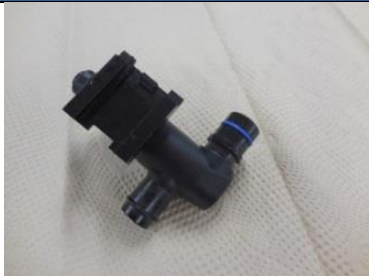
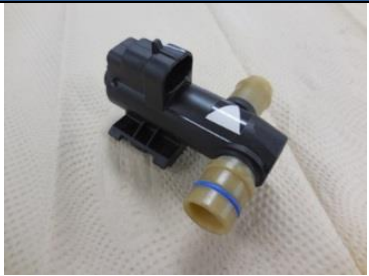
1 each  (when applicable)
	Port color : Black	Port color : Ivory	
	31453-3K600	<b>31453-3K600FFF</b>	
Air Drain Case

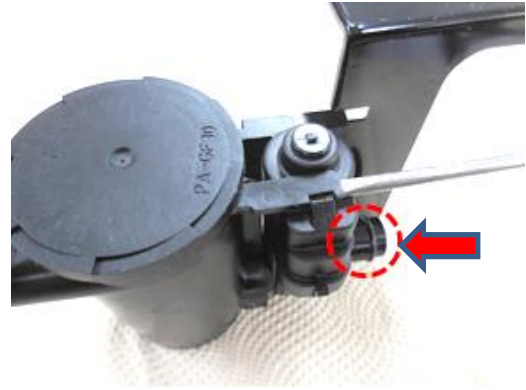
4. Check the color of the CCV Port and its interior condition:

**CCV Port color is Black:**

- a. Continue to step 5 to replace the CCV valve part.
- b. **Claim 31035F03**  
(CCV INSPECTION AND CCV & AIR DRAIN CASE REPLACEMENT).

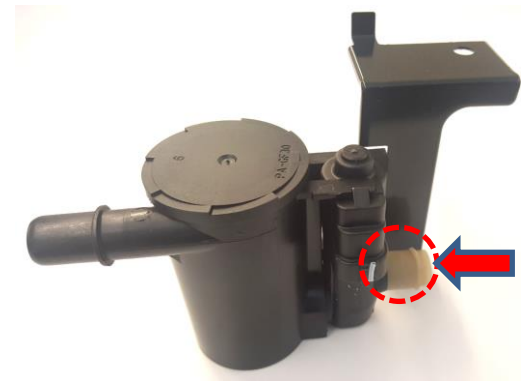
**CCV Port color is Ivory:**

- a) **Interior of CCV Port is clean.**
  - i. The CCV will not be replaced. Reinstall it back on the vehicle.
  - ii. Skip to step 11 to replace the Air Drain.
  - iii. **Claim 31035F02**  
(CCV INSPECTION AND AIR DRAIN CASE REPLACEMENT).

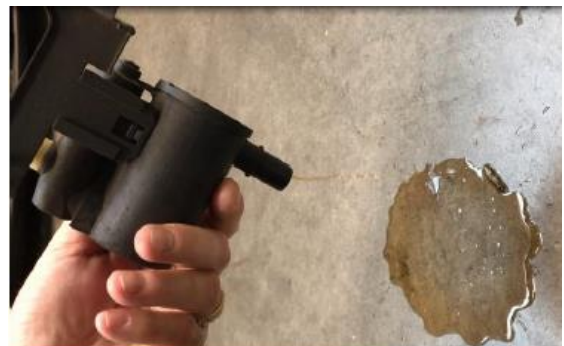
- b) **Interior of CCV Port has liquid or foreign material deposit.**
  - i. Go to step 5 to replace the CCV valve part.
  - ii. **Claim 31035F03**  
(CCV INSPECTION AND CCV & AIR DRAIN CASE REPLACEMENT).

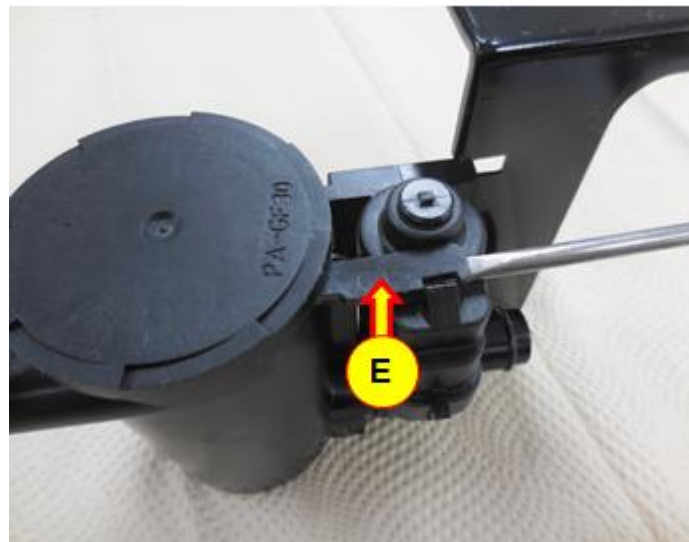
5. Release the mounting lever using a narrow flat blade screwdriver.

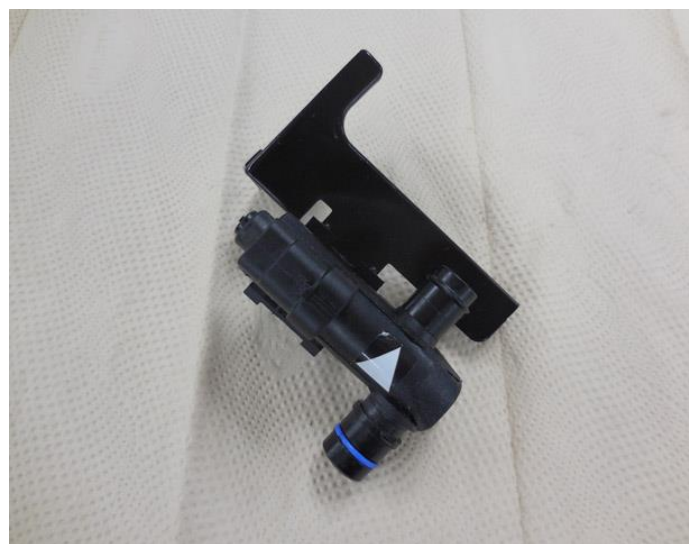
6. Rotate the CCV & bracket (F) clockwise and pull the CCV towards the red arrow direction to remove it from the fuel tank air filter (G).

The fuel tank air filter will be reused. After removal, blow shop air through the filter to fully remove any liquid and foreign material, making sure that air can pass through freely.

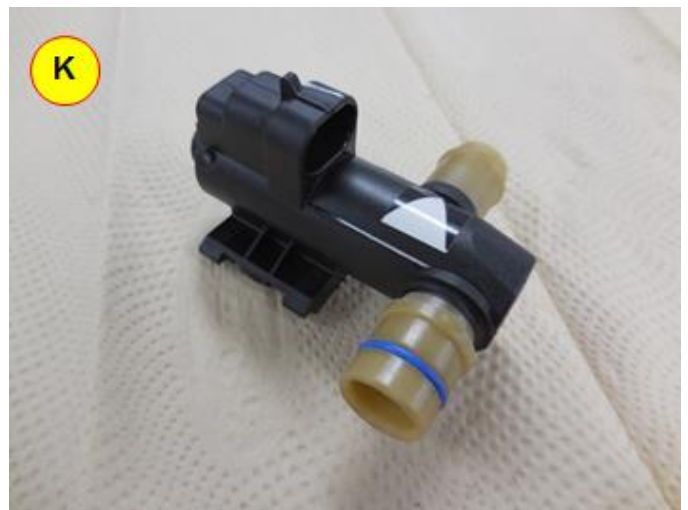
9. Install the new CCV (K) listed in the Parts Information of page-1.
10. Reinstall all removed parts in reverse order of removal.

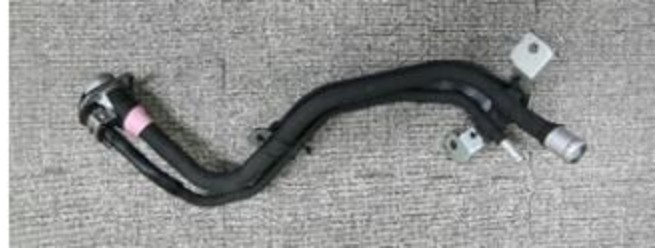
11. Remove the fuel filler neck assembly referring to the applicable vehicle shop manual.  
\*Engine control/fuel system > Fuel delivery system > Filler-neck assembly”

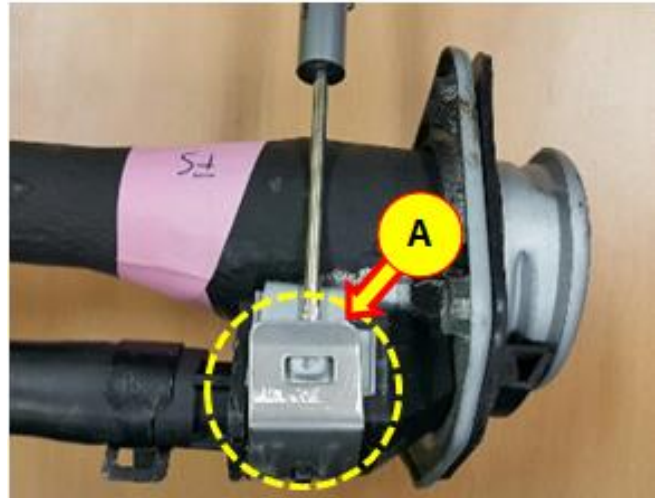
12. Remove the retaining clip (A) from the air drain case using a flat head screwdriver.

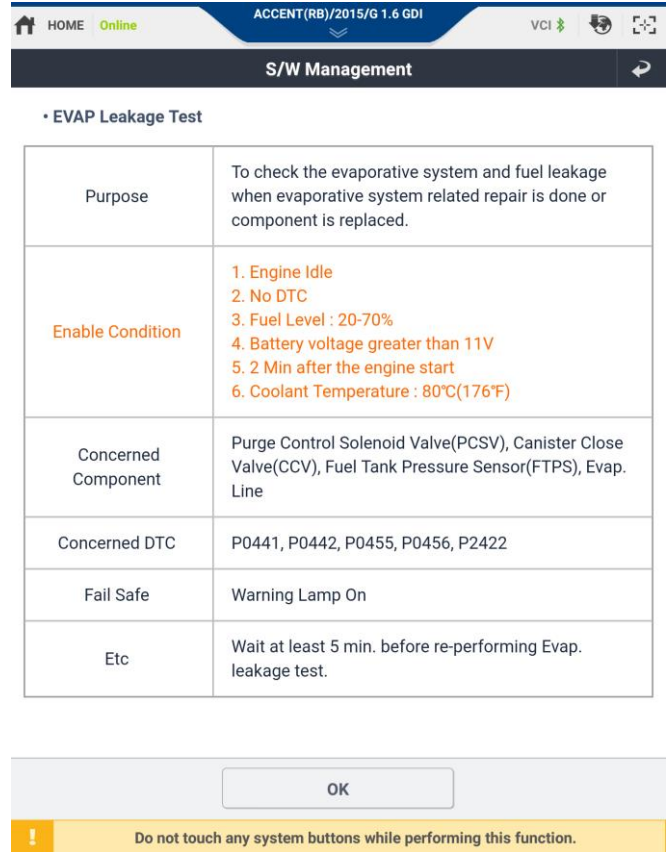
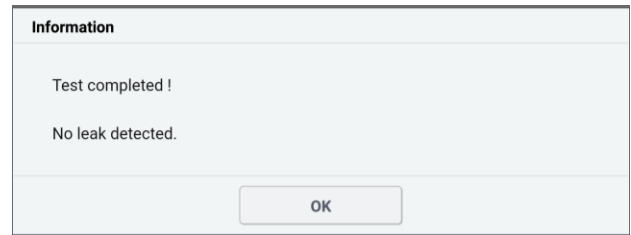
17. Connect the GDS and perform the **Evap Leakage Test** to ensure a result of **No Leak Detected**. This will confirm proper installation and that the original DTC P0455/P0456 condition has been resolved.

This is the result when Evap Leakage Test completes successfully with “No leak detected.” →

**If the result shows Leakage Detected, confirm the repair areas, then check for leakage from other areas of the Evap system.**
