LTB00990NAS4 TECHNICAL BULLETIN 18 May 2018

206-04: Rear Disc Brake

Rear Brake Disc Corrosion

LTB00990NAS4 - Rear Brake Disc Corrosion | TOPIx

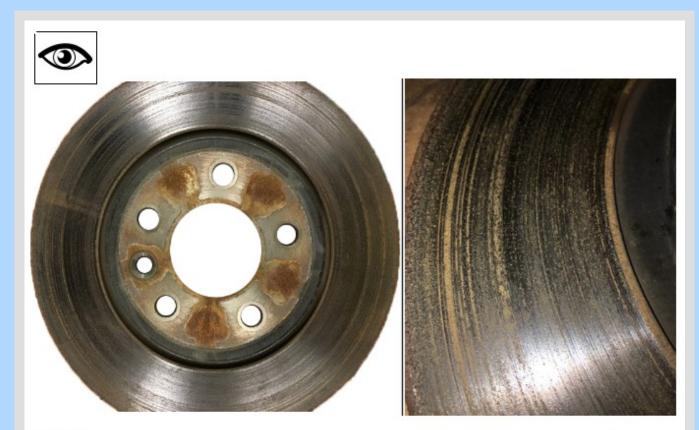
E225443

Rear brake disc replacement NOT required.

Brake disc surface corrosion is visible; grinding noise or vibration may be present: advise the customer that the concern does not affect the function of the brakes.

1 Go Workshop Procedure 'A'.

For vehicles where visible brake disc surface corrosion is visible and where a grinding noise or vibration may be present, advise the customer that the rear brake disc condition will improve after a period of normal use. Where requested, an example of a typical drive cycle and brake deployment may be suggested as follows

1 Where safe and reasonable to do so, use the brakes to decelerate when required by the traffic conditions. Braking from a moderate speed 50-56 km/h (30-35 mph) is adequate with moderate deceleration, avoiding the use of engine braking or coasting to slow down.

Return the vehicle to the customer. Advise the customer that the rear brake disc condition will improve after a period of normal use, dependent on road type, weather conditions. and brake usage.

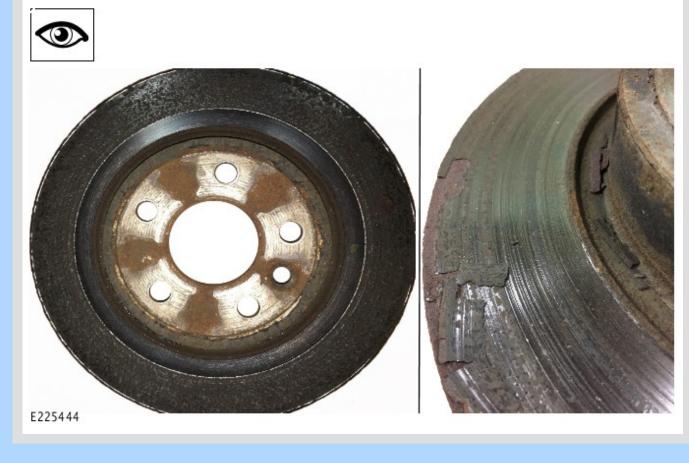
Rear brake disc replacement required.

Heavy brake disc surface corrosion is visible and grinding/vibration is present.

1 Go Workshop Procedure 'B'.

Replace the rear brake discs (see TOPIx Workshop Manual section 206-04: Rear Disc Brake Removal and Installation - Brake Disc).
