INSTRUCTION TO SERVICE

ITS: 6825	
SECTION:	405 ARTIC JOINT.
WRITTEN BY:	Michael Rooney
SUBJECT:	Remove & Replace A/C Hoses.

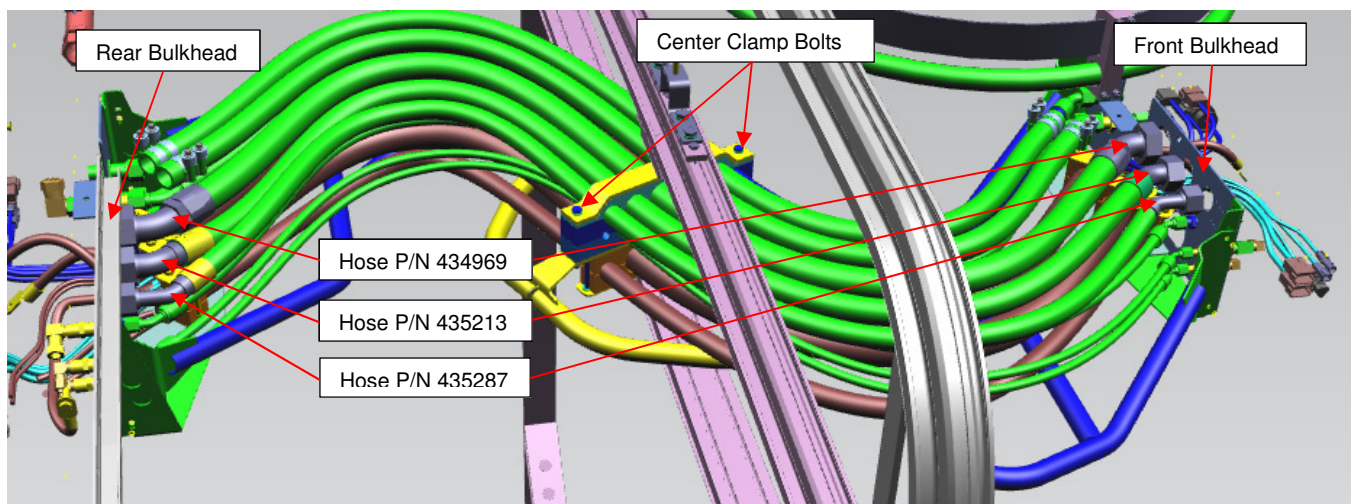
Figure 1: Artic Joint Hoses Viewed from Above.

3. Locate the center clamp that secures the center point of the hoses in the articulated joint. Mark all the hoses at the point where they pass through the clamp at the forward edge to facilitate re-assembly later.
4. Remove the bulkhead covers to access the copper lines behind the bulkheads. Use a backup wrench on the nuts on the copper lines to prevent damage due to twisting when the hoses are being removed.
5. Locate hoses NF P/N 435213, P/N 435287. Disconnect these hoses at the front and rear bulkheads of the articulated joint.
6. Locate the orings inside the connectors at the bulkheads. Replace them with new orings. The -16 oring is NF P/N 010630 and the -20 oring is NF P/N 010629.

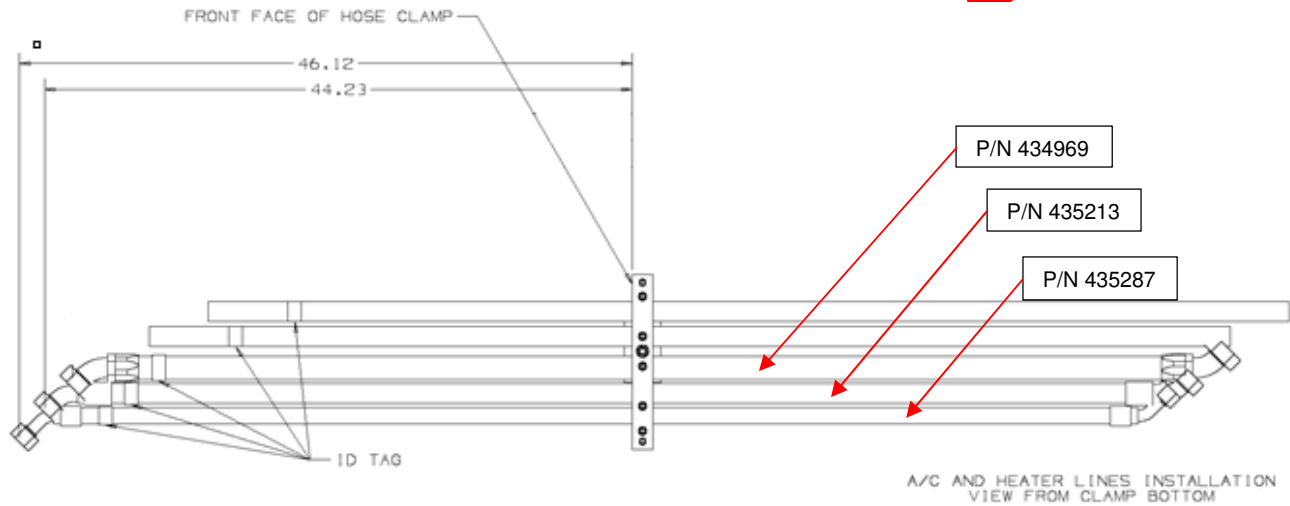
Figure 2: Locations to Mark A/C Hoses.

7. Remove the bolts that secure the two halves of the center clamp and loosen the center bolt so the two hoses can be removed.
8. Lay out the new replacement hoses NF P/N 435213, P/N 435287 on a table and mark the point where the hoses will be clamped by the forward edge of the center clamp.

9. Install the new replacement hoses in their respective positions in the center clamp, aligning the marks with the forward edge of the center clamp. Reinstall the center clamp end bolt but leave the bolts loose.
10. At the forward bulkhead, reconnect the hoses to their respective connection points. Note that there are alignment marks on the bulkhead for orienting hose P/N 435213 & P/N 435287. Figure 3.
 - a. The alignment marks for hose P/N 435213 are 10 deg upward from horizontal.
 - b. The alignment marks for hose P/N 435287 are 10 deg downward from horizontal.

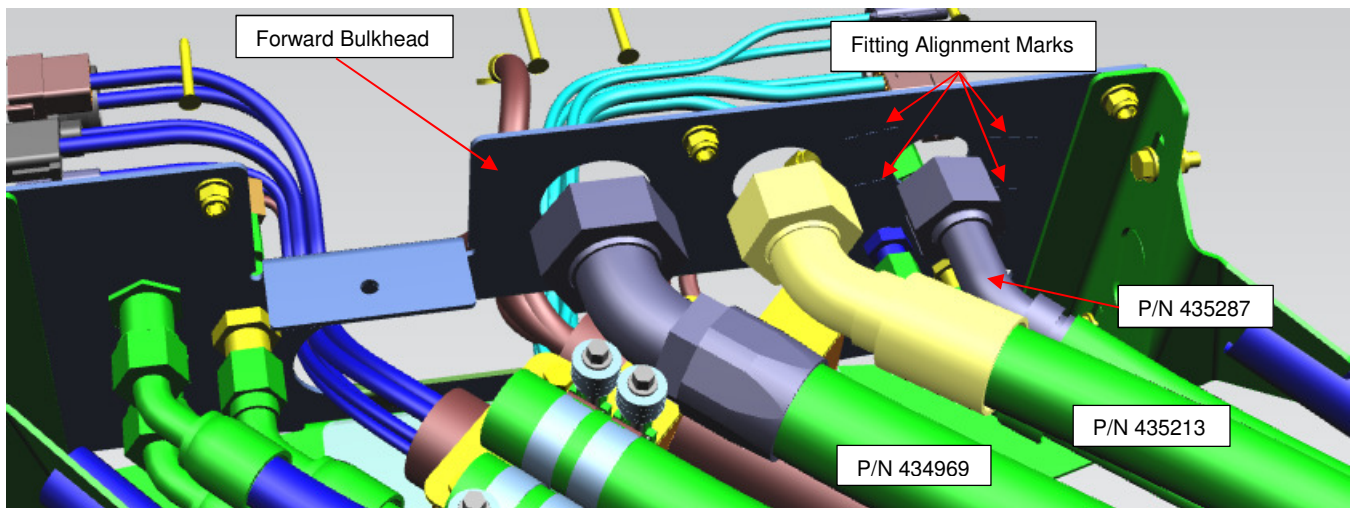
Figure 3: A/C Hoses & Alignment Marks at Forward Bulkhead.

NOTE: It is important that the hose fittings are oriented correctly to prevent binding and interference of hoses which may result in damage due to pulling and chaffing when the artic joint moves through its range of motion.

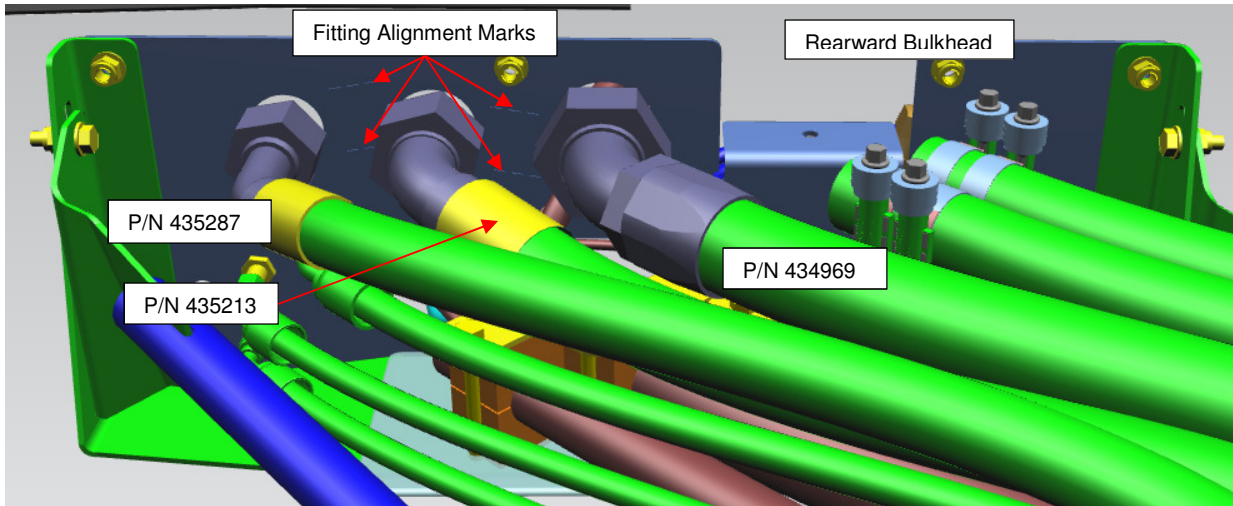
Figure 4: A/C Hoses & Alignment Marks at Rearward Bulkhead.

11. At the rearward bulkhead, reconnect the hoses to their respective connection points. Note that there are alignment marks on the bulkhead for orienting hose P/N 435213 & P/N 435287. Figure 4.
 - a. The alignment marks for hose P/N 435213 are 10 deg downward from horizontal.
 - b. The alignment marks for hose P/N 435287 are 10 deg upward from horizontal.
