Fresh/Recirculation Servo Actuator Separation

Service Category Vehicle Interior

Section Heating/Air Conditioning

Market USA

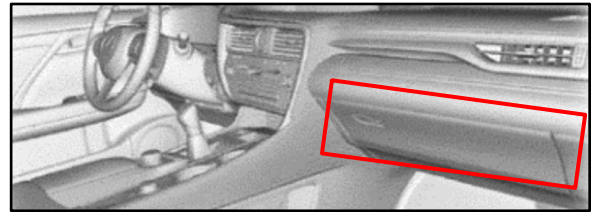
Figure 1.

- B. Remove the glove compartment door assembly.

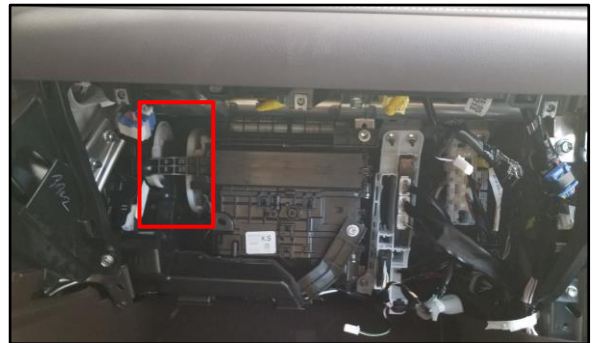
Figure 2. Actuator Installed

- C. Check the fresh/recirculation servo motor actuator.

Is the actuator separated from the blower assembly?

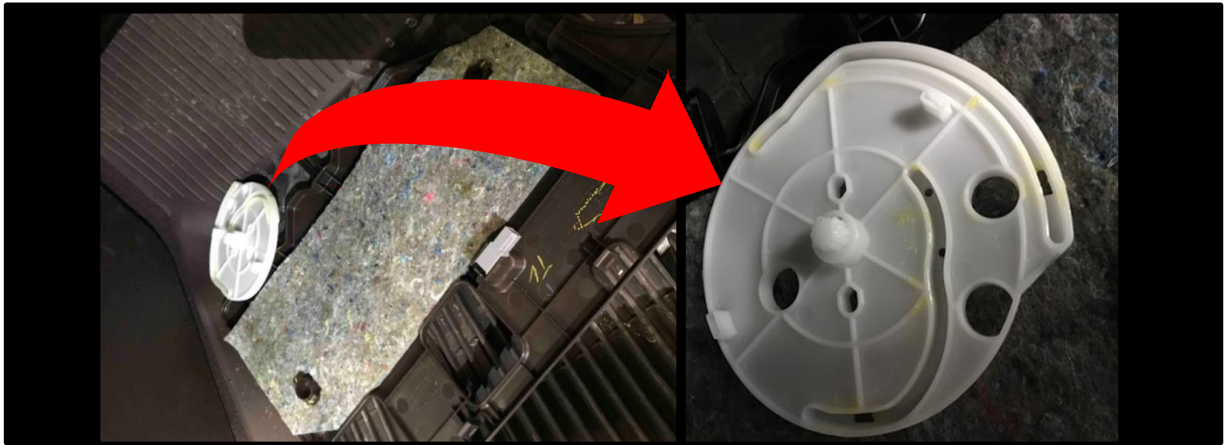
Figure 3.

2. Check for the servo motor actuator on the passenger kick plate or in the passenger side foot well.

Is the servo motor actuator present?

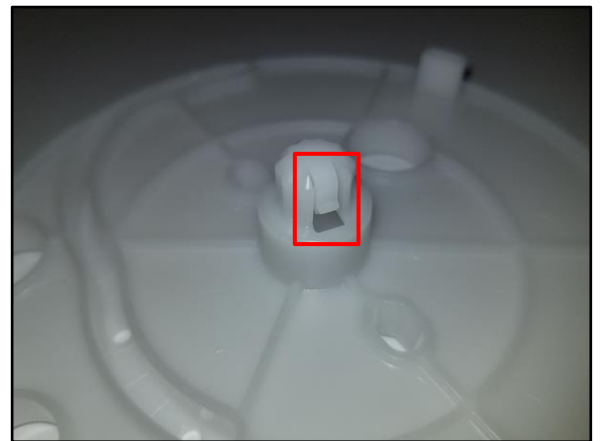
Figure 4.

3. Inspect the servo motor actuator for ANY damage, specifically the locking tab.

Is ANY damage present?

4. Install a NEW damper servo sub-assy.

Installation of a NEW damper servo sub-assy is ONLY required if the servo motor actuator is missing or damaged

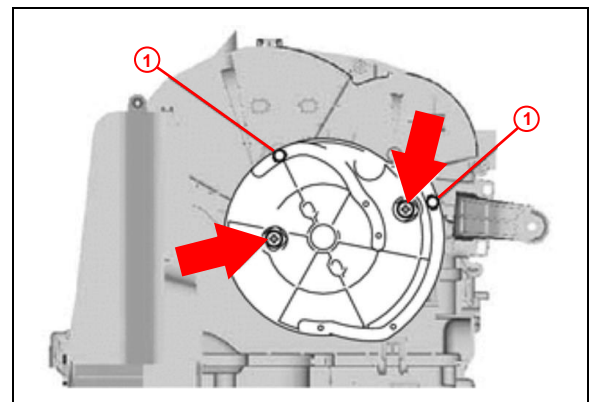
Figure 5.

1	Link
----------	-------------

5. Reinstall the servo motor actuator.

With two links of the blower assembly in the appropriate channels (as shown), install the servo motor actuator to the servo motor until a click is heard.
