# Infotainment System Reboots Under Cold Temperatures

YEAR(S)	MODEL(S)	ADDITIONAL INFORMATION
2016	iA

Some 2016 model year iA vehicles may exhibit a condition where the infotainment system reboots or the infotainment screen turns black under cold temperatures. This condition occurs when the vehicle interior is cold, and stops as the interior temperature increases. Follow the Repair Procedure in this bulletin to address this condition.

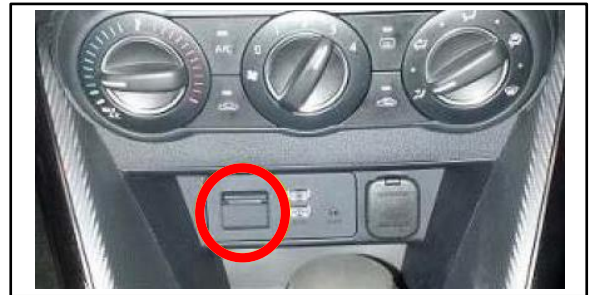
**Figure 1. SD Card Slot**

2. Is an SD card already installed in the vehicle?

3. Remove the SD card.
