# Replace Bolts In Steering Rack Housing

**Classification** Recall Bulletin      **Section/Group** 32 - Steering      **Country/Region** All

**Year** 2012-2016      **Model** Model S      **Version** All

Long-term exposure to high-corrosion environments might weaken the bolts that attach the power steering motor to the steering rack housing.

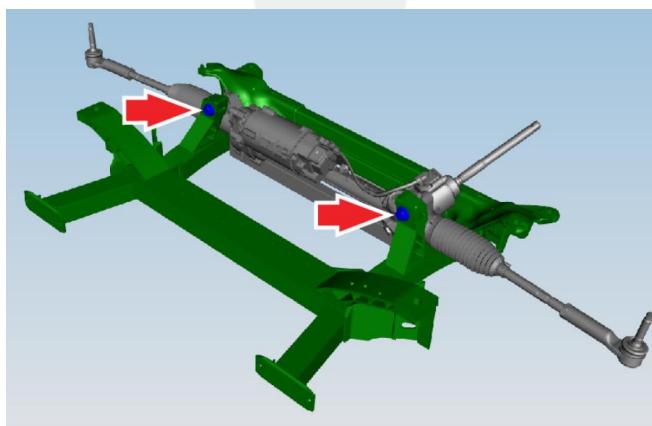
Figure 1

1. Remove the underhood storage unit (refer to Service Manual procedure 15240701).
2. Disconnect 12V power (refer to Service Manual procedure 17010100).
3. Loosen the RH front wheel lug nuts.
4. Raise the vehicle slightly so that the tires are off the ground.
5. Remove the LH and RH steering rack mounting bolts that attach the steering rack to the front subframe (Figure 1).

**⚠ CAUTION:** A washer might be located between the steering rack and the subframe. If there is a washer, retain and use this washer during reinstallation of the steering rack mounting bolts later in this procedure.

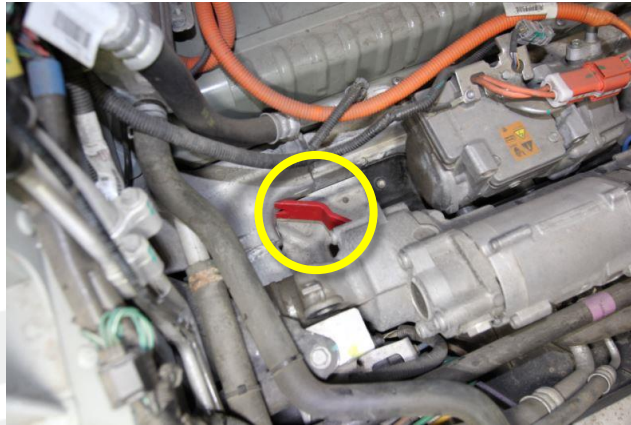
**Figure 2 (Red plastic trim tool highlighted)**

6. Use a plastic trim tool or block between the steering rack and the front subframe to raise and support the RH side of the steering rack (Figure 2).

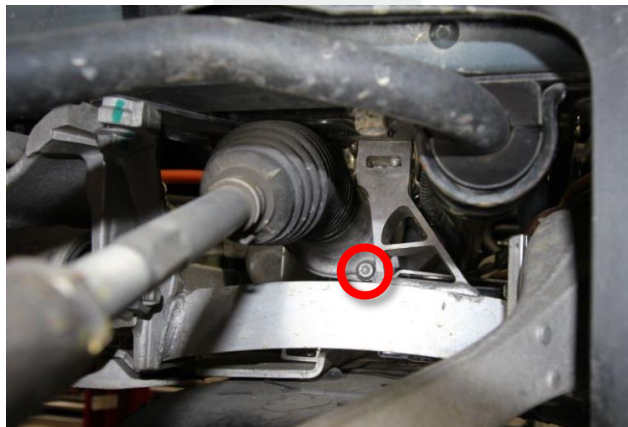
**Figure 3**

7. Partially raise the vehicle so that it is at a comfortable working height.
8. Remove the RH front wheel (refer to Service Manual procedure 34015001).
9. Clean the area around the front lower steering rack housing bolt with a shop towel, and then clean debris away with compressed air (Figure 3).

10. Inspect the front lower steering rack housing bolt (Figure 3):

- If the front lower steering rack housing bolt is sheared off or damaged, discontinue this procedure and replace the steering rack (refer to Service Manual procedure 32010102).
- If the front lower steering rack housing bolt is not sheared off or damaged, continue to the next step.

11. Remove and discard the front lower steering rack housing bolt (Figure 3).

12. Install a new front lower steering rack housing bolt, tighten the bolt to 5 Nm (+/- 0.5 Nm) plus 90 degrees (Figure 3), and then mark the bolt with a paint pen.

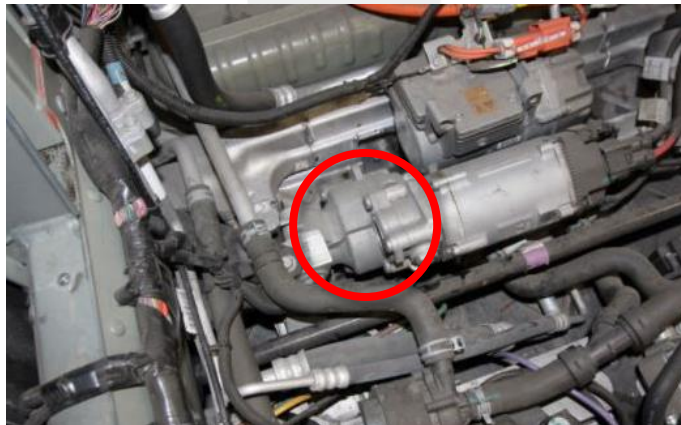
Figure 4

15. Clean the area around the remaining steering rack housing bolts with a shop towel, and then clear any debris away with compressed air (Figure 4).

**⚠ CAUTION:** Do not use a steel or brass brush to clean the area around the steering rack housing bolts. Rust damage to the steering rack might result.

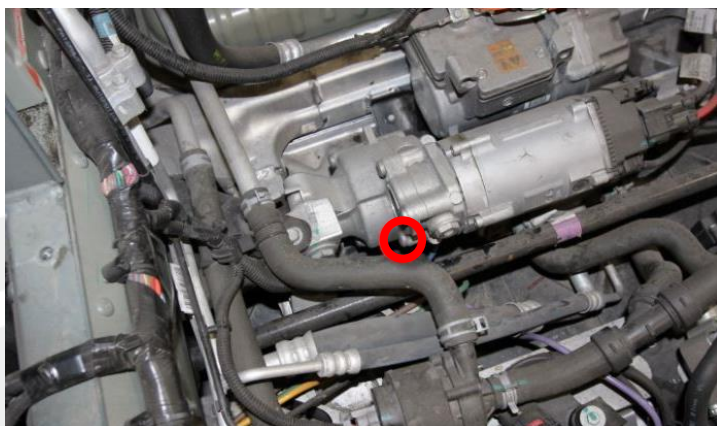
**Figure 5**

16. Inspect the front middle steering rack housing bolt (Figure 5):

- If the front middle steering rack housing bolt is sheared off or damaged, discontinue this procedure and replace the steering rack (refer to Service Manual procedure 32010102).
- If the front middle steering rack housing bolt is not sheared off or damaged, continue to the next step.

17. Remove and discard the front middle steering rack housing bolt (Figure 5).

18. Install a new front middle steering rack housing bolt, tighten the bolt to 5 Nm (+/- 0.5 Nm) plus 90 degrees (Figure 5), and then mark the bolt with a paint pen.

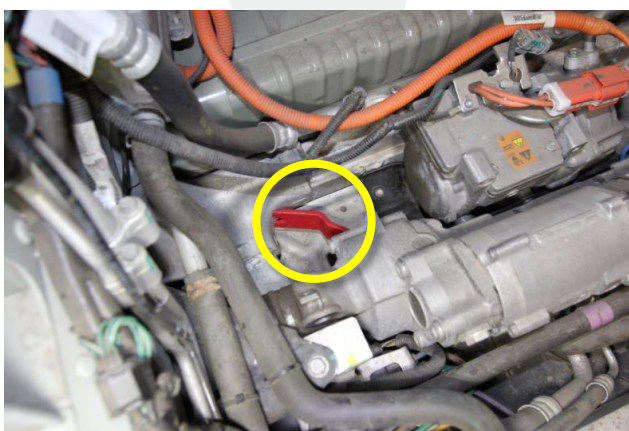
**Figure 6 (Red plastic trim tool highlighted)**

19. Remove the plastic trim tool or block that was supporting the steering rack (Figure 6).

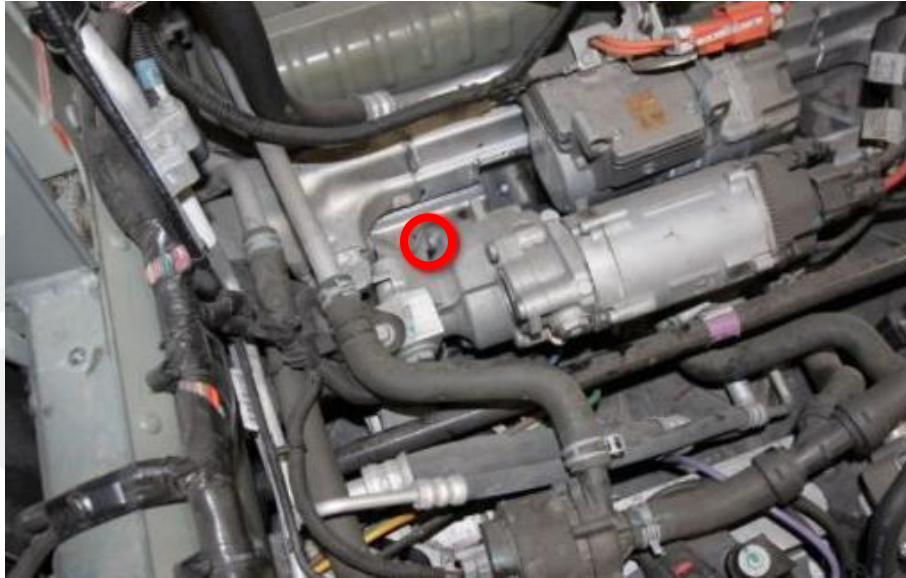
**Figure 7**

23. Inspect the rear lower steering rack housing bolt (Figure 7):

- If the rear lower steering rack housing bolt is sheared off or damaged, discontinue this procedure and replace the steering rack (refer to Service Manual procedure 32010102).
- If the rear lower steering rack housing bolt is not sheared off or damaged, continue to the next step.

24. Remove and discard the rear lower steering rack housing bolt (Figure 7).

25. Install a new rear lower steering rack housing bolt, tighten the bolt to 5 Nm (+/- 0.5 Nm) plus 90 degrees (Figure 7), and then mark the bolt with a paint pen.

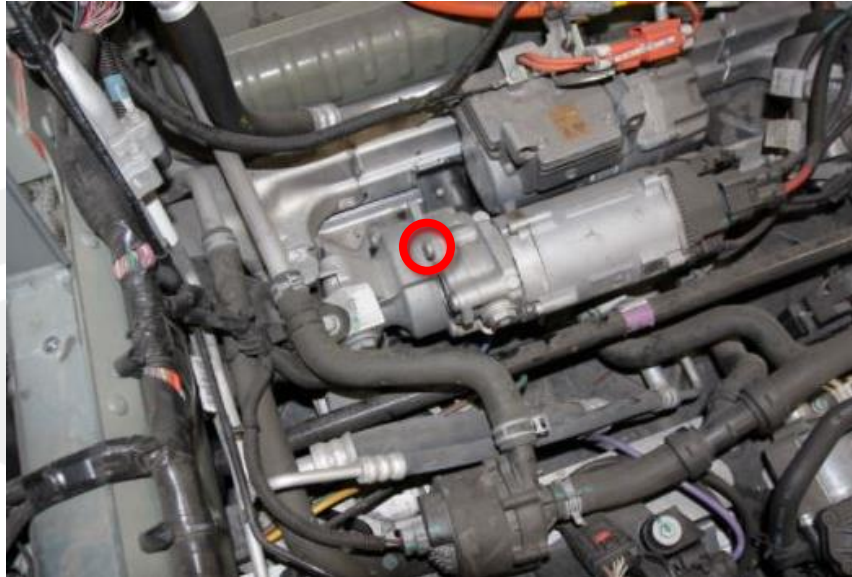
**Figure 8**

26. Inspect the rear upper steering rack housing bolt (Figure 8):

- If the rear upper steering rack housing bolt is sheared off or damaged, replace the steering rack (refer to Service Manual procedure 32010102).
- If the rear upper steering rack housing bolt is not sheared off or damaged, continue to the next step.

27. Remove and discard the rear upper steering rack housing bolt (Figure 8).

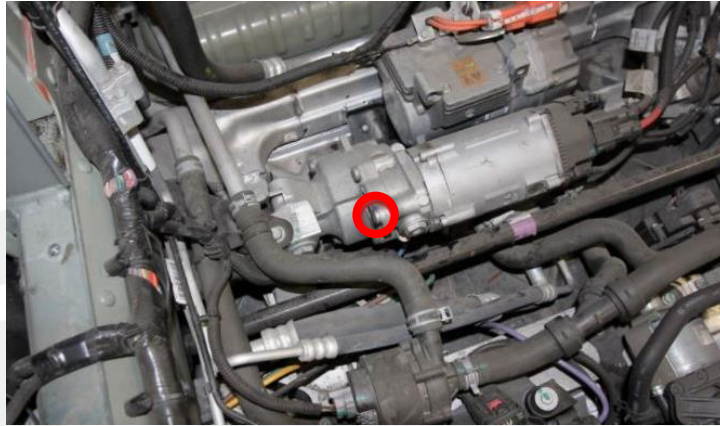
**Figure 9**

- If the front upper steering rack housing bolt is sheared off or damaged, discontinue this procedure and replace the steering rack (refer to Service Manual procedure 32010102).
- If the front upper steering rack housing bolt is not sheared off or damaged, continue to the next step.

**⚠ WARNING:** If the front upper steering rack housing bolt is damaged or sheared off during removal, discontinue this procedure and replace the steering rack (refer to Service Manual procedure 32010102).

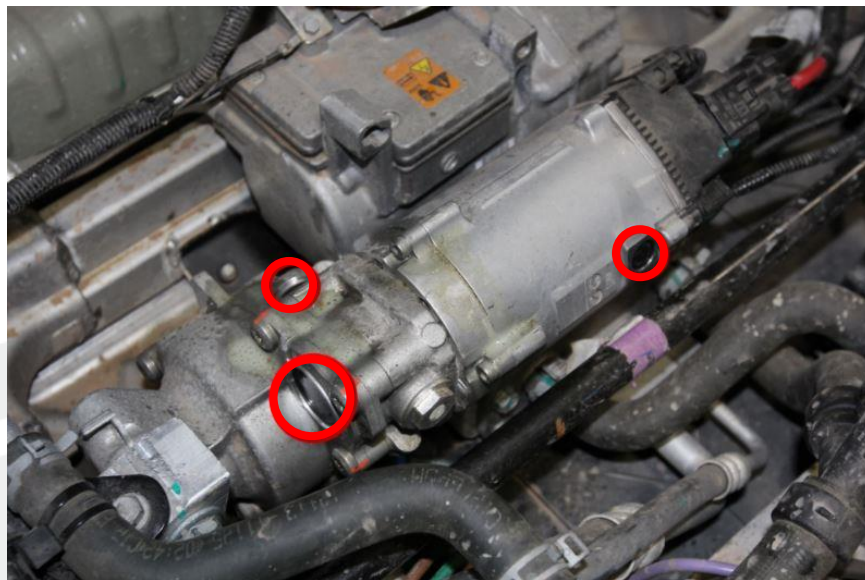
**Figure 10**

35. Clean the sealing plugs (x3) on the steering gear with isopropyl alcohol (IPA) wipes, and then allow the area to dry for at least 1 minute (Figure 10).

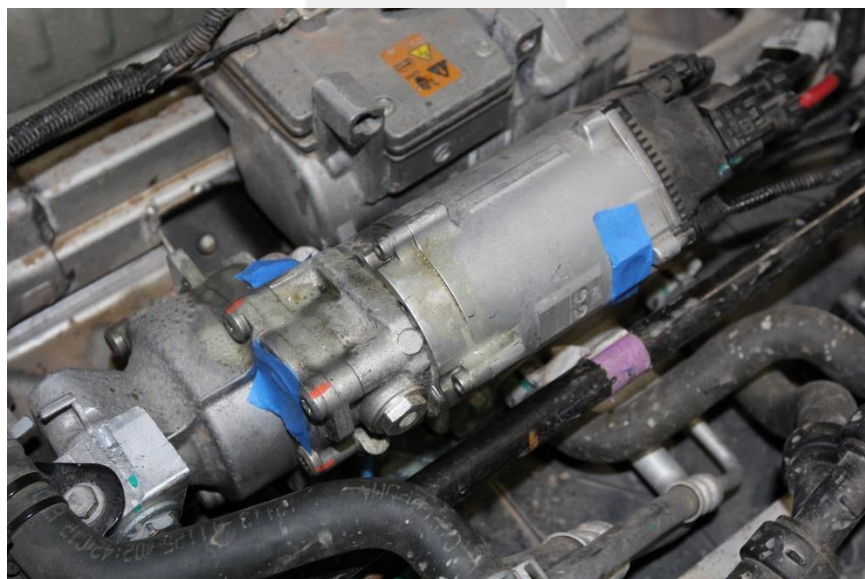
**Figure 11**

36. Apply masking tape to cover the sealing plugs (x3) on the steering rack (Figure 11).

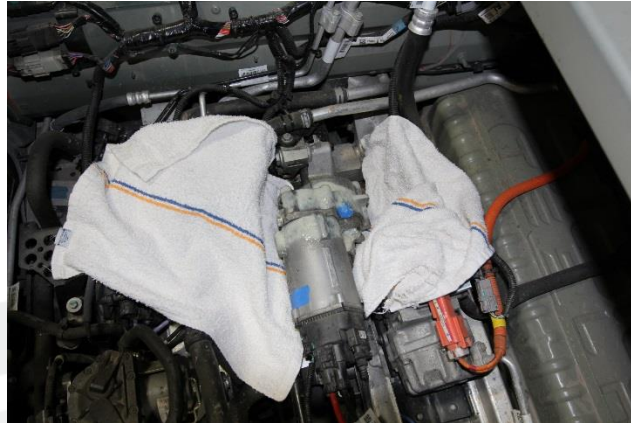
**Figure 12**

37. Cover the components near the steering rack with shop towels to protect from drips during wax sealant application (Figure 12).

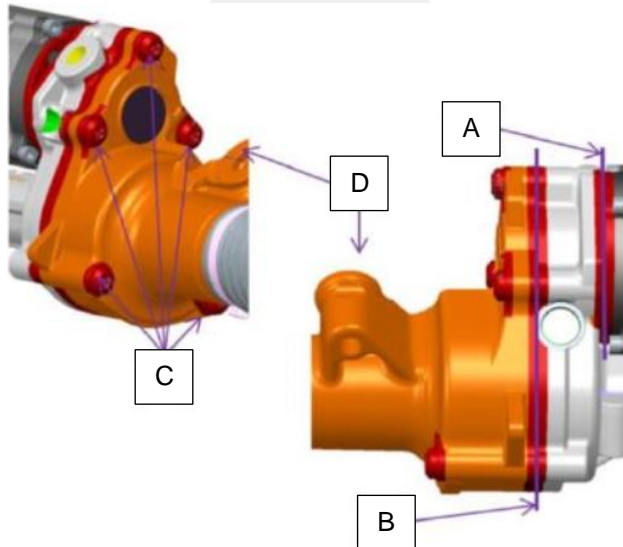
**Figure 13**

38. Apply the wax sealant to the steering rack housing bolts and steering rack housing seams. Make sure to apply wax sealant to the underside of the steering rack, as well as the motor housing. Completely cover the following areas with the wax sealant (Figure 13):
- A. The entire flange at the interface of the steering rack housing and the motor
  - B. The entire flange at the interface of the steering rack housing and the gear cover
  - C. All 5 bolt heads
  - D. The open screw thread bore

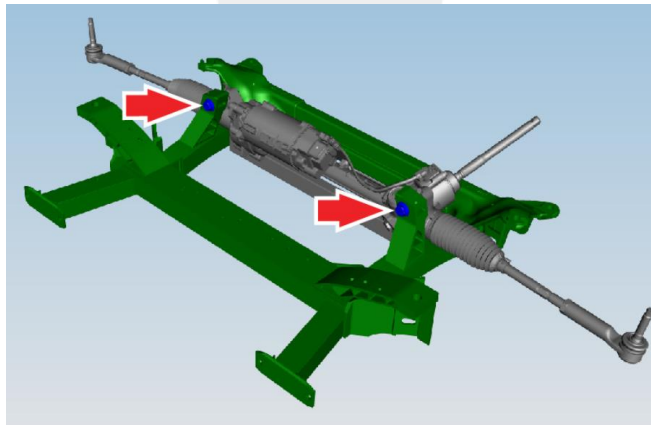
Figure 14

1. Remove the underhood storage unit (refer to Service Manual procedure 15242001).
2. Disconnect 12V power (refer to Service Manual procedure 17010200).
3. Loosen the RH front wheel lug nuts.
4. Raise the vehicle slightly so that the tires are off the ground.
5. Remove the LH and RH steering rack mounting bolts that attach the steering rack to the front subframe (Figure 14).

**⚠ CAUTION:** A washer might be located between the steering rack and the subframe. If there is a washer, retain and use this washer during reinstallation of the steering rack mounting bolts later in this procedure.

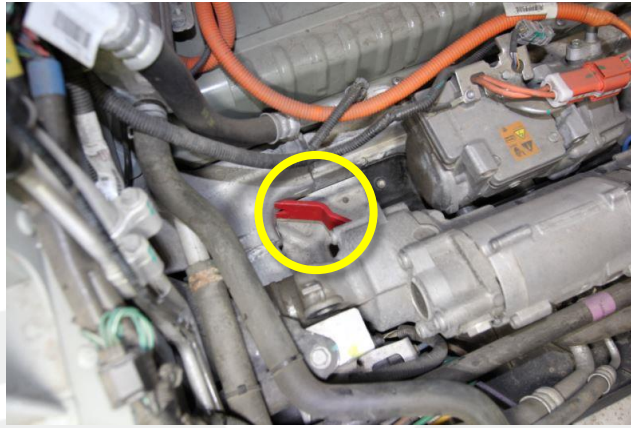
**Figure 15 (Red plastic trim tool highlighted)**

6. Use a plastic trim tool or block between the steering rack and the front subframe to raise and support the RH side of the steering rack (Figure 15).

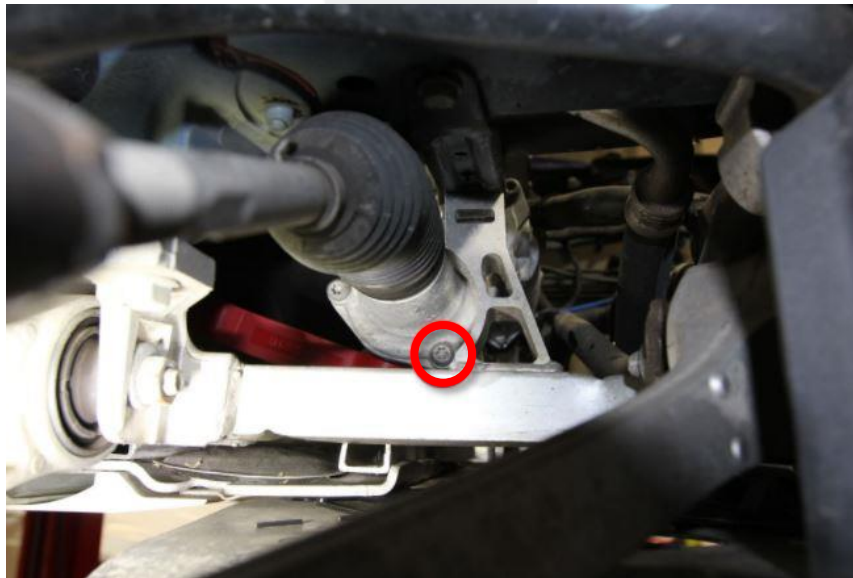
**Figure 16**

7. Partially raise the vehicle so that it is at a comfortable working height.
  8. Remove the RH front wheel (refer to Service Manual procedure 34015001).
  9. Clean the area around both lower steering rack housing bolts with a shop towel, and then clean debris away with compressed air (Figure 16).
- ! CAUTION:** Do not use a steel or brass brush to clean the area around the lower steering rack housing bolts. Rust damage to the steering rack might result.

10. Inspect the front lower steering rack housing bolt (Figure 16):

- If the front lower steering rack housing bolt is sheared off or damaged, discontinue with procedure and replace the steering rack (refer to Service Manual procedure 32012202).
- If the front lower steering rack housing bolt is not sheared off or damaged, continue to the next step.

11. Remove and discard the front lower steering rack housing bolt (Figure 16).

12. Install a new front lower steering rack housing bolt, tighten the bolt to 5 Nm (+/- 0.5 Nm) plus 90 degrees (Figure 16), and then mark the bolt with a paint pen.

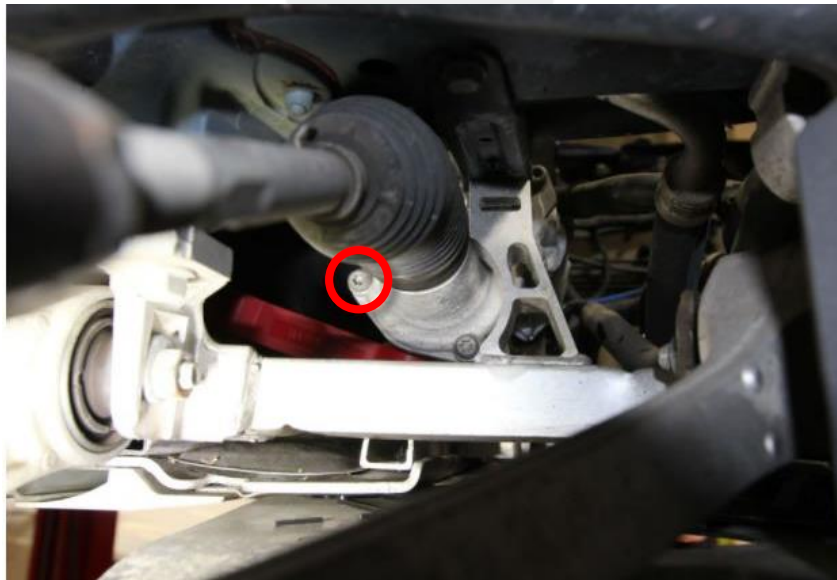
**Figure 17**

13. Inspect the rear lower steering rack housing bolt (Figure 17):

- If the rear lower steering rack housing bolt is sheared off or damaged, discontinue with procedure and replace the steering rack (refer to Service Manual procedure 32012202).
- If the rear lower steering rack housing bolt is not sheared off or damaged, continue to the next step.

14. Remove and discard the rear lower steering rack housing bolt (Figure 17).

15. Install a new rear lower steering rack housing bolt, tighten the bolt to 5 Nm (+/- 0.5 Nm) plus 90 degrees (Figure 17), and then mark the bolt with a paint pen.

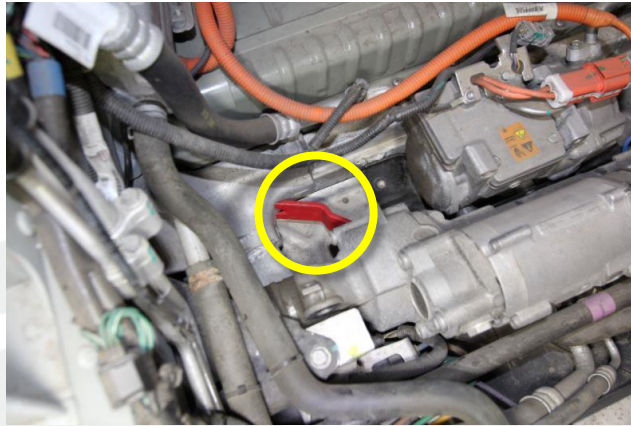
**Figure 18 (Red plastic trim tool highlighted)**

18. Remove the plastic trim tool or block that was supporting the steering rack (Figure 18).

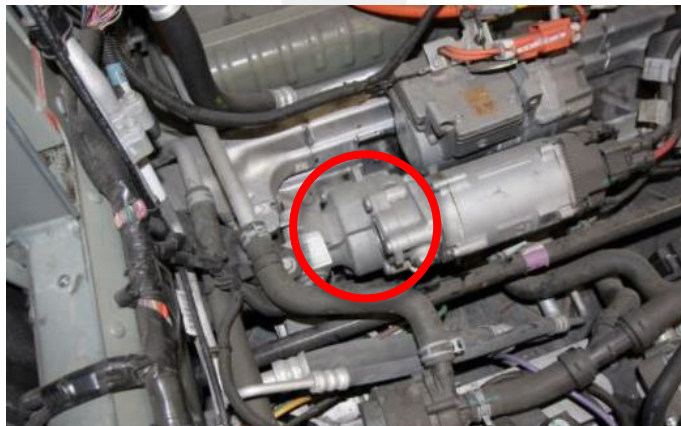
**Figure 19**

22. Clean the area around the remaining steering rack housing bolts with a shop towel, and then clear any debris away with compressed air (Figure 19).

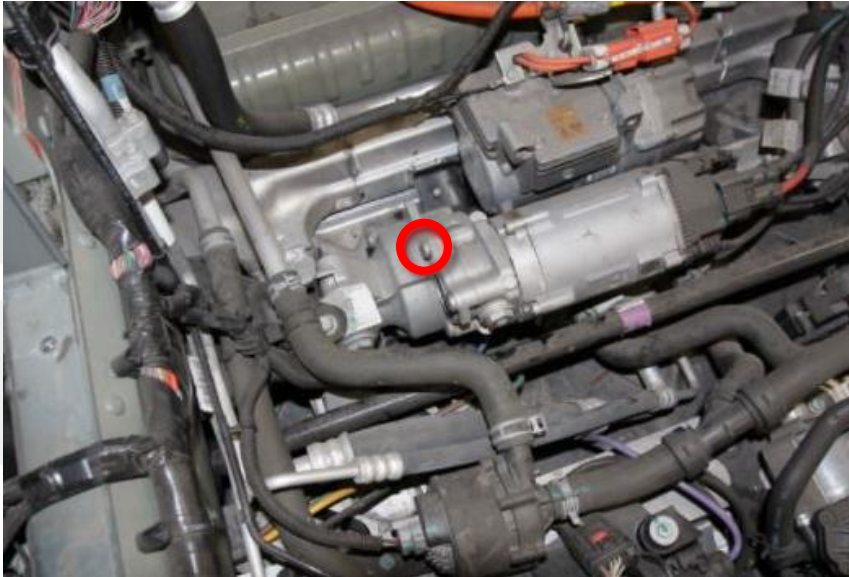
Figure 20

23. Inspect the rear upper steering rack housing bolt (Figure 20):

- If the rear upper steering rack housing bolt is sheared off or damaged, discontinue with procedure and replace the steering rack (refer to Service Manual procedure 32012202).
- If the rear upper steering rack housing bolt is not sheared off or damaged, continue to the next step.

24. Remove and discard the rear upper steering rack housing bolt (Figure 20).

25. Install a new rear upper steering rack housing bolt, tighten the bolt to 5 Nm (+/- 0.5 Nm) plus 90 degrees (Figure 20), and then mark the bolt with a paint pen.

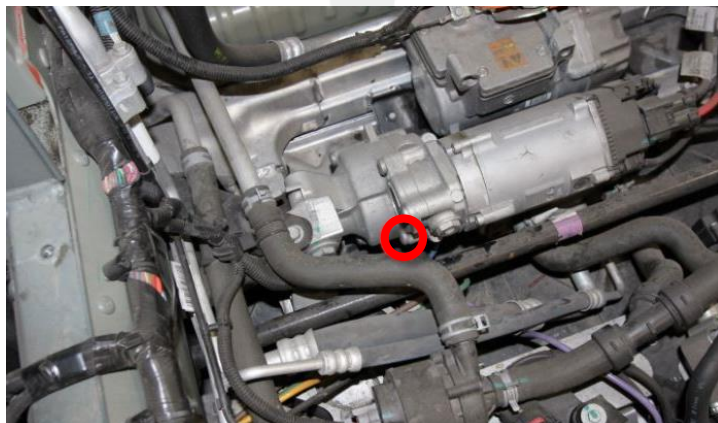
Figure 21

26. Inspect the front middle steering rack housing bolt (Figure 21):

- If the front middle steering rack housing bolt is sheared off or damaged, discontinue this procedure and replace the steering rack (refer to Service Manual procedure 32012202).
- If the front middle steering rack housing bolt is not sheared off or damaged, continue to the next step.

27. Remove and discard the front middle steering rack housing bolt (Figure 21).

28. Install a new front middle steering rack housing bolt, tighten the bolt to 5 Nm (+/- 0.5 Nm) plus 90 degrees (Figure 21), and then mark the bolt with a paint pen.

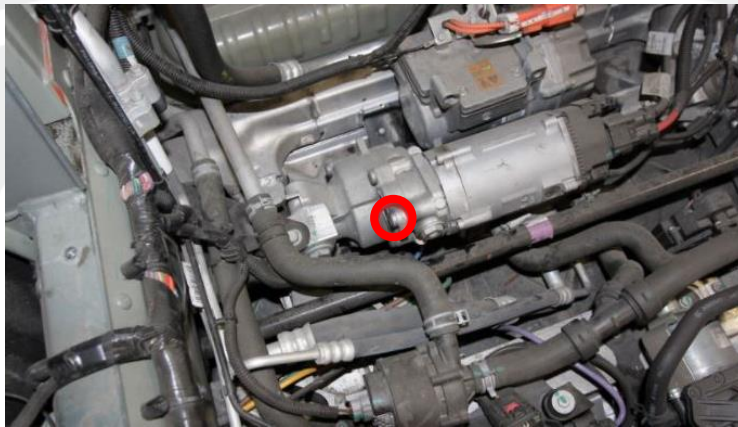
**Figure 22**

29. Inspect the front upper steering rack housing bolt (Figure 22):

- If the front upper steering rack housing bolt is sheared off or damaged, discontinue this procedure and replace the steering rack (refer to Service Manual procedure 32012202).
- If the front upper steering rack housing bolt is not sheared off or damaged, continue to the next step.

30. Remove and discard the front upper steering rack housing bolt (Figure 22).

31. Install a new front upper steering rack housing bolt, tighten the bolt to 5 Nm (+/- 0.5 Nm) plus 90 degrees (Figure 22), and then mark the bolt with a paint pen.

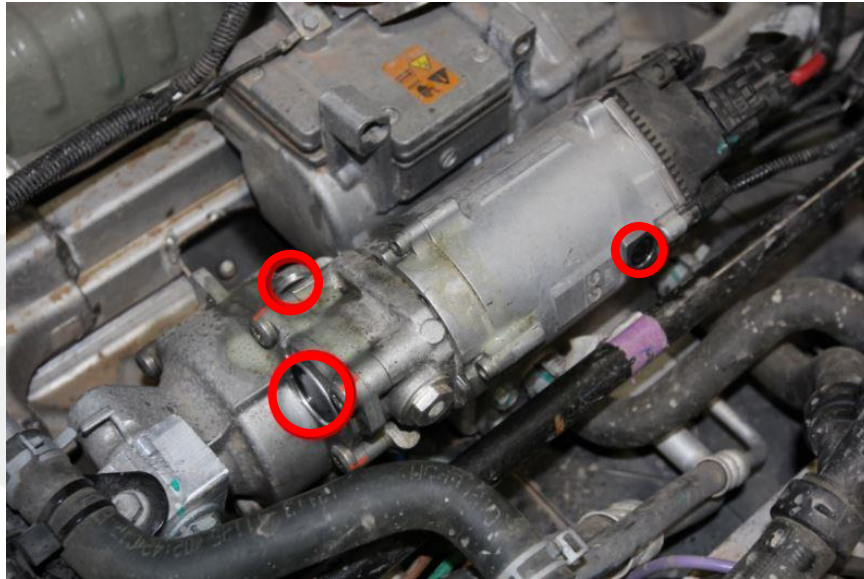
**Figure 23**

34. Clean the 5 steering rack housing bolts and the steering rack housing seams with isopropyl alcohol (IPA) wipes, and then allow the area to dry for at least 1 minute.
35. Clean the sealing plugs (x3) on the steering gear with isopropyl alcohol (IPA) wipes, and then allow the area to dry for at least 1 minute (Figure 23).

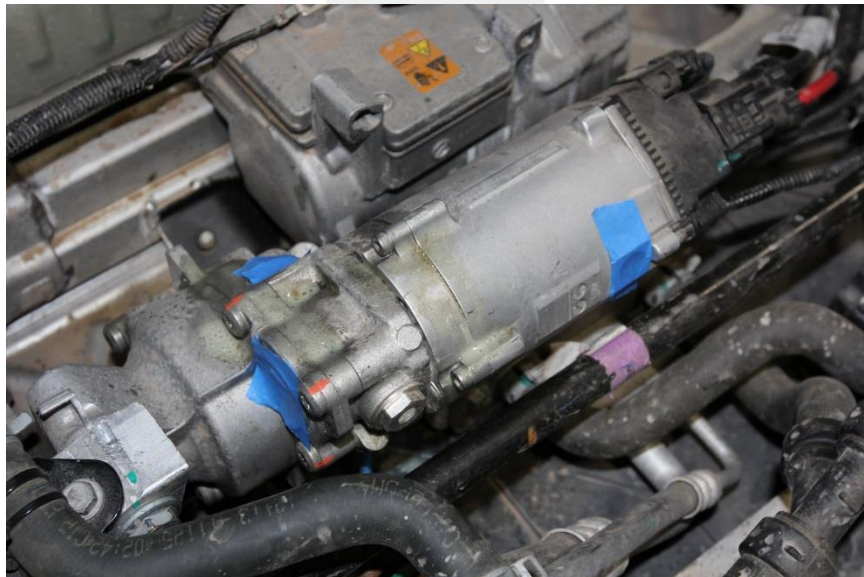
**Figure 24**

36. Apply masking tape to cover the sealing plugs (x3) on the steering rack (Figure 24).

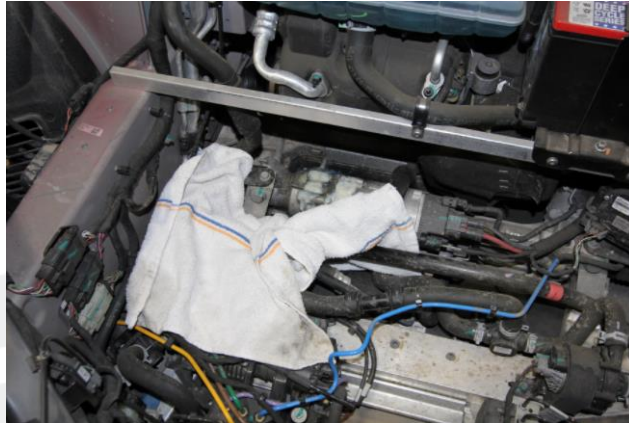
**Figure 25**

37. Cover the components near the steering rack with shop towels to protect from drips during wax sealant application (Figure 25).

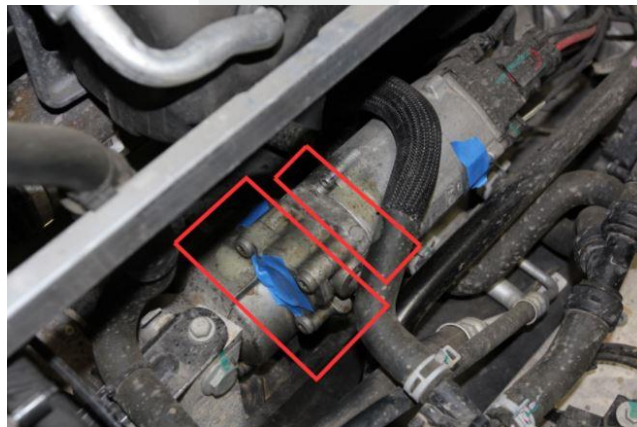
**Figure 26**

- A. The entire flange at the interface of the steering rack housing and the motor
- B. The entire flange at the interface of the steering rack housing and the gear cover
- C. All 5 bolt heads
- D. The open screw thread bore

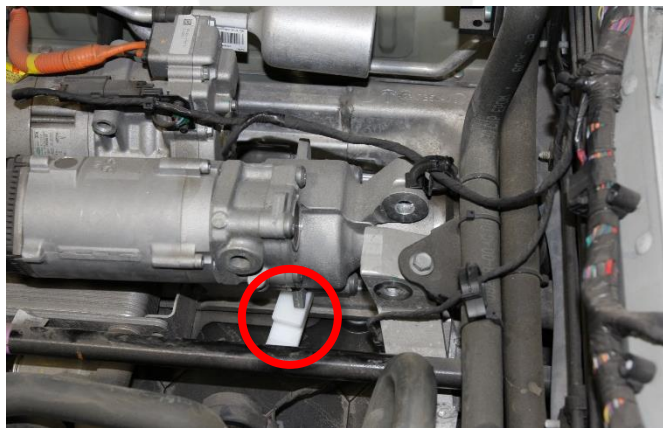
**Figure 29 (White plastic trim tool highlighted)**

6. Use a plastic trim tool or block between the steering rack and the front subframe to raise and support the LH side of the steering rack (Figure 29).

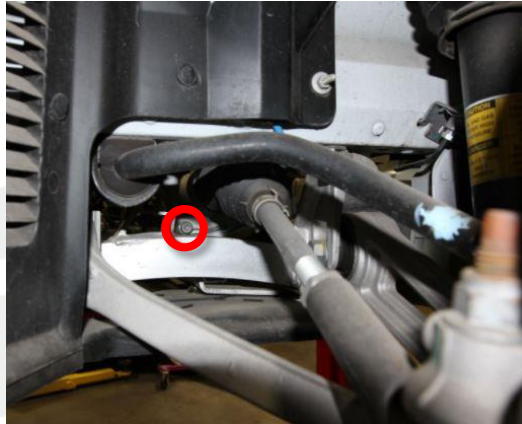
**Figure 30**

9. Clean the area around the front lower steering rack housing bolt with a shop towel, and then clean debris away with compressed air (Figure 30).

10. Inspect the front lower steering rack housing bolt (Figure 30):

- If the front lower steering rack housing bolt is sheared off or damaged, discontinue this procedure and replace the steering rack (refer to Service Manual procedure 32012602).
- If the front lower steering rack housing bolt is not sheared off or damaged, continue to the next step.

11. Remove and discard the front lower steering rack housing bolt (Figure 30).

12. Install a new front lower steering rack housing bolt, tighten the bolt to 5 Nm (+/- 0.5 Nm) plus 90 degrees (Figure 30), and then mark the bolt with a paint pen.

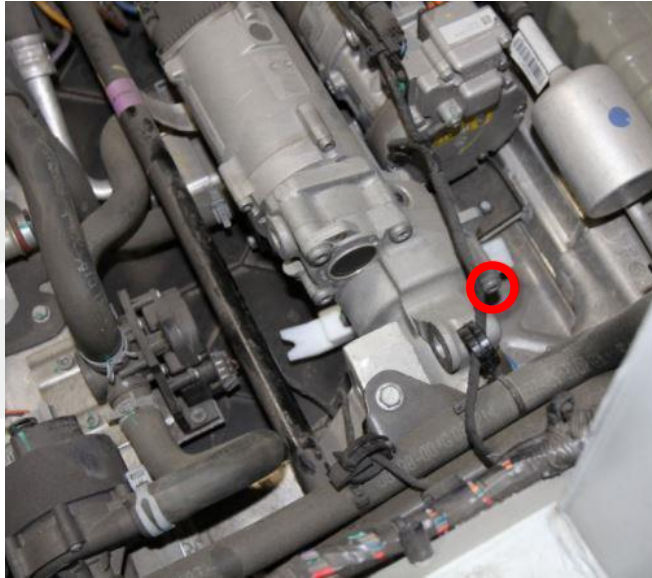
**Figure 35**

23. Inspect the rear lower steering rack housing bolt (Figure 35):

- If the rear lower steering rack housing bolt is sheared off or damaged, discontinue this procedure and replace the steering rack (refer to Service Manual procedure 32012602).
- If the rear lower steering rack housing bolt is not sheared off or damaged, continue to the next step.

24. Remove and discard the rear lower steering rack housing bolt (Figure 35).

25. Install a new rear lower steering rack housing bolt, tighten the bolt to 5 Nm (+/- 0.5 Nm) plus 90 degrees (Figure 35), and then mark the bolt with a paint pen.

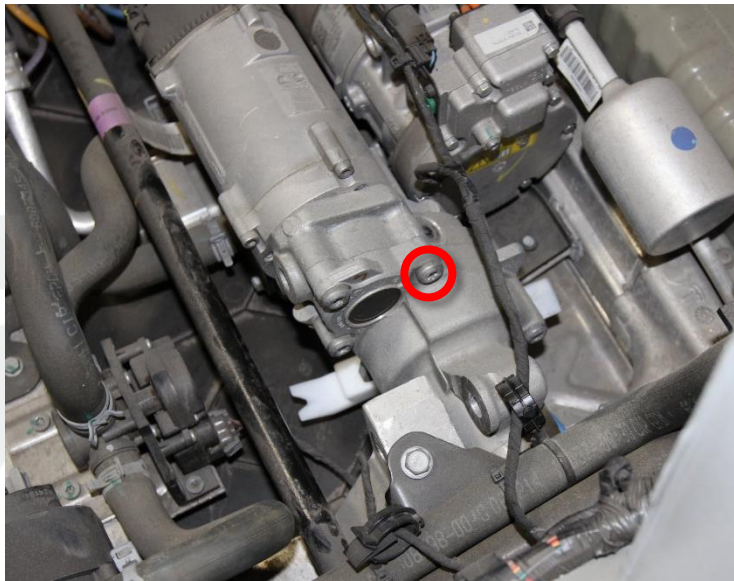
**Figure 36**

26. Inspect the rear upper steering rack housing bolt (Figure 36):

- If the rear upper steering rack housing bolt is sheared off or damaged, discontinue this procedure and replace the steering rack (refer to Service Manual procedure 32012602).
- If the rear upper steering rack housing bolt is not sheared off or damaged, continue to the next step.

27. Remove and discard the rear upper steering rack housing bolt (Figure 36).

28. Install a new rear upper steering rack housing bolt, tighten the bolt to 5 Nm (+/- 0.5 Nm) plus 90 degrees (Figure 36), and then mark the bolt with a paint pen.

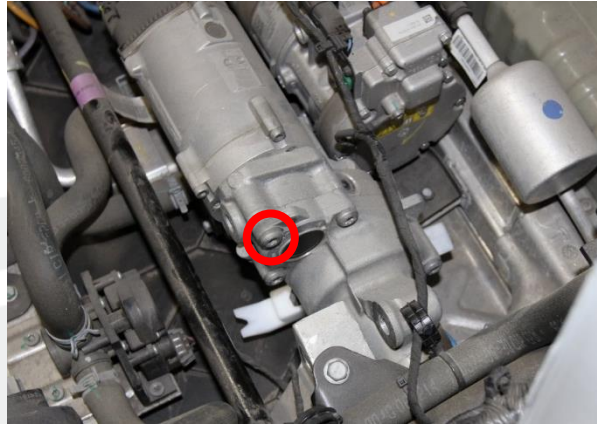
**Figure 37**

29. Inspect the front upper steering rack housing bolt (Figure 37):

- If the front upper steering rack housing bolt is sheared off or damaged, discontinue this procedure and replace the steering rack (refer to Service Manual procedure 32012602).
- If the front upper steering rack housing bolt is not sheared off or damaged, continue to the next step.

30. Remove and discard the front upper steering rack housing bolt (Figure 37).

31. Install a new front upper steering rack housing bolt, tighten the bolt to 5 Nm (+/- 0.5 Nm) plus 90 degrees (Figure 37), and then mark the bolt with a paint pen.

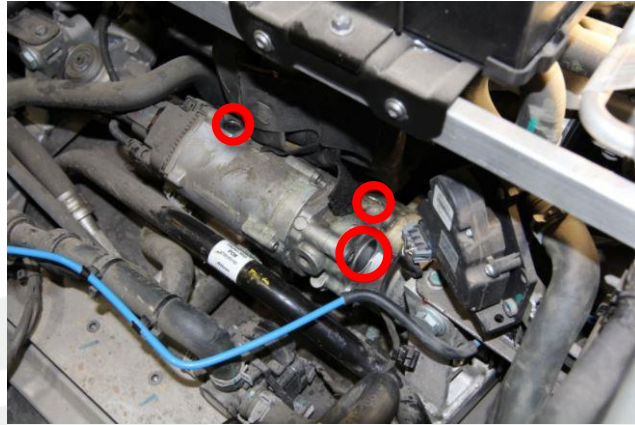
**Figure 38**

35. Clean the sealing plugs (x3) on the steering gear with isopropyl alcohol (IPA) wipes, and then allow the area to dry for at least 1 minute (Figure 38).

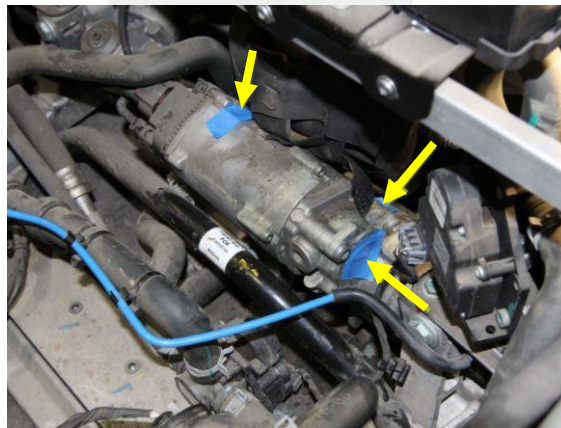
**Figure 39**

36. Apply masking tape to cover the sealing plugs (x3) on the steering rack (Figure 39).

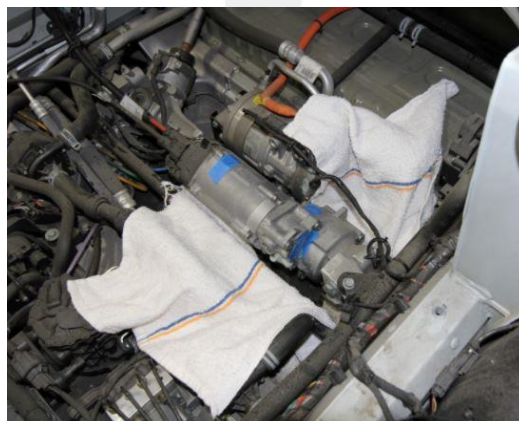
**Figure 40**

37. Cover the components near the steering rack with shop towels to protect from drips during wax sealant application (Figure 40).

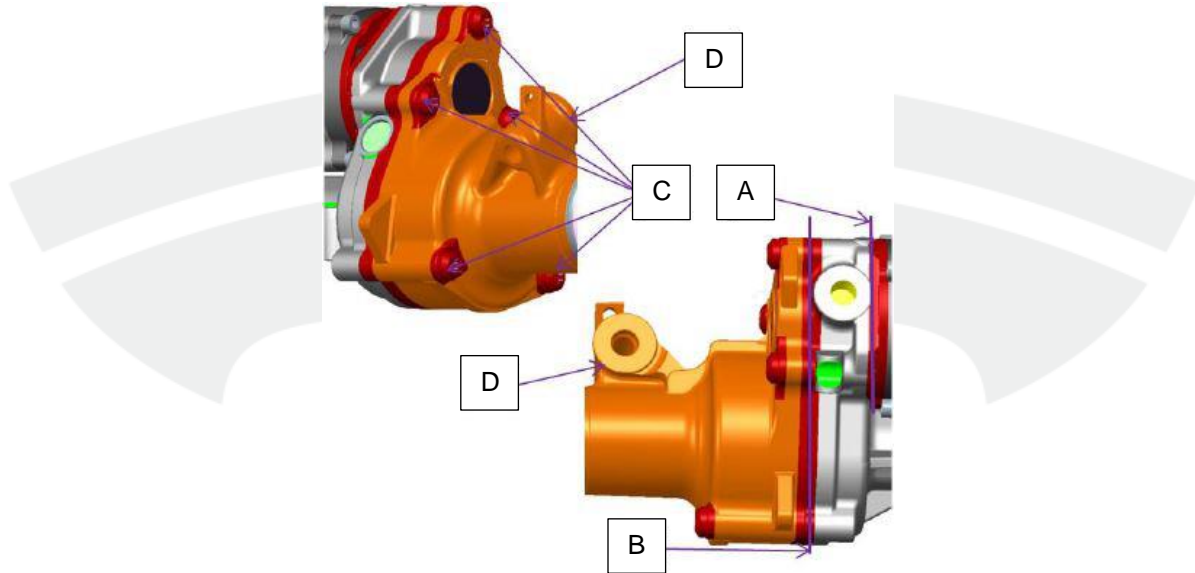
**Figure 41**

- A. The entire flange at the interface of the steering rack housing and the motor
- B. The entire flange at the interface of the steering rack housing and the gear cover
- C. All 5 bolt heads
- D. The open screw thread bore

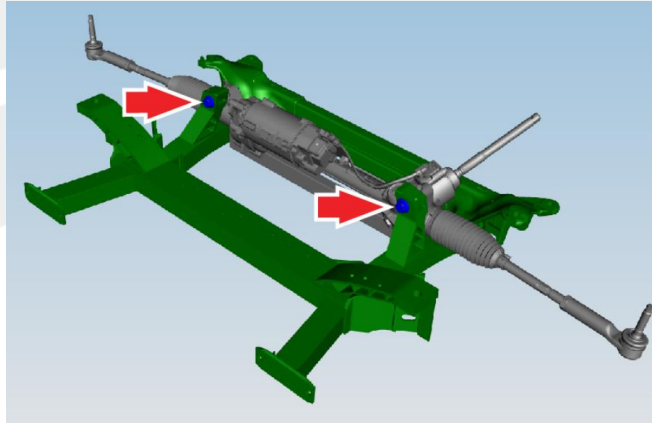
**Figure 42**

2. Disconnect 12V power (refer to Service Manual procedure 17010200).
3. Loosen the LH front wheel lug nuts.
4. Raise the vehicle slightly so that the tires are off the ground.
5. Remove the LH and RH steering rack mounting bolts that attach the steering rack to the front subframe (Figure 42).

**⚠ CAUTION:** A washer might be located between the steering rack and the subframe. If there is a washer, retain and use this washer during reinstallation of the steering rack mounting bolts later in this procedure.

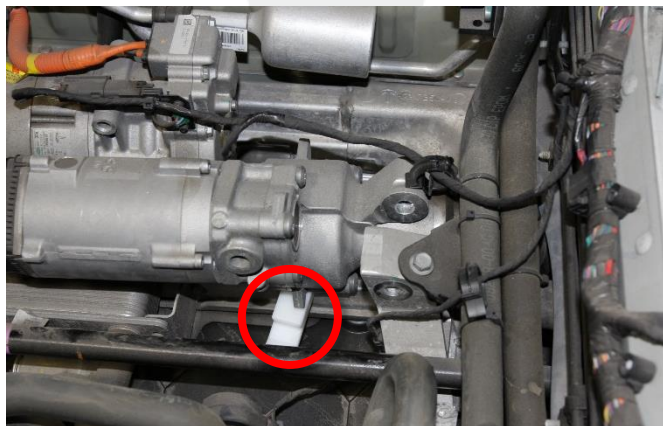
**Figure 43 (White plastic trim tool highlighted)**

6. Use a plastic trim tool or block between the steering rack and the front subframe to raise and support the LH side of the steering rack (Figure 43).

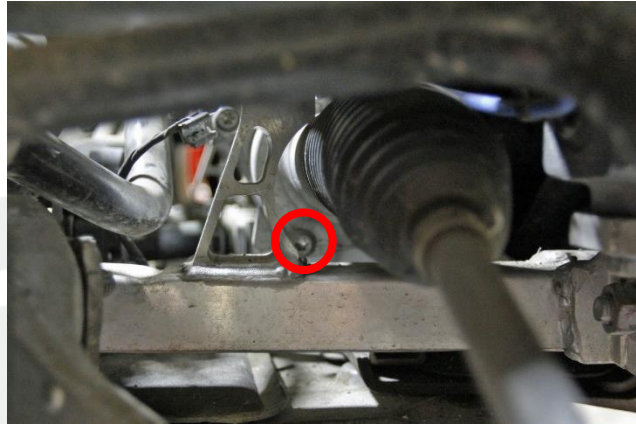
**Figure 44**

9. Clean the area around both lower steering rack housing bolts with a shop towel, and then clean debris away with compressed air (Figure 44).

10. Inspect the front lower steering rack housing bolt (Figure 44):

11. Remove and discard the front lower steering rack housing bolt (Figure 44).

12. Install a new front lower steering rack housing bolt, tighten the bolt to 5 Nm (+/- 0.5 Nm) plus 90 degrees (Figure 44), and then mark the bolt with a paint pen.

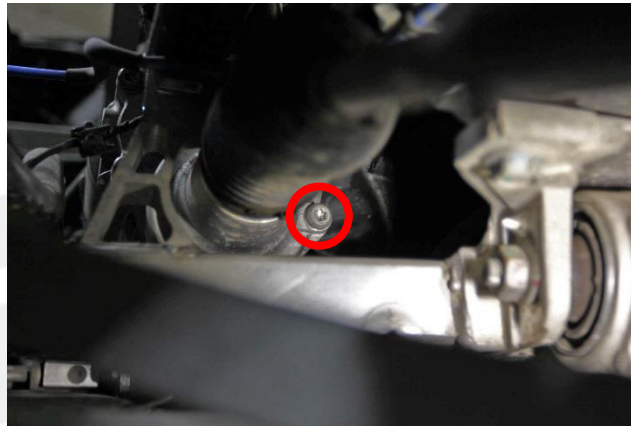
**Figure 45**

13. Inspect the rear lower steering rack housing bolt (Figure 45):

- If the rear lower steering rack housing bolt is sheared off or damaged, discontinue this procedure and replace the steering rack (refer to Service Manual procedure 32012602).
- If the rear lower steering rack housing bolt is not sheared off or damaged, continue to the next step.

14. Remove and discard the rear lower steering rack housing bolt (Figure 45).

15. Install a new rear lower steering rack housing bolt, tighten the bolt to 5 Nm (+/- 0.5 Nm) plus 90 degrees (Figure 45), and then mark the bolt with a paint pen.

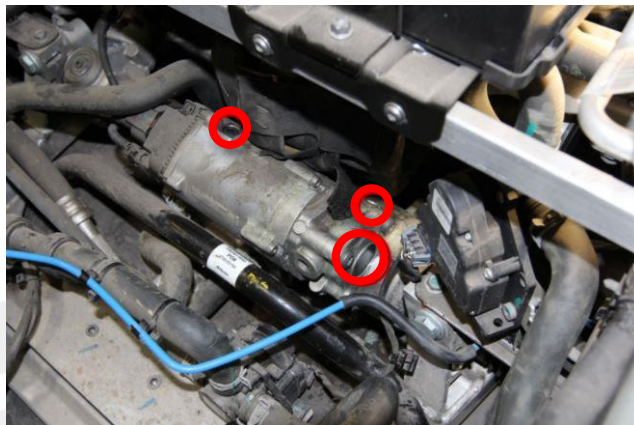
**Figure 52**

35. Clean the sealing plugs (x3) on the steering gear with isopropyl alcohol (IPA) wipes, and then allow the area to dry for at least 1 minute (Figure 52).

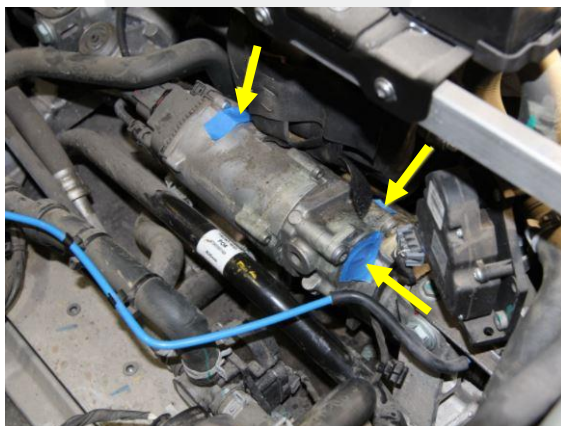
**Figure 53**

36. Apply masking tape to cover the sealing plugs (x3) on the steering rack (Figure 53).

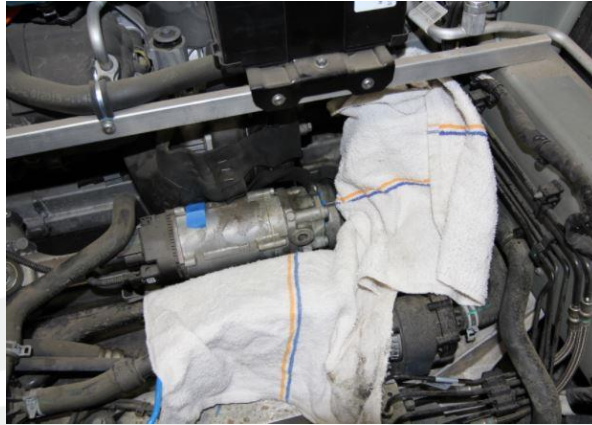
**Figure 54**

37. Cover the components near the steering rack with shop towels to protect from drips during wax sealant application (Figure 54).

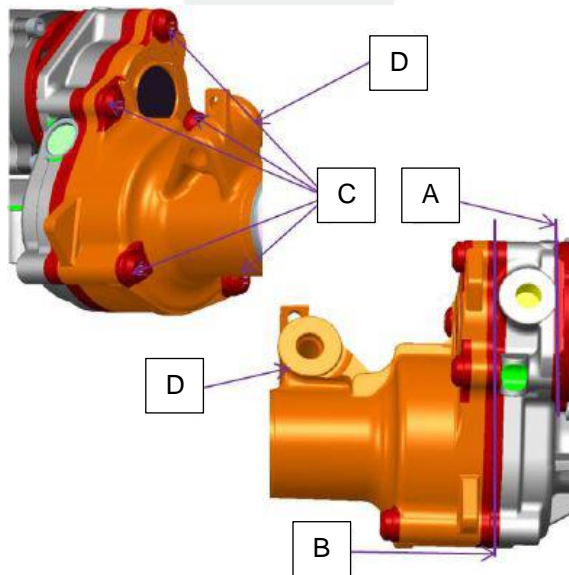
**Figure 55**

38. Apply the wax sealant to the 5 steering rack housing bolts and the steering rack housing seams. Make sure to apply wax sealant to the underside of the steering rack, as well as the motor housing. Completely cover the following areas with the wax sealant (Figure 55):
- A. The entire flange at the interface of the steering rack housing and the motor
  - B. The entire flange at the interface of the steering rack housing and the gear cover
  - C. All 5 bolt heads
  - D. The open screw thread bore
