## SURGE TANK SUPPORT REPLACEMENT

Prevost vehicles

On the vehicles affected by this bulletin, the existing surge tank support has to be replaced by a new configuration including two supports. That will allow a better distribution of the load between the tank and the support.

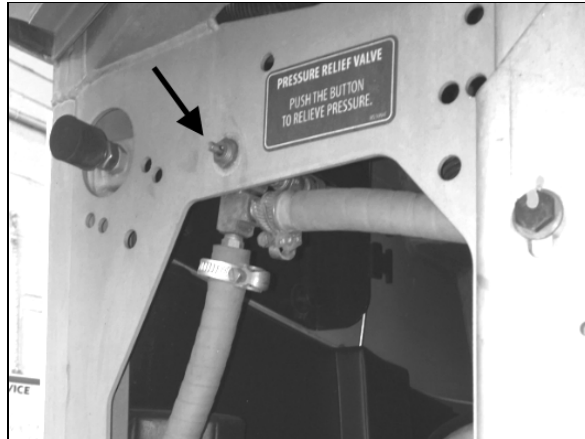
Figure 2

2. As a safety precaution, release the system pressure by pressing the relief valve button (Figure 2).

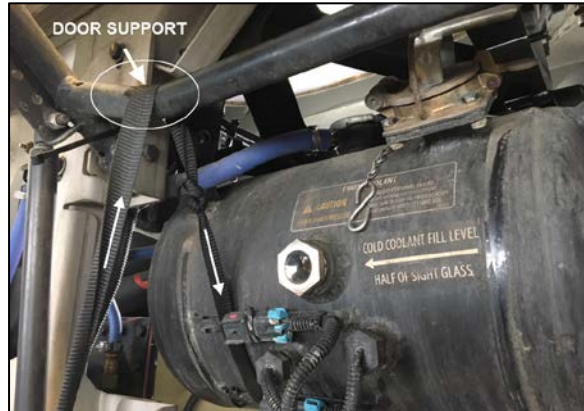
Figure 7

- Pass the strap over the door support as shown (Figure 7).

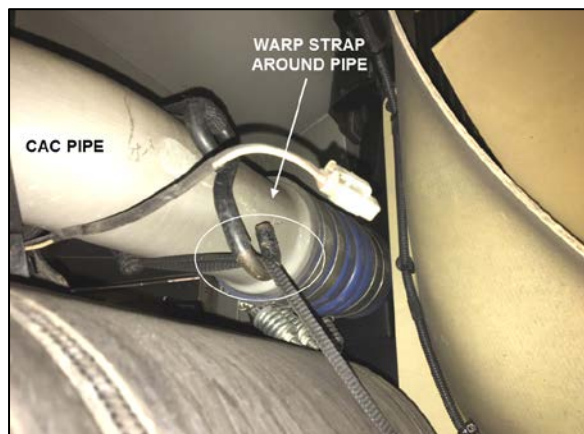
- Wrap the strap over the CAC pipe located behind the surge tank – Hook the strap end as shown in Figure 9 to secure the assembly (remove any slack).

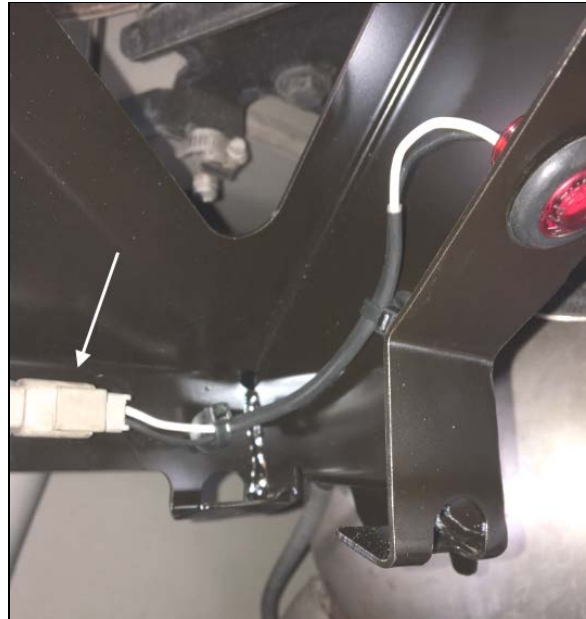
Figure 20

21. Connect the new coolant level warning light #382564 male connector to the existing connector (Figure 20).

22. Install the connectors on the new Christmas tree type mounting clip #564108 (Figure 20).

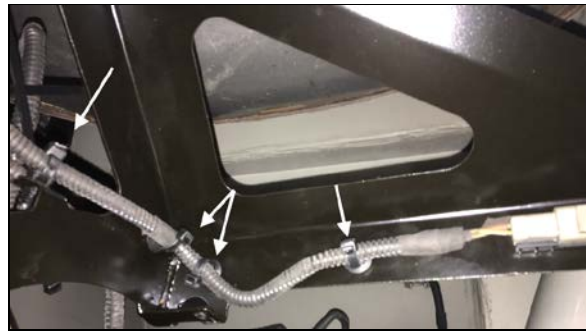
Figure 21

23. Fix the wiring along the support with cable ties using the new cable tie mounts (Figure 21 & Figure 22).

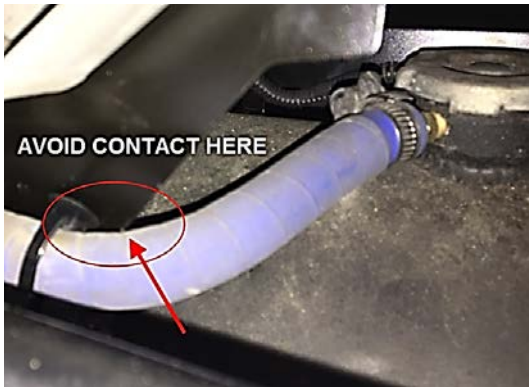
Figure 25

28. Fix the overflow hose on the tank support with a cable tie as shown on Figure 25.

Make sure that there is no contact between the hose and the edge of the support as shown below.

If contact is present, replace the hose with a longer one. Use the required length of 3/8" ID hose # **503821**
