## Advanced Technical Information

Panamera S Hybrid

### Fault P055600 Brake Vacuum System: Mechanical Fault Stored in DME (1303)

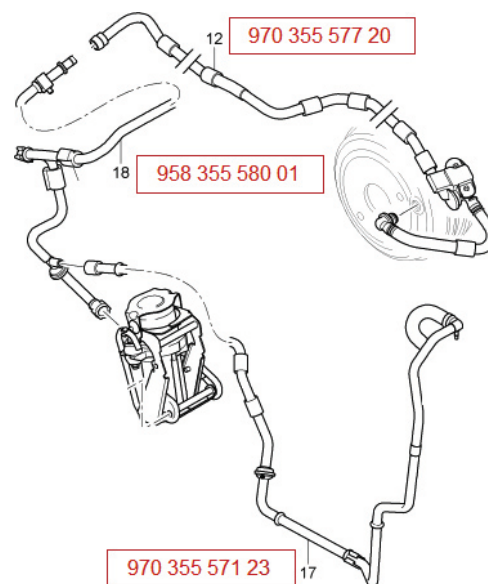
If no electrical or vacuum faults are found after following Guided Fault Finding and Diagnosis Information, the fault may have been set by an intermittent stuck open pump relay or check valve in the vacuum lines. The pump relay and three vacuum lines containing check valves should then be replaced.

If the fault is not resolved after following Guided Fault Finding, Diagnosis Information, and replacing the relay / vacuum lines containing check valves, please submit a PTEC-TLAR for additional support.
