# Technical Service Bulletin

| <b>Technical Service Bulletin:</b><br>TSB180058 | <b>Released Date:</b> 04-Jun-2018 |

## Belt Noise and Front Engine Accessory Drive Belt Re-routing: Tiffin Recreational Vehicles

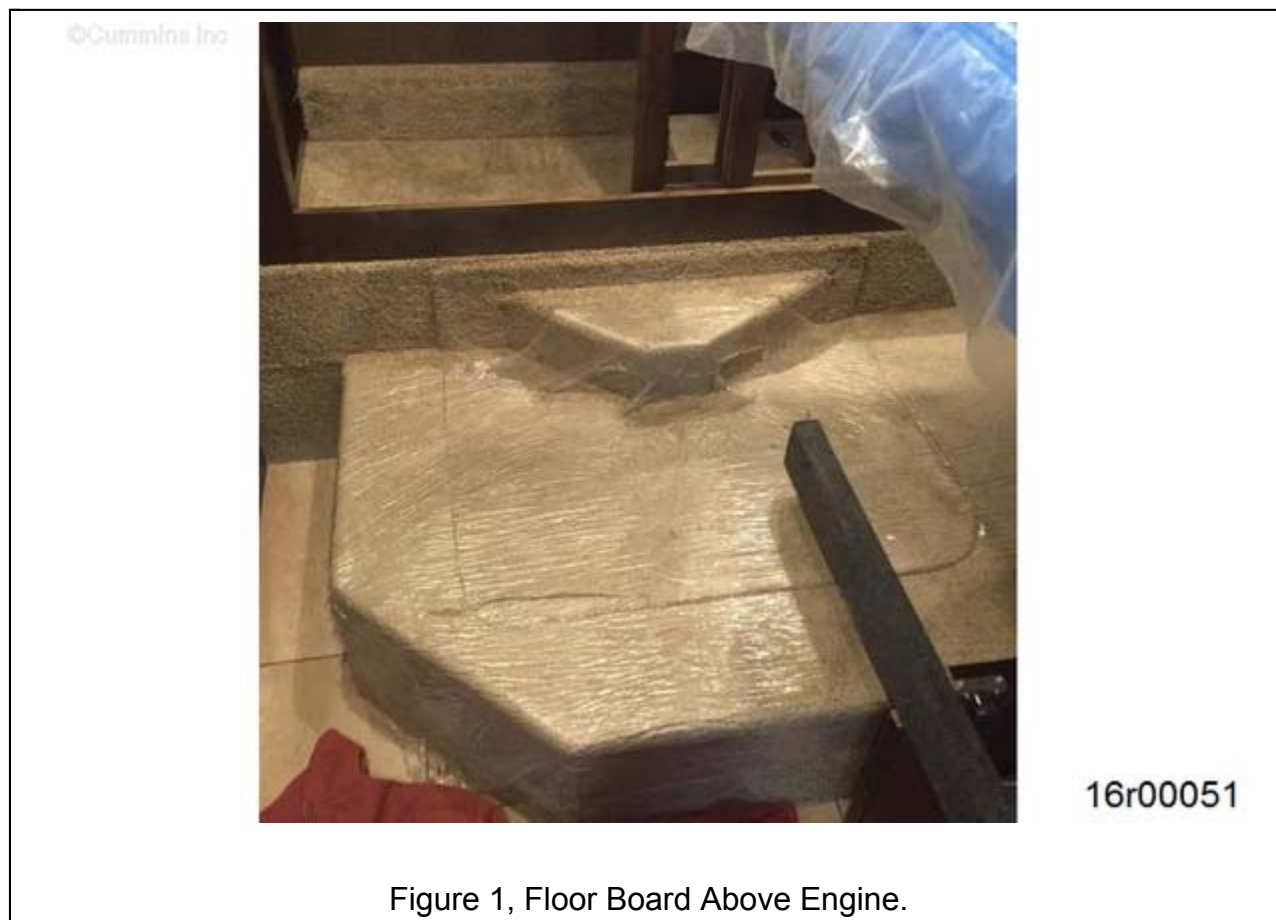
1. Remove floor board for access (Figure 1). See equipment manufacturer service information.
2. Evacuate refrigerant Freon™ system. See equipment manufacturer service information.
3. Disconnect refrigerant Freon™ pressure and return hoses (Figure 2). See equipment manufacturer service information. Secure hoses out of the way.

28. Leak check refrigerant Freon™ system. See equipment manufacturer service information.
29. Fill refrigerant Freon™ system with appropriate amount of oil. See equipment manufacturer service information.
30. Charge system with necessary amount of the proper Freon™ refrigerant. See equipment manufacturer service information.
31. Test operation of dash air conditioning system. See equipment manufacturer service information.
32. Verify belt noise is no longer present.
33. Install floor board which was removed for access. (Figure 1) See equipment manufacturer service information.
34. Return vehicle to service.

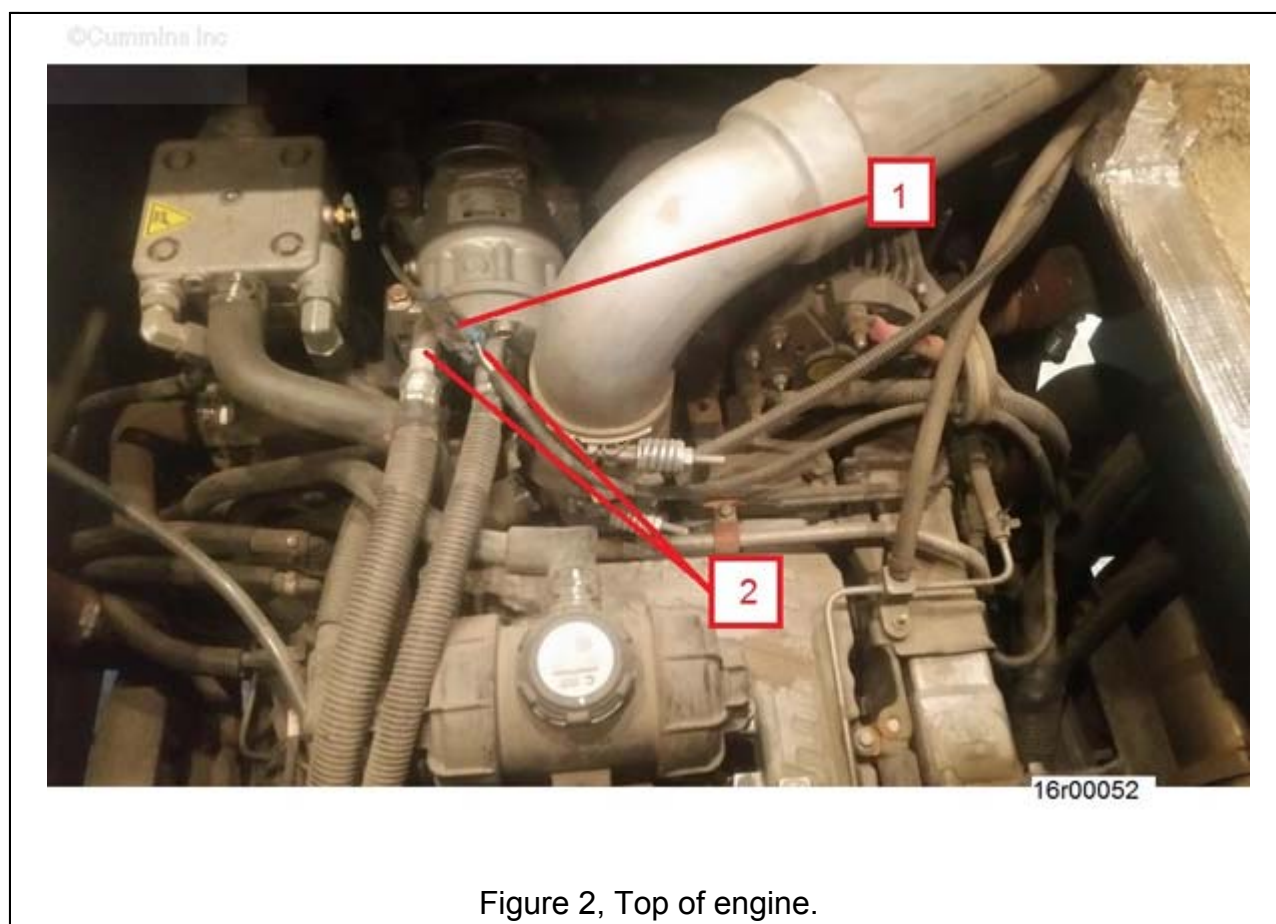
1. Freon™ compressor wiring connector.
2. Freon™ compressor supply/return lines.
4. Remove and discard belts, Part Number: 4335361 and 4335602 (Figure 3).
5. Remove and discard lower idler pulley assembly, Part Number 4390735 (Figure 3).
6. Remove refrigerant Freon™ compressor (Figure 3) from upper refrigerant compressor support.
  - a. Mounted on refrigerant compressor support bracket, Part Number 4360003 (Figure 3).
  - b. Two Sanden Freon™ compressor models have been identified as being used in Tiffin production.
    - i. Model Number U4520 can be reused.
    - ii. Model Number U4897 **must** be replaced due to interference fit in lower position.
      1. Acceptable replacements:
        - a. Model Number U4520
        - b. Model Number U6677
        - c. Model Number U4883

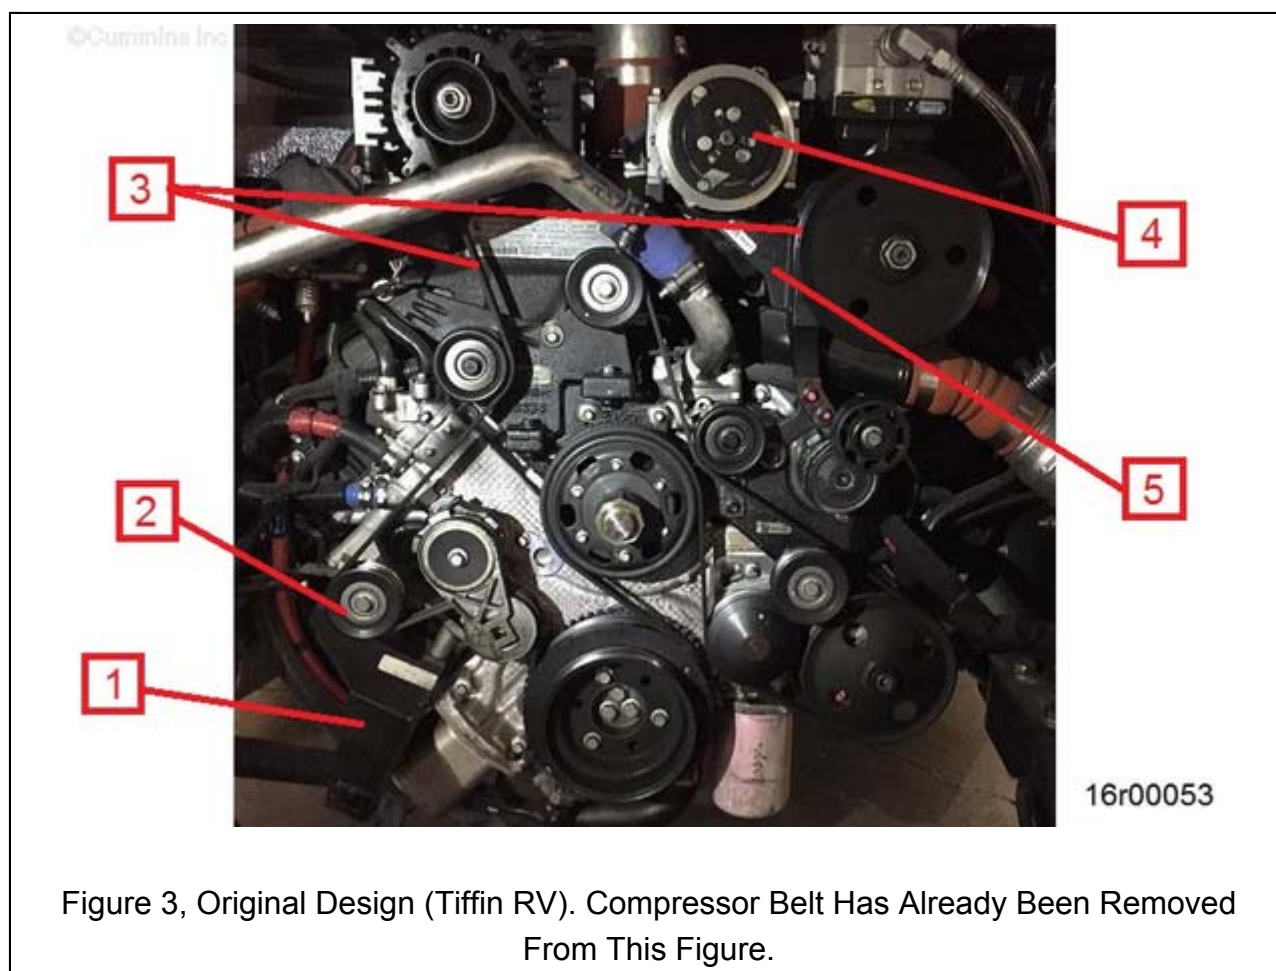
1. OEM Lower Fan Shroud Support Bracket.
2. Lower Idler Pulley.
3. Belts to be removed.
4. Refrigerant Freon™ Compressor.
5. Upper Freon™ Compressor Support.

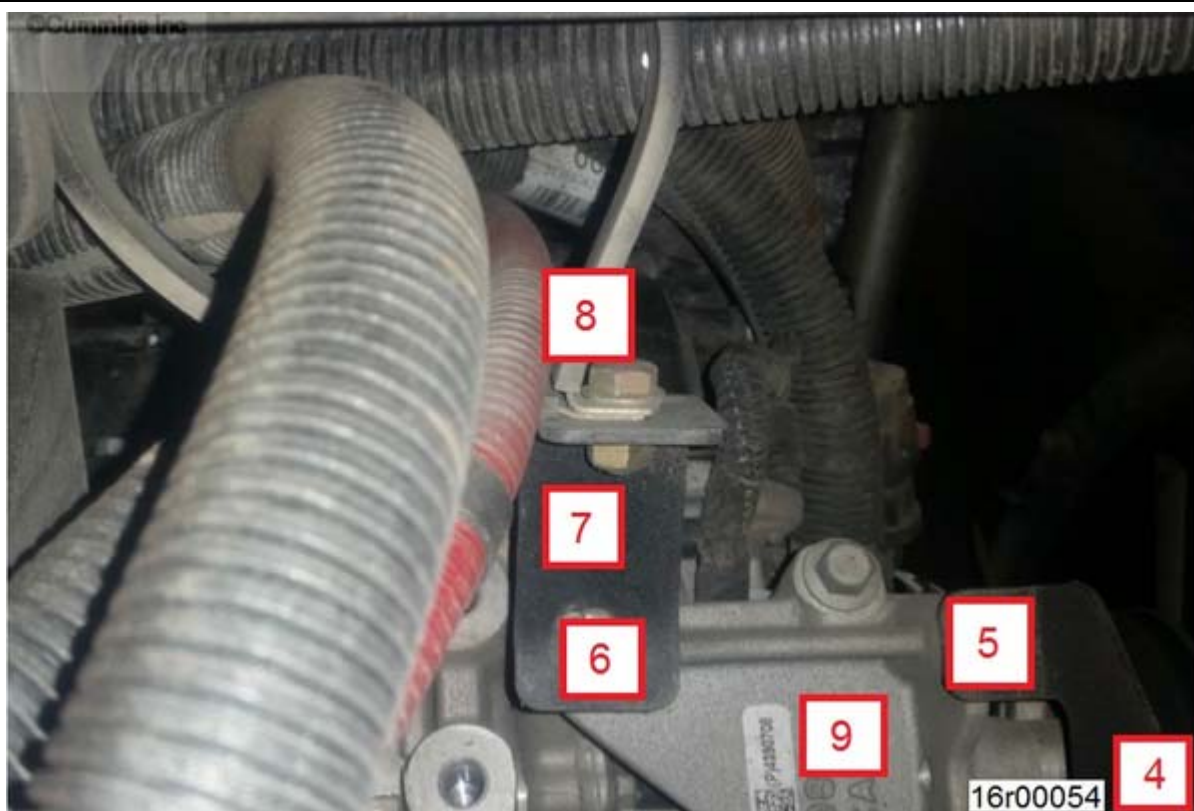
Figure 4, Lower Accessory Drive Mounting with L-Bracket and P-Clamp.

7. Remove L-Bracket (Figure 4 - 7) and P-clamp (Figure 4 - 8) assembly from lower accessory support, Part Number 4390708 (Figure 4 - 9).

8. Remove OEM lower fan shroud support bracket (Figure 4 - 4) mounted to lower accessory support bracket, Part Number 4390708, (Figure 4 - 9) and OEM fan shroud.

- a. Discard OEM supplied cap screws which mounts the lower accessory support bracket to the engine. (Figure 4 - 5 and Figure 4 - 6).
- b. Install new OEM lower fan shroud support bracket (Figure 4 - 4) using new cap screws, washers, and nut at fan shroud position. (Figure 4)
- c. Reuse L-bracket (Figure 4 - 7) and P-Clamp assembly (Figure 4 - 8)
- d. Tighten all fasteners to proper specifications. See equipment manufacturer service information.

9. Install Sanden Freon™ compressor on lower accessory support, Part Number 4390708 (Figure 4 - 9).

- a. Do **not** tighten capscrews at this time.
- b. Reuse two of the OEM supplied freon compressor mounting bolts from upper mount configuration. (capscrews M8 x 80mm x 1.25)
- c. Install first capscrew in the lower mounting hole towards the rear of the engine.
- d. Install second capscrew (Figure 4 - 6) through the L-bracket and P-clamp assembly (Figure 4 - 8) in upper mounting hole towards the rear of the engine.

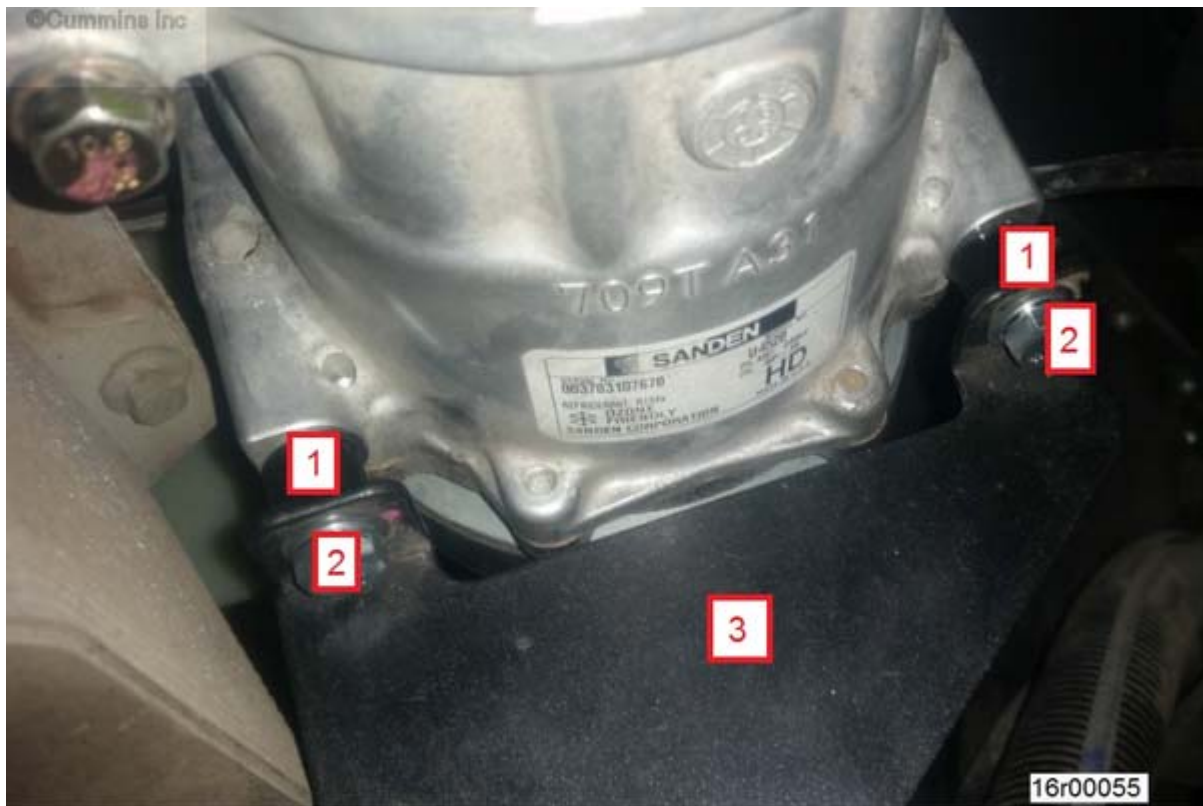
Figure 5, Freon™ Compression Lower Mount Option With Spacers Installed on Fan Shroud Support Bracket.

Fabricate lower fan support bracket (if needed) (Figure 5 - 3).

11. Install 12.5 mm [ ½ in ] spacers (Figure 5 - 1) between bracket and Freon™ compressor body with two new mounting capscrews (M8 x 120mm x 1.25) (Figure 5 - 2) in remaining holes. (12.5 mm [ ½ in ] spacers allow for access to belt).

- a. Align refrigerant Freon™ compressor drive pulley and tighten refrigerant Freon compressor mounting capscrews to specifications.
- b. 12.5 mm [ ½ in ] spacer can be manufactured or sourced. Fabricated with 9.5mm [ 3/8 ] ID x 12.5 mm [ ½ in ] long in black pipe. Paint spacers black before installing.

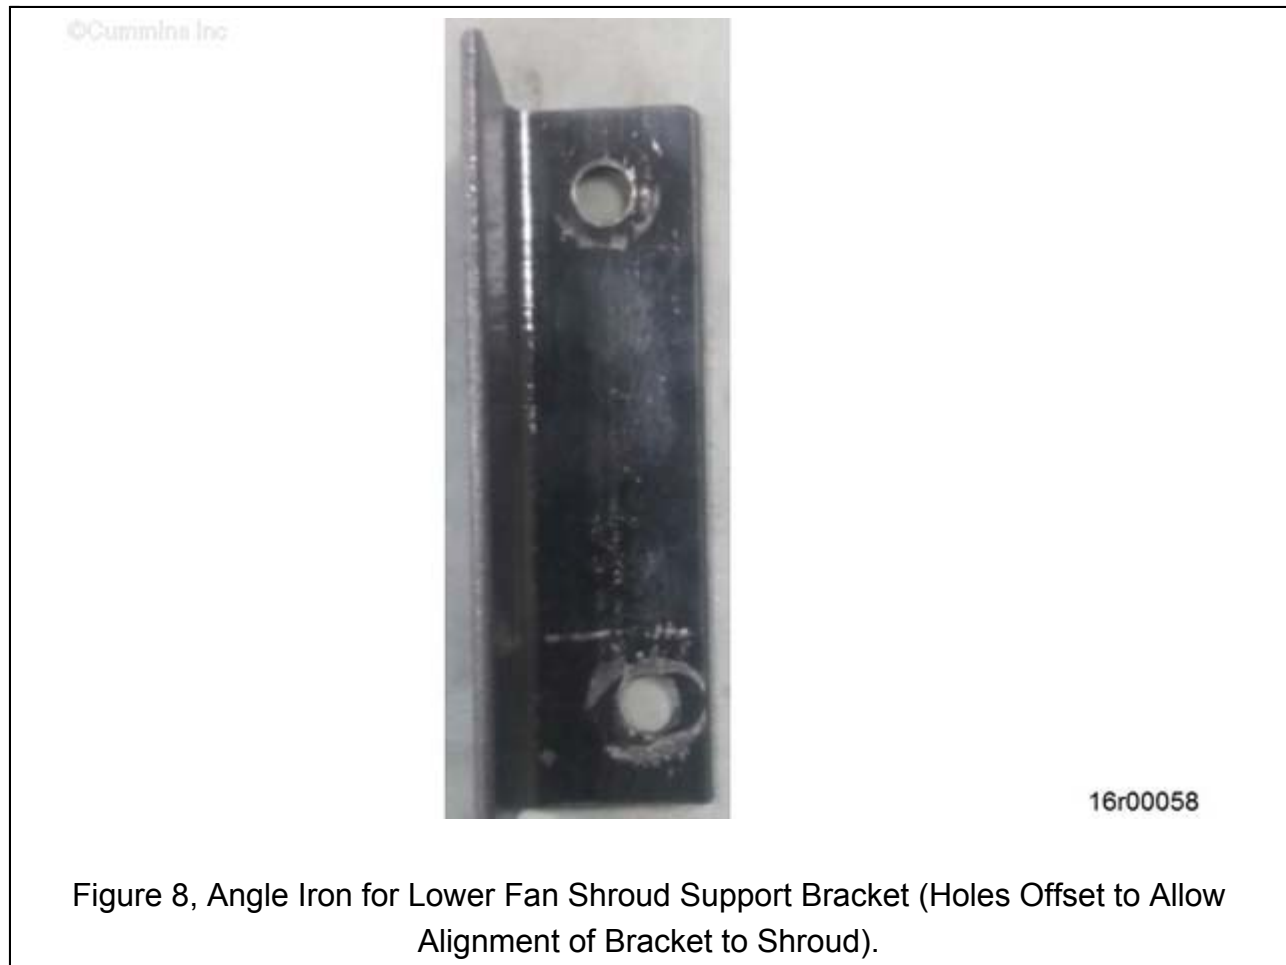
- a. Fabricate 100 mm [ 4 in ] long bracket from 38 mm [ 1 ½ in ] x 3 mm [ 1/8 in ] angle iron (Figure 8). Drill two holes as shown.

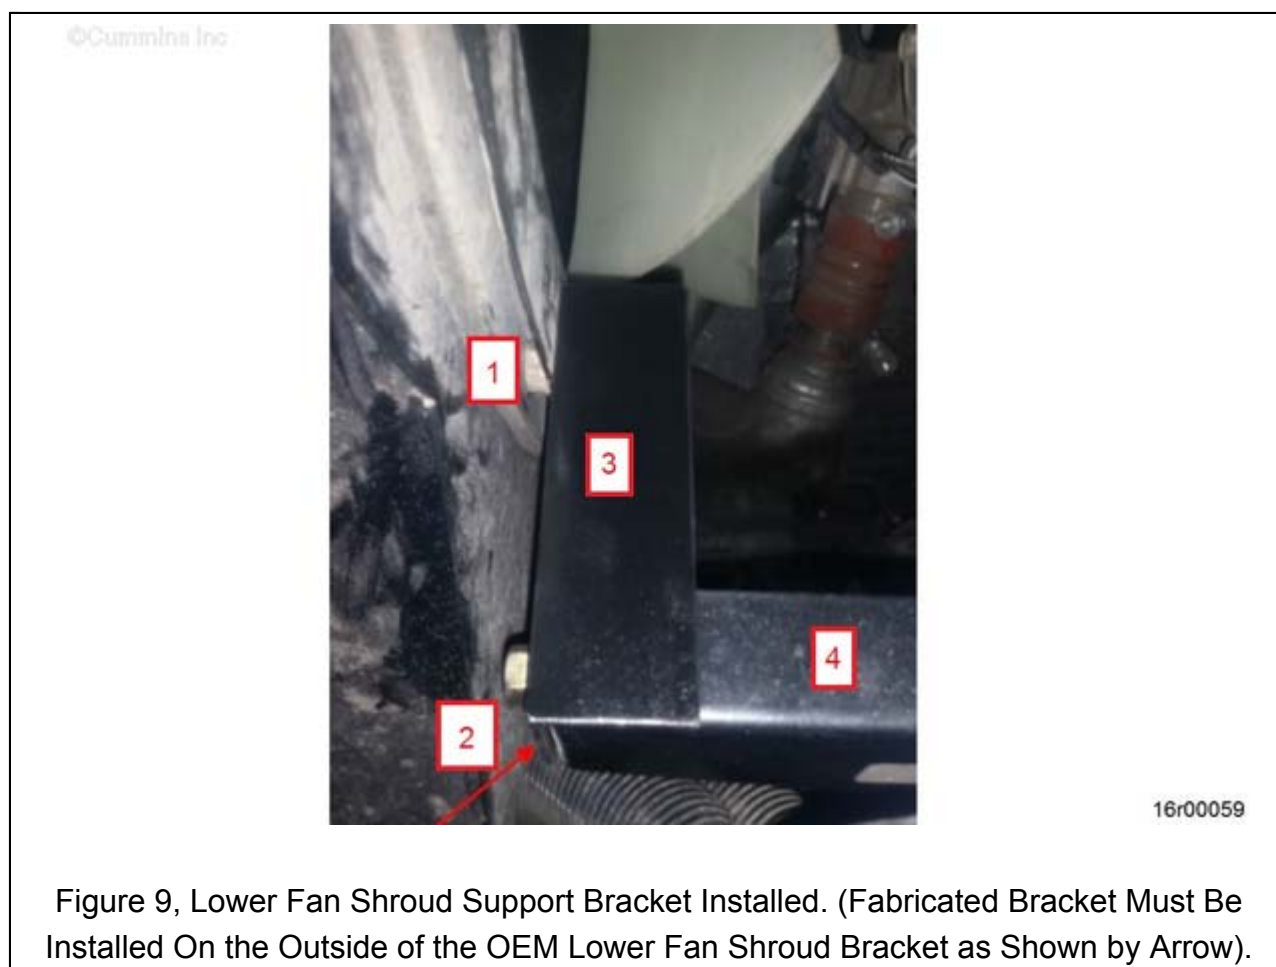
- a. Reuse OEM hardware to secure fabricated bracket to fan shroud (Figure 9 -1).
- b. Secure fabricated angle bracket to the OEM fan support bracket (Figure 9 – 4) using a new capscrew, flat washer and locking nut. Install angle bracket on the outside of the OEM bracket as shown by arrow (Figure 9).
- c. Tighten fasteners to proper specifications.

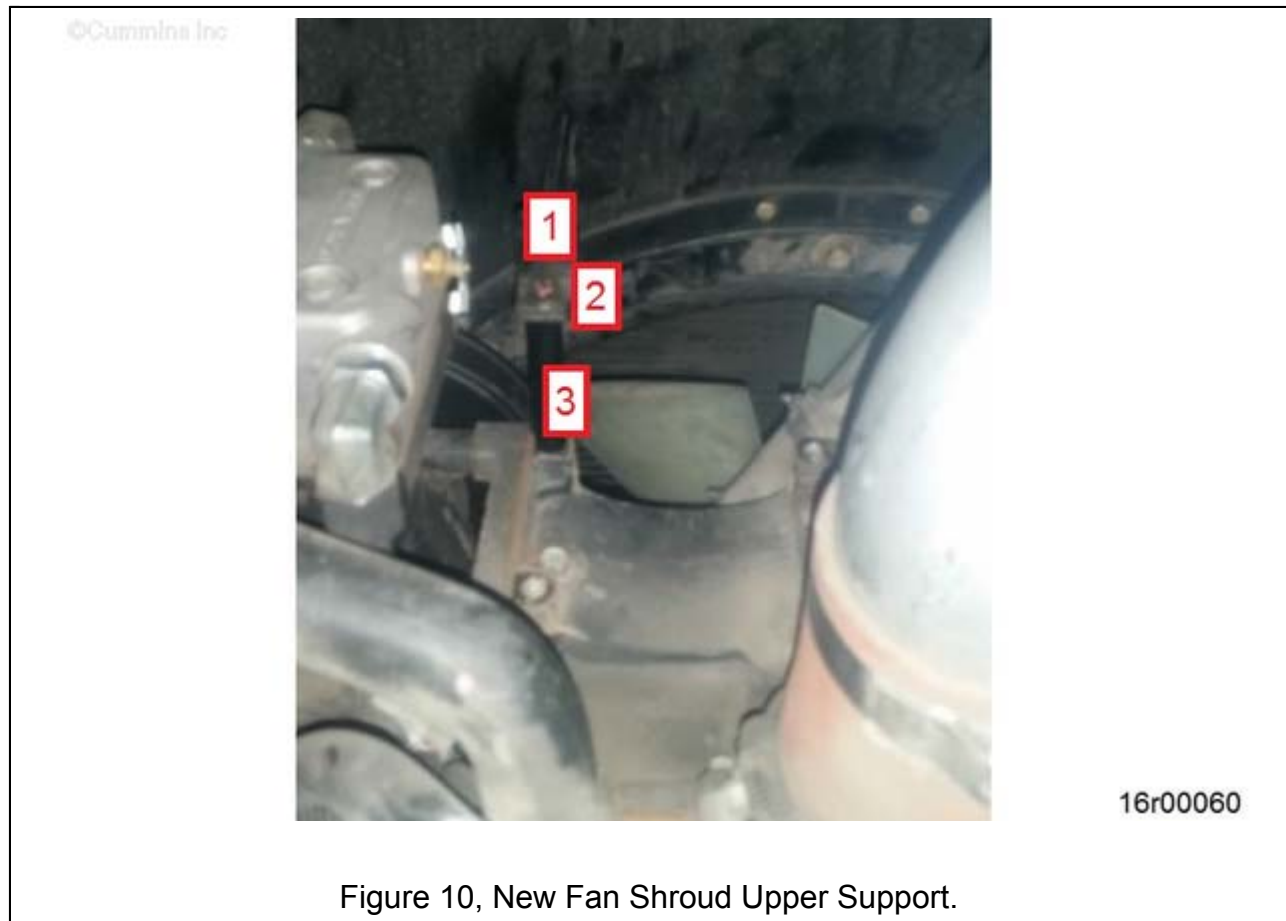
15. Fan Shroud upper support bracket (Figure 10 – 1 & 11 – 1) originally mounted with refrigerant Freon™ compressor mounting capscrew (Figure 11 - 2). With refrigerant Freon™ compressor (Figure 11 - 3) no longer in the upper location, a spacer needs to be installed. Spacer can be sourced or fabricated.

- a. Fabricated with 9.5mm [ 3/8 ] ID x 75 mm [ 3 in ] long black pipe.
- b. Install spacer (Figure 10 - 3) in place of Freon™ compressor in upper OEM fan shroud support. Reuse 1 of original Freon™ compressor mounting capscrews. M8 x 80mm x 1.25 (Figure 10 – 2).
- c. Paint spacer before installing
- d. Tighten all fasteners to proper specifications.

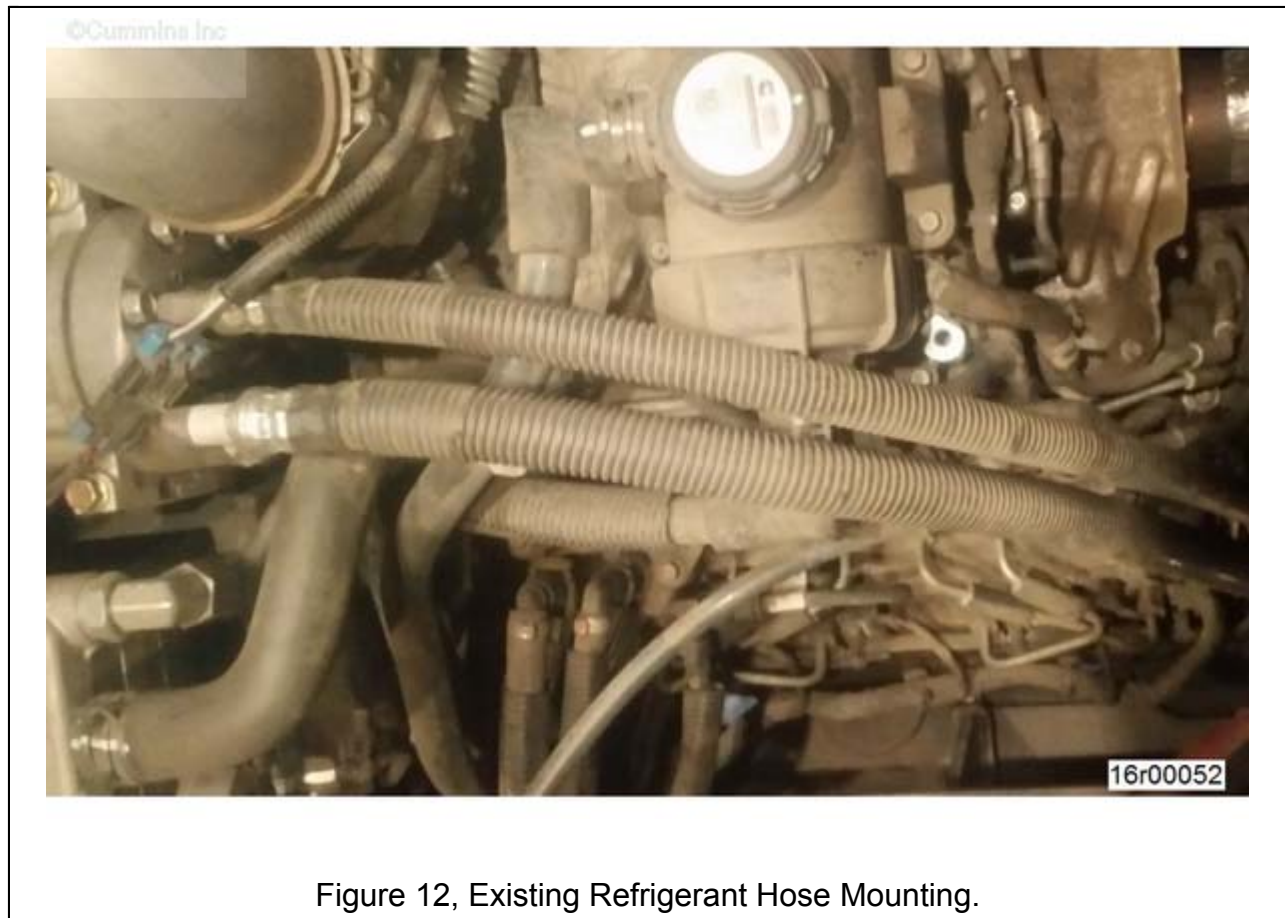
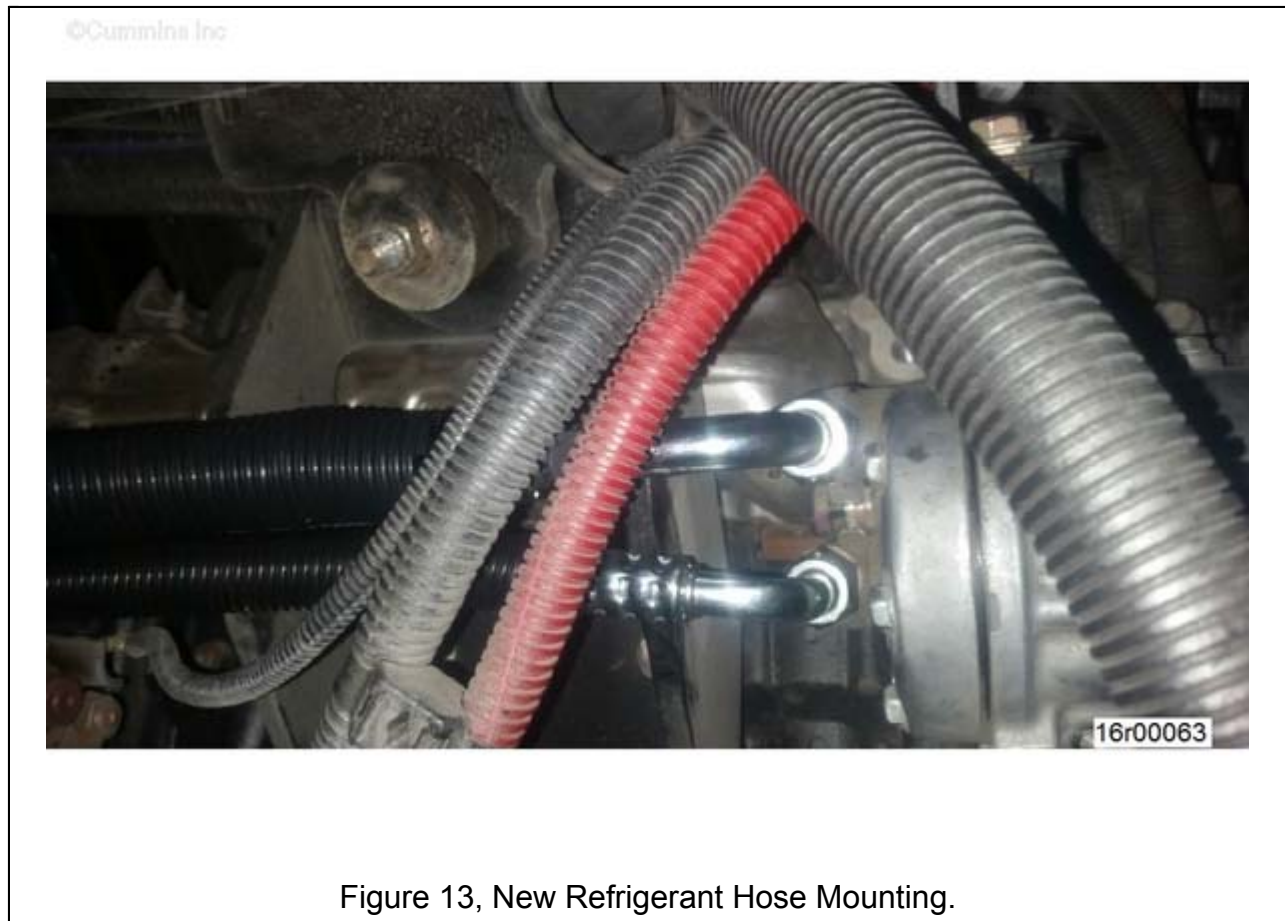
25. Route hoses to new refrigerant Freon™ compressor mount location. See Figures 12-13.

- a. Secure with wire ties and p-clamps as necessary.
- b. Secure away from heat sources.

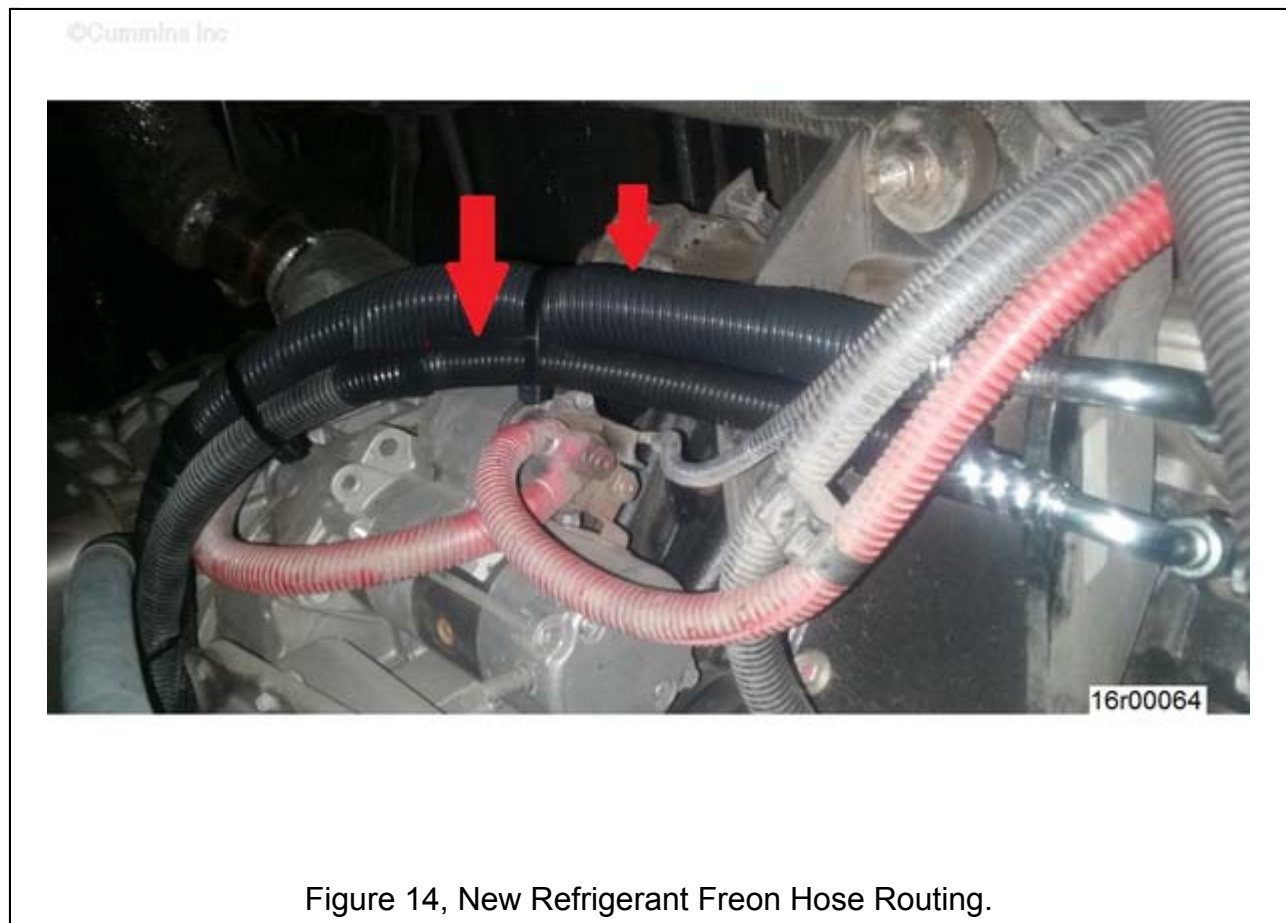
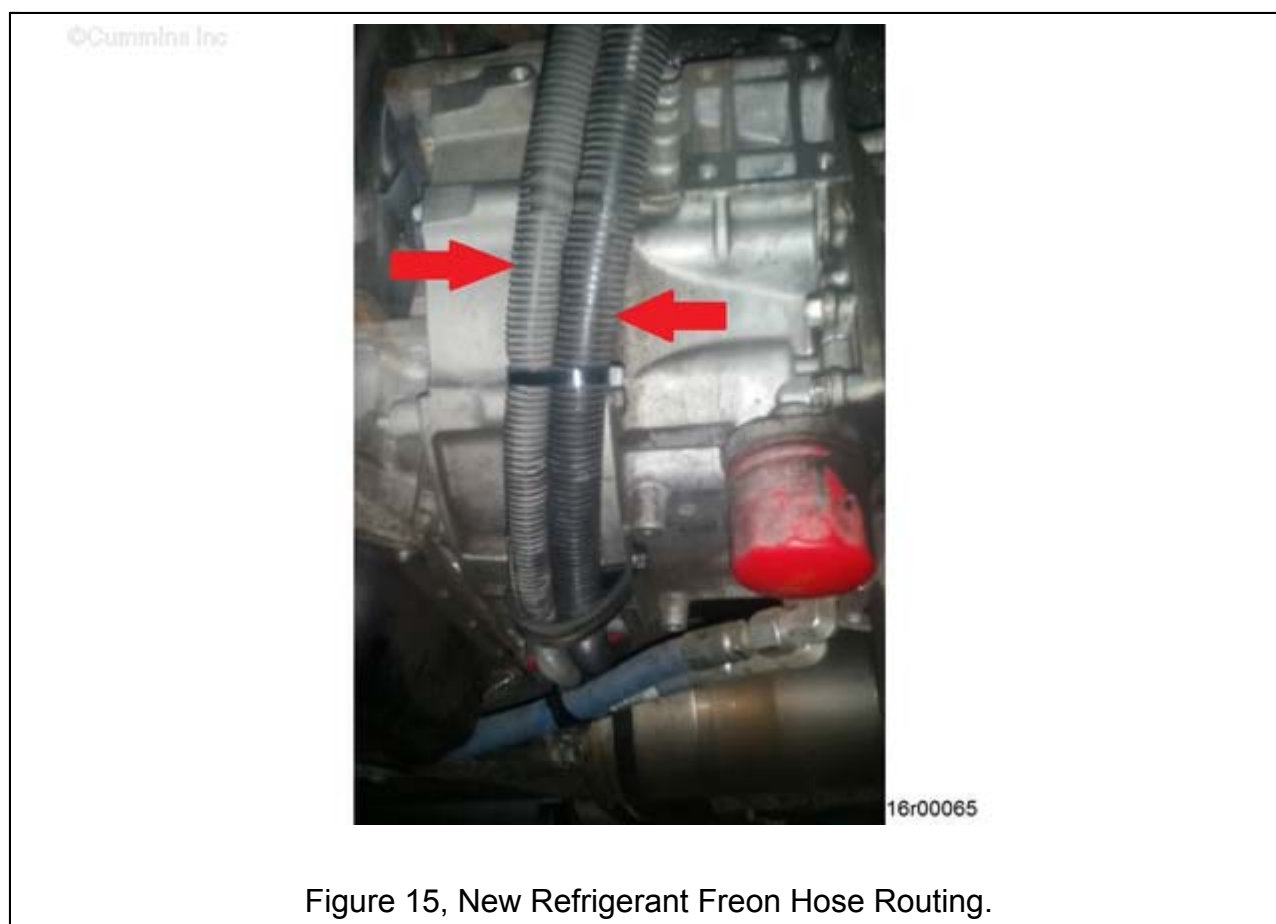
- a. Option 1- Preferred method: Use union fitting or bulkhead fitting and a short total length approximately 24 in refrigerant Freon™ hose with 90 degree fitting on compressor end and straight fitting to union connected into original 90 degree fitting on original hose.
- b. Option 2- Hose cut and spliced to proper length approximately 610 mm [ 24 in ] longer.
  - i. Contact your local air conditioning component supplier for necessary parts.
