## CR158 – Replacement of clutch actuator slave cylinder Scrambler 1100 Model Year 2018 (all model versions) Service Repair Bulletin SRV-TSB-18-012

Ongoing product quality tests and the analysis of our supplier identified a condition that may potentially result in fluid seepage at the clutch actuator slave cylinder, that could result in an erratic operation of the clutch. Therefore, we decided to preventively upgrade the vehicles involved and install an improved clutch actuator slave piston kit.

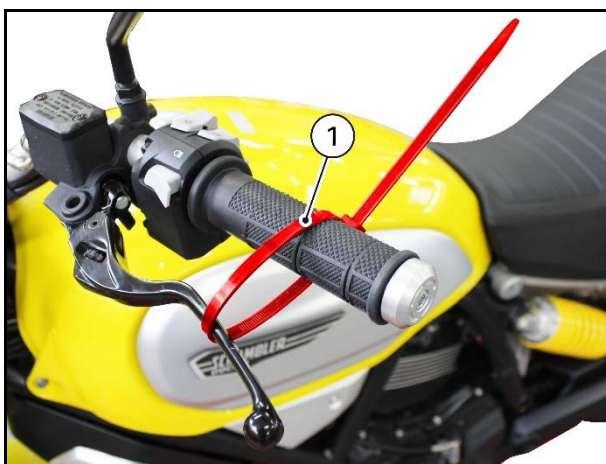
**2.0** Use a **self-locking tie (1)** to keep the clutch lever slightly pulled approximately at half its travel as shown in the figure

Do NOT use a rubber band since it would move the lever when the clutch actuator unit is removed

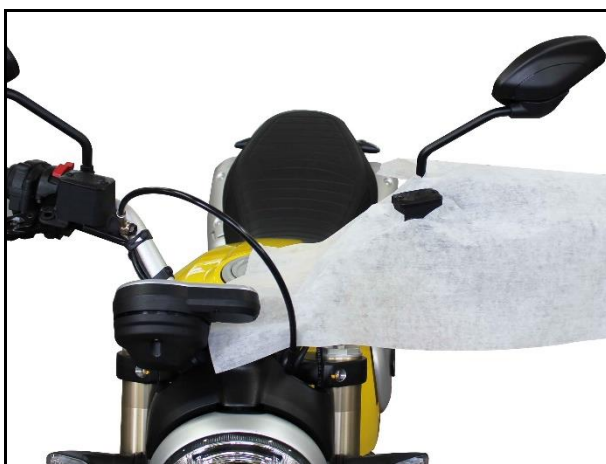
**3.0** Turn handlebar straight and use a cloth to protect the parts near and under the clutch master cylinder, as shown in the figure

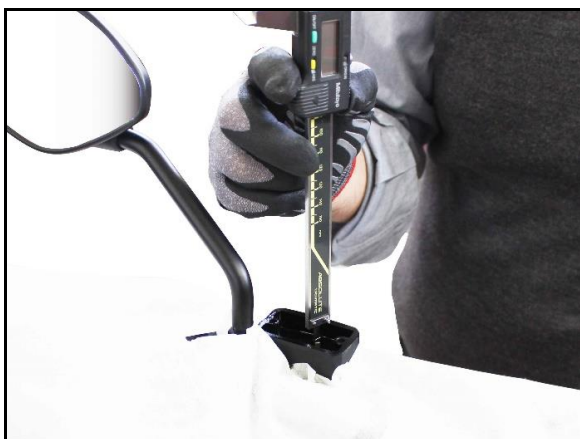
- 5.0 Measure and record the clutch fluid level in the reservoir. Set a gauge on the clutch fluid reservoir surface and bring **stylus (5)** down until it touches the surface of the fluid

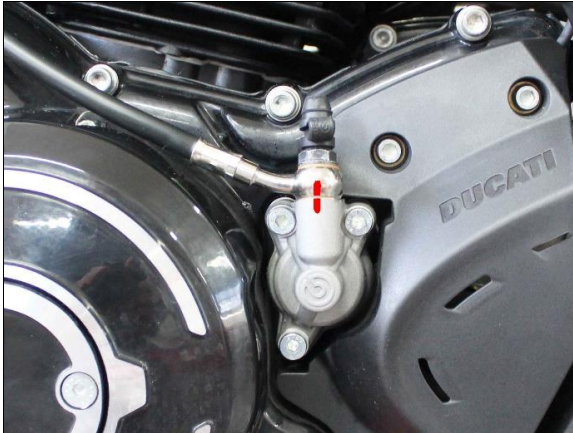
**6.0** Mark the clutch control hose union and the clutch actuator unit with a felt-tip pen as shown in the figure to enable correct positioning at reassembly, then remove the **bleed cap (6)**

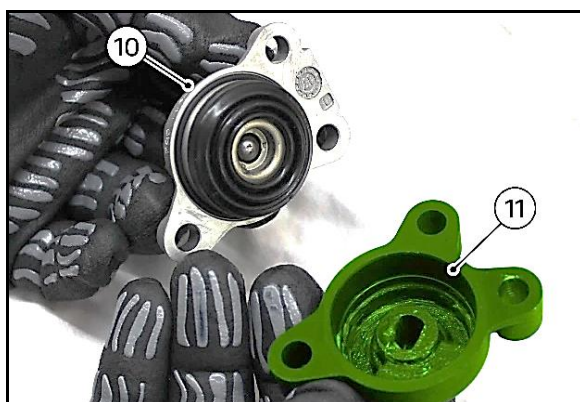
**9.0** Remove the **spacer (11)**, from **clutch actuator unit (10)**

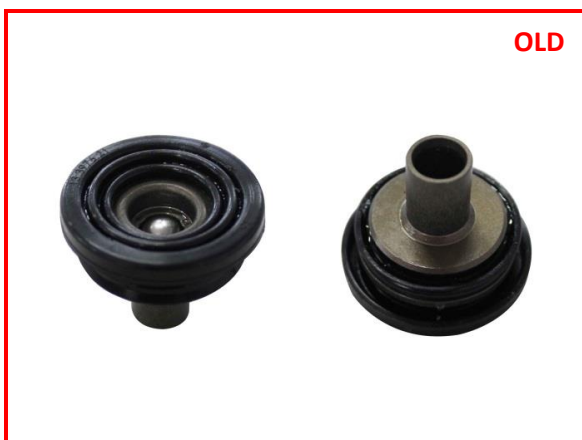
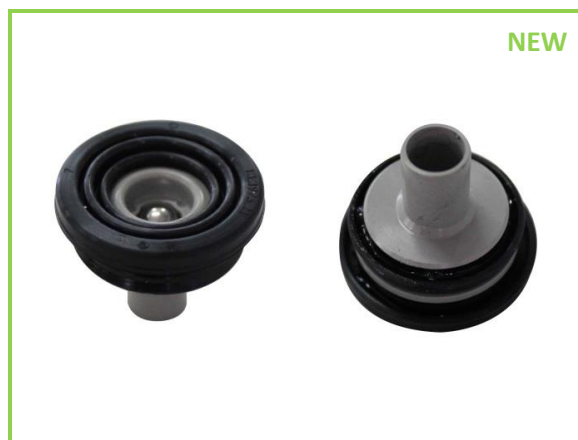
**11.0** From the kit part no.61041941A locate the new clutch actuator slave cylinder. The new version can be identified by a new surface treatment with a smoother surface for better system sealing

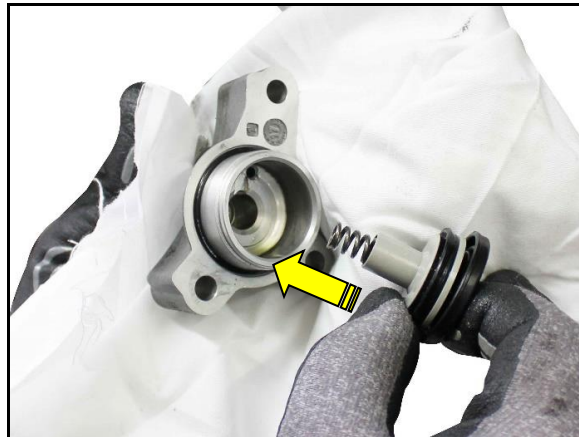
**14.0** Insert the spring-clutch actuator slave cylinder assembly inside the clutch actuator by pushing it in the axial direction

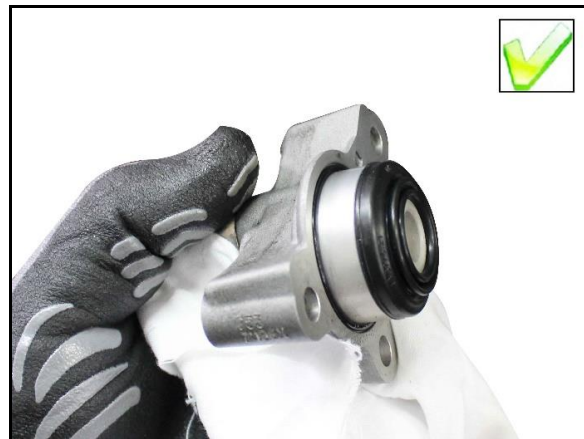
Check that the clutch actuator slave cylinder has been inserted correctly inside the actuator so that the rubber **boot (14)** is correctly positioned along the circumference on the **seat (15)**

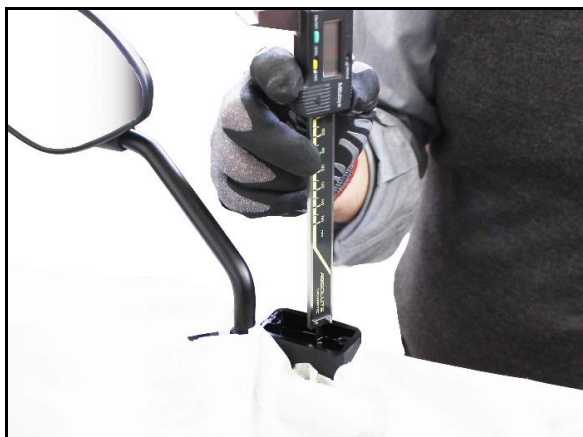
**22.0** Fill the clutch fluid reservoir with DOT 4 until reaching the level previously measured with gauge **stylus (5)**
