SI B61 06 18  
General Electrical Systems

## SERVICE ACTION: REPOSITION DOOR WIRING HARNESS

| G12 (7 Series) | |

This Service Action involves (316) 7 Series vehicles produced from 3/2/2018 to 3/15/2018.

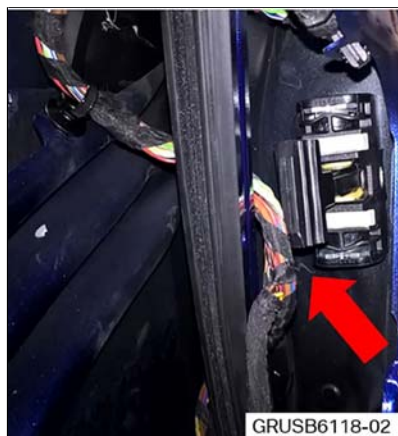
Door wiring harnesses may be installed such that the harness can be damaged by contact with sharp edges of the door brake.

2. Inspect the wiring harness for chafing, near the door brake (left side shown).
-

**Is there evidence of chafed or exposed wiring?**  
**YES-** replace the harness and then go to Step 3.  
**NO –** go to Step 3.

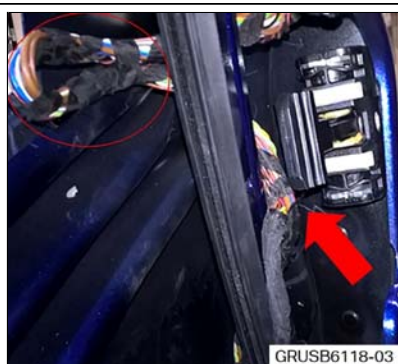
3. Identify which wiring harness installation version this vehicle contains.

**Is the wiring harness looped-over and taped together inside the door (as shown)?**  
**YES-** go to Extra Length Procedure, below.  
**NO –** follow Short Wiring Harness Procedure

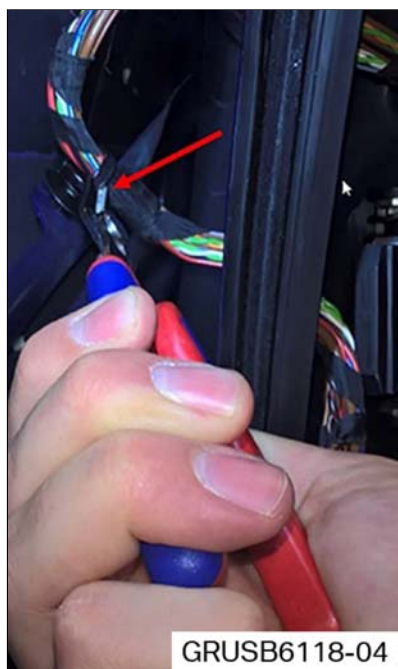
A. Detach the cable strap using a pair diagonal cutters.

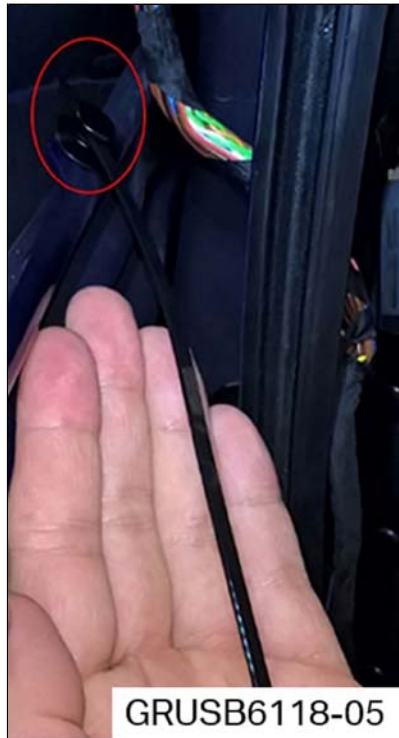
B. Insert a new cable strap in the anchor point.

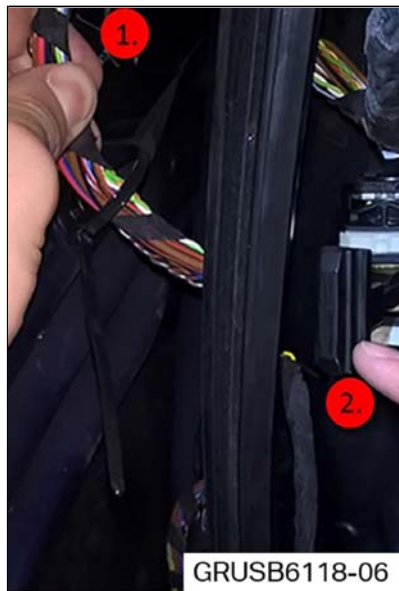
C. Remove the harness and check for freedom of movement at the indicated points (1 and 2).

D. Pull any slack in the harness into the inside of the door.  
E. Tighten the cable strap (3) around the harness.

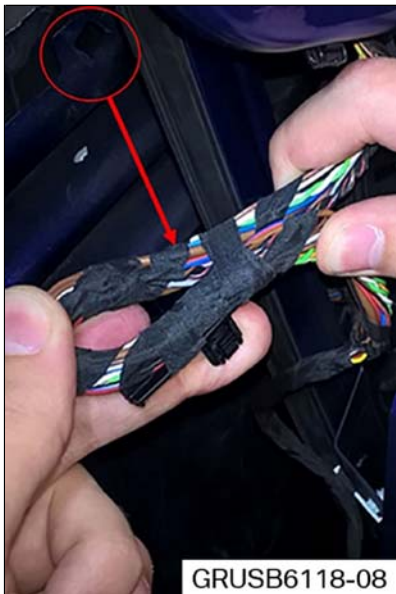
A. Remove the tape holding the wiring harness into a loop.

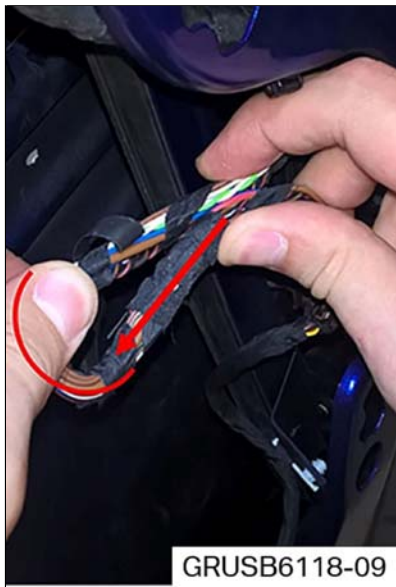
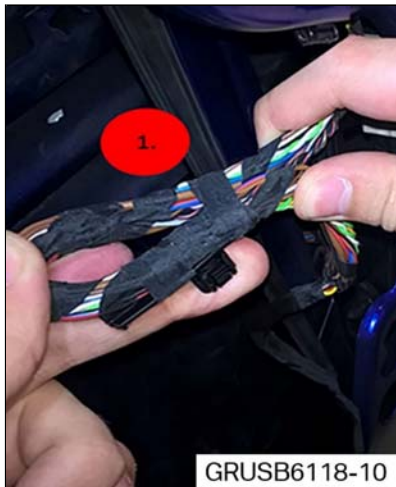
B. Reposition the harness to make the loop longer (pull some of the slack in the harness into the loop).

C. Retape, making a larger loop in the wiring harness.

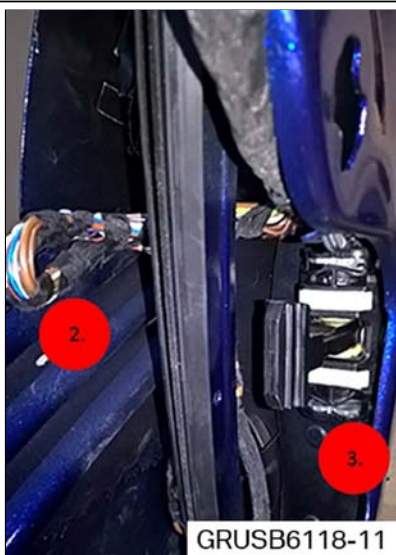
D. Mount the wiring harness loop (2) out of the range of motion of the door brake, ensuring adequate freedom of movement (3).  
E. Go to Step 4 below.
