## CR157 – Replacement of clutch actuator slave cylinder and brake and clutch reservoir baffles

Multistrada 1260 Model Year 2018 (all model versions)

### Service Repair Bulletin SRV-TSB-18-011

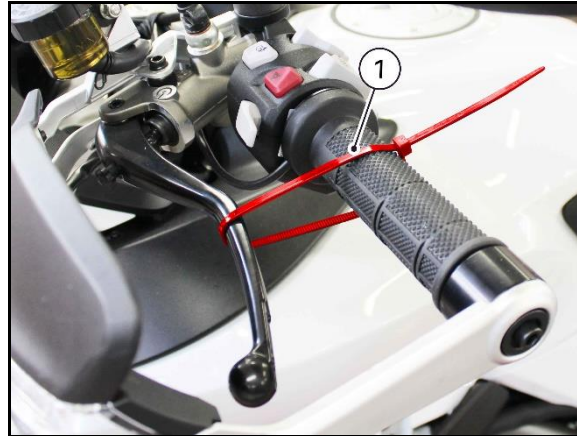
2. Use a ***self-locking tie (1)*** to keep the clutch lever slightly pulled approximately at half its travel as shown in the figure

Do NOT use a rubber band since it would move the lever when the clutch actuator unit is removed

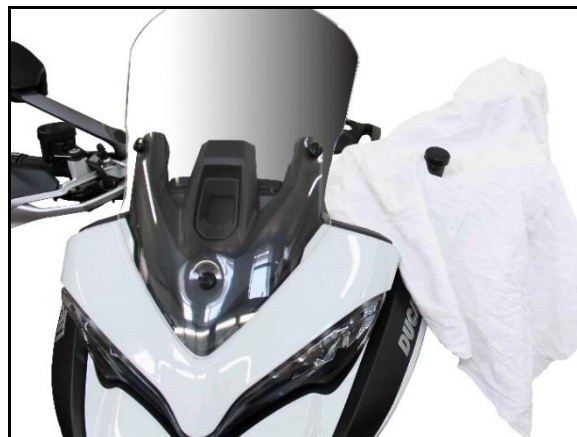
3. Turn handlebar straight and use a cloth to protect the parts near and under the clutch master cylinder, as shown in the figure

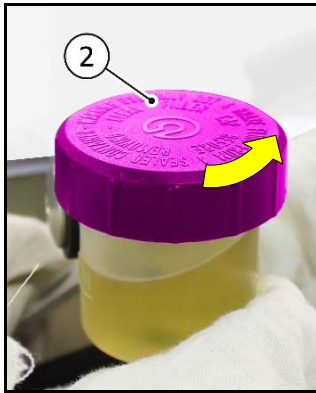
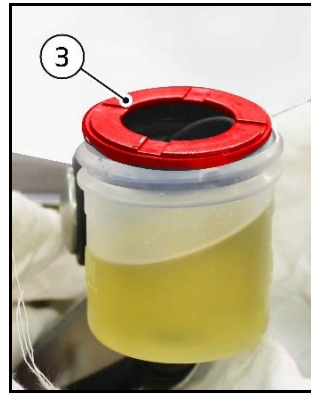
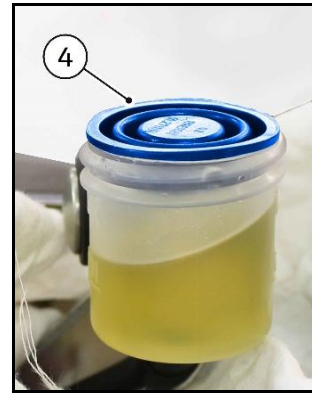
4. Remove the *clutch fluid reservoir cap (2)* by rotating it counter clockwise, the *baffle (3)* and the *diaphragm (4)* in sequence

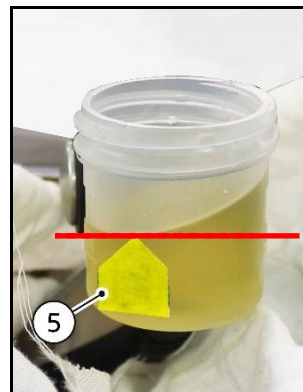
5. Prepare an *arrow (5)* using adhesive tape and stick it on the reservoir to mark the initial fluid level, as shown in the figure

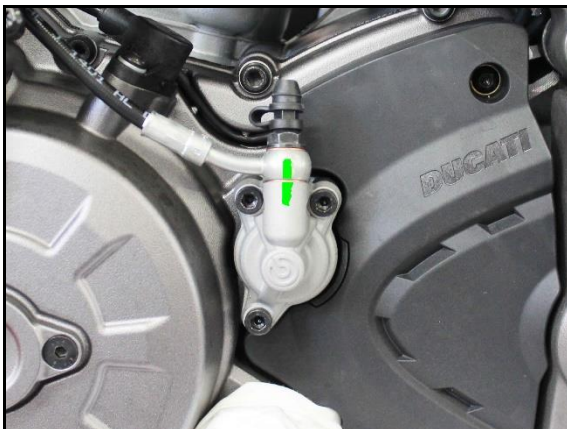
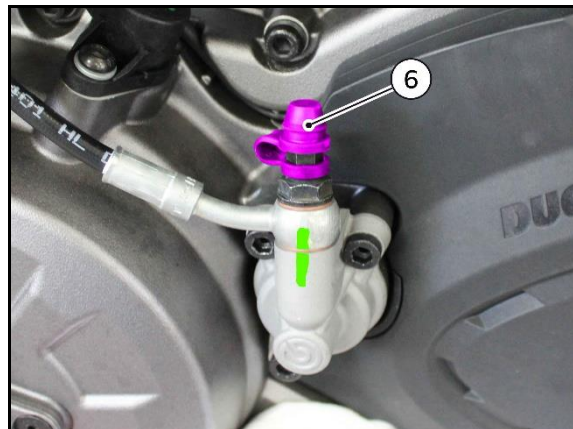
6. Mark the clutch control hose union and the clutch actuator unit with a felt-tip pen as shown in the figure to enable correct positioning at reassembly, then remove the *bleed cap (6)*

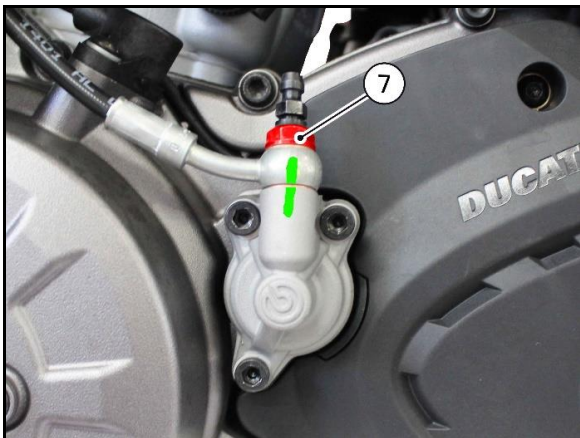
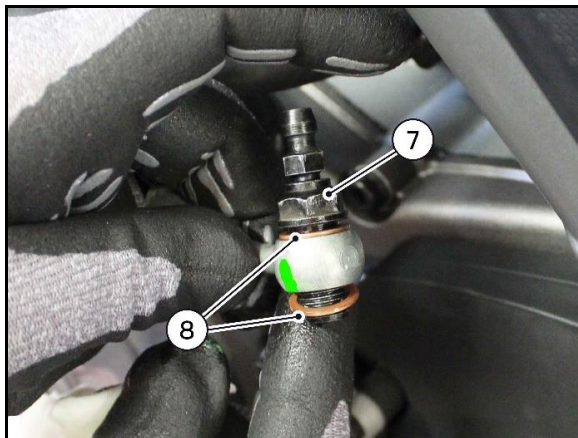
7. Remove the connection **screw (7)** with **2 copper washers (8)** and allow hose to drain into suitable waste fluid container

Protect the surrounding area with a cloth to prevent the fluid inside the clutch actuator unit from touching the silencer or other components

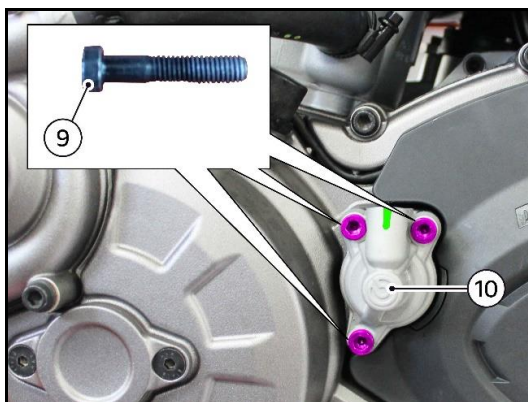
8. Remove the **3 M6x30 screws (9)** that retain the **clutch actuator unit (10)**, then remove the **clutch actuator unit (10)** from the motor and clutch pushrod

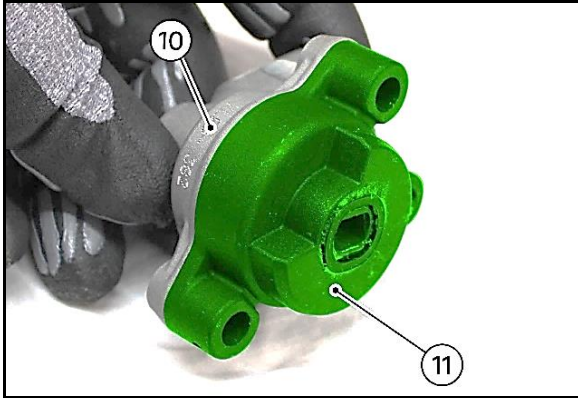
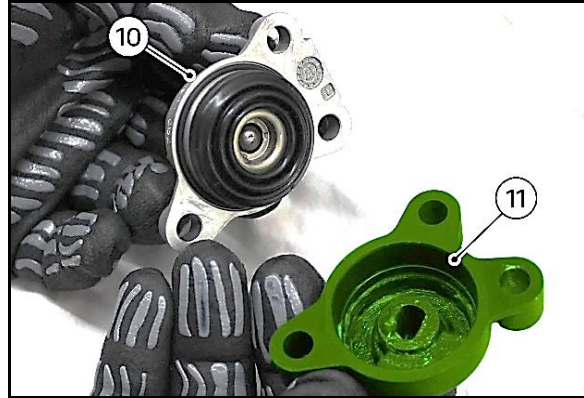
9. Remove the *spacer (11)*, from *clutch actuator unit (10)*

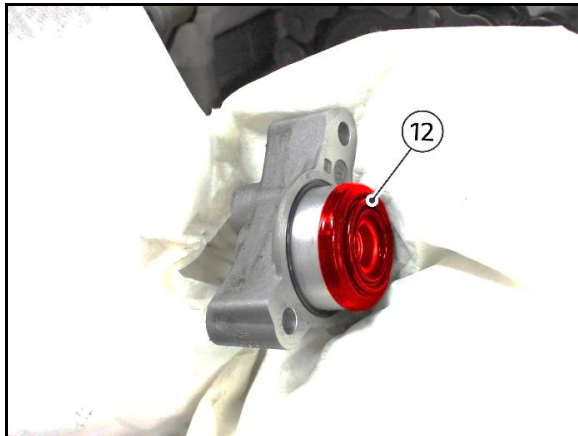
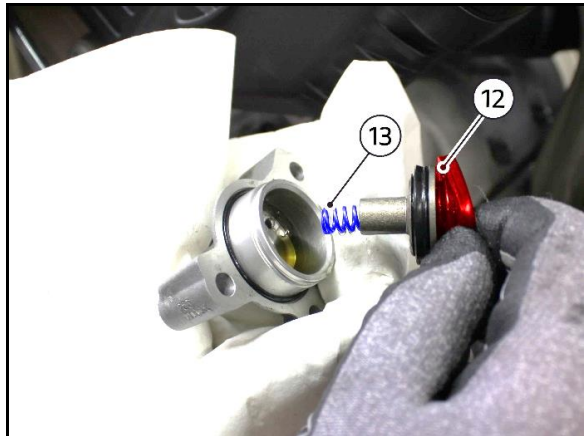
10. Remove the clutch actuator slave cylinder by pulling it outward to release the *rubber boot (12)* and the *spring (13)*.

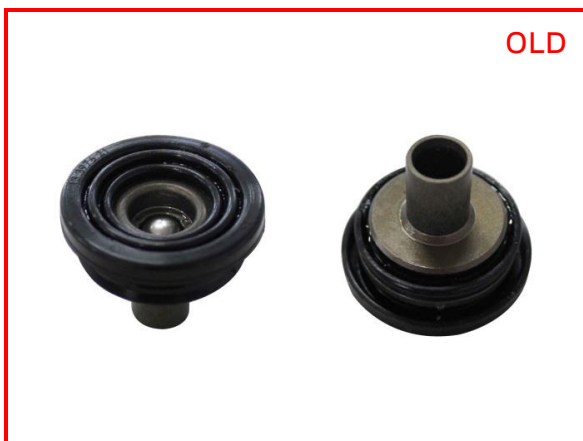
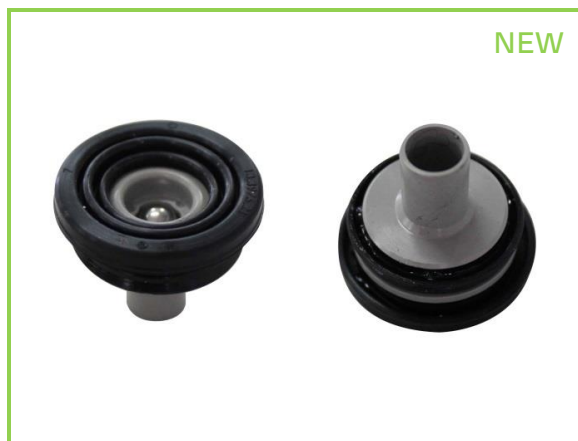
11. From the kit part no.61041941A locate the new clutch actuator slave cylinder. The new version can be identified by a new surface treatment with a smoother surface for better system sealing

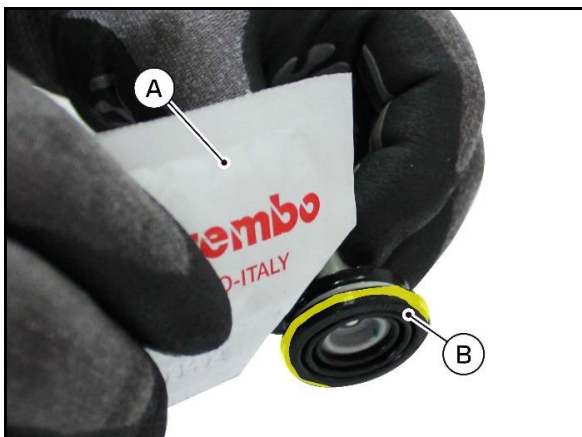
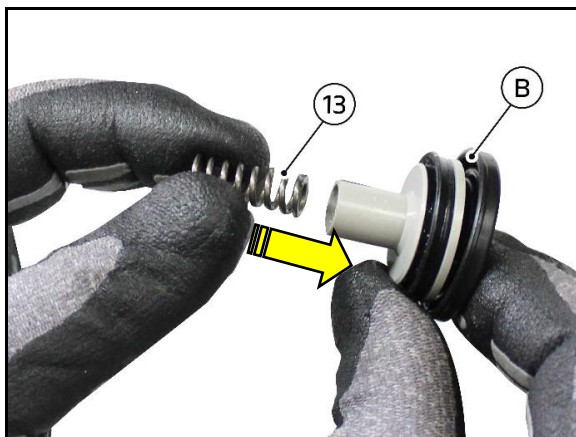
12. Take *grease (A)* from kit part no.61041941A and apply it along the rubber seal of the new *cylinder (B)*
13. Insert the previously removed *spring (13)* inside the new *clutch actuator slave cylinder (B)* as shown in the figure

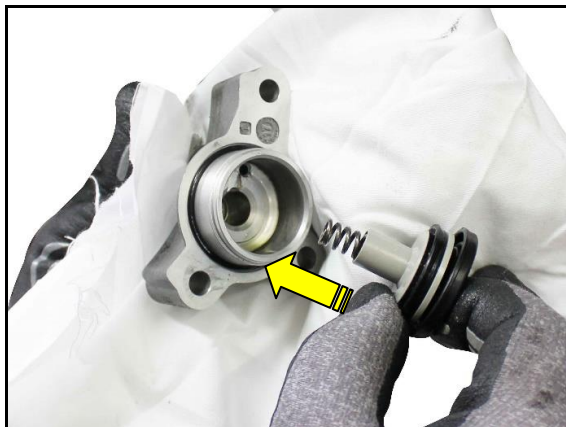
14. Insert the spring-clutch actuator slave cylinder assembly inside the clutch actuator by pushing it in the axial direction

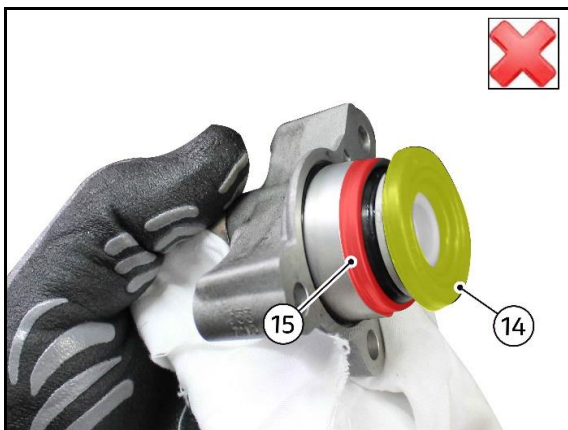
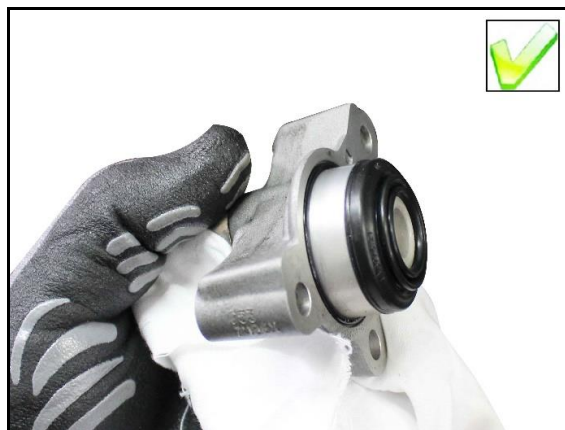
Check that the clutch actuator slave cylinder has been inserted so that the rubber *boot (14)* is correctly positioned along the circumference on the *seat (15)*

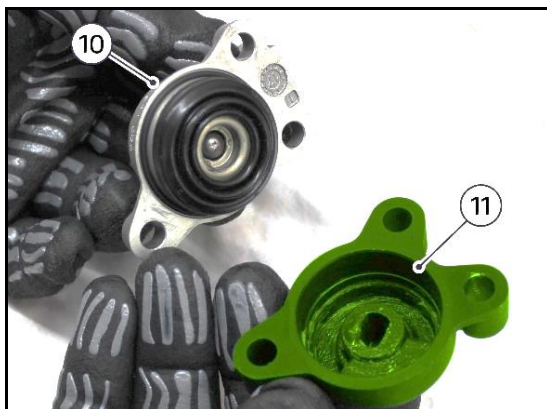
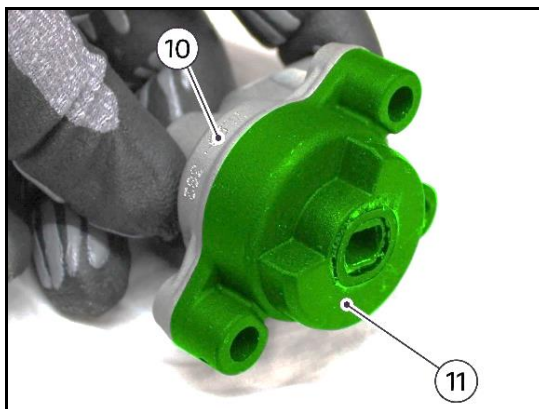
15. Install *spacer (11)* onto *clutch actuator unit (10)*, positioning it as shown in the figure

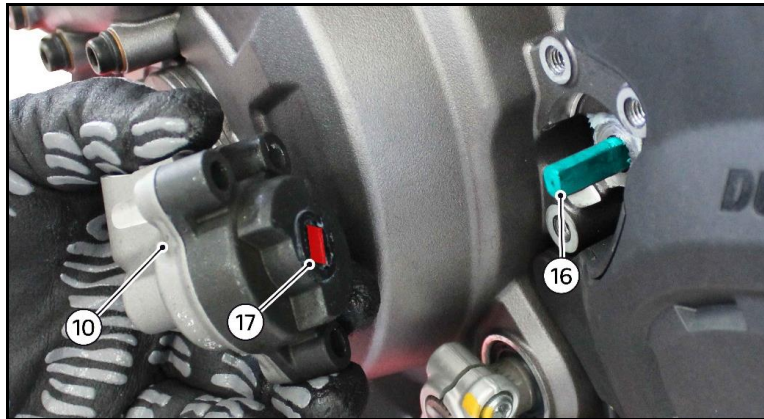
16. Install the *clutch actuator unit (10)* matching the position relative to *clutch control rod (16)* and *seal (17)* fitted to the spacer

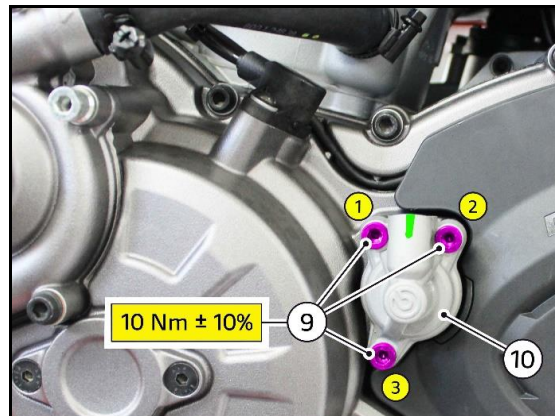
17. Start the *3 M6x30 screws (9)* that retain the *clutch actuator unit (10)*. Then tighten *the 3 screws M6x30 (9)* to **10 Nm  $\pm$  10%**, following tightening sequence 1-2-3-1

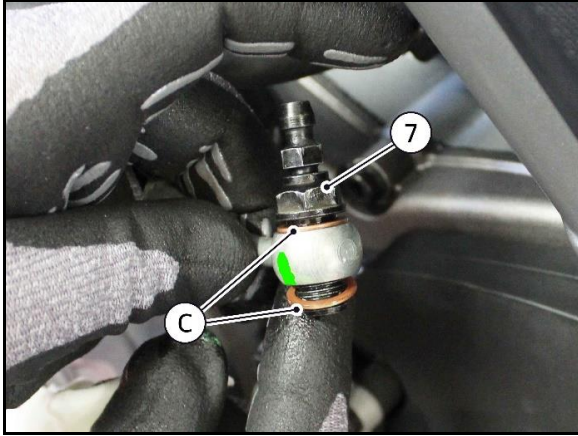
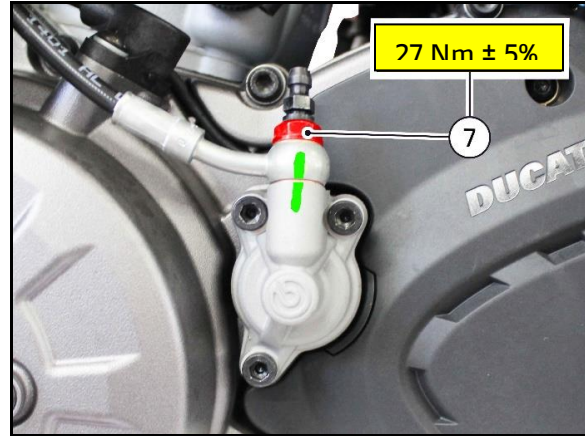
18. Take the new copper washers from the kit part no.61041941A
19. Insert the *connection screw (7)* with the *2 new copper washers (C)* on the clutch control hose union as shown in the figure and position it on the previously marked point on the clutch actuator unit

20. Tighten the *connection screw (7)* to 27 Nm  $\pm$  5%

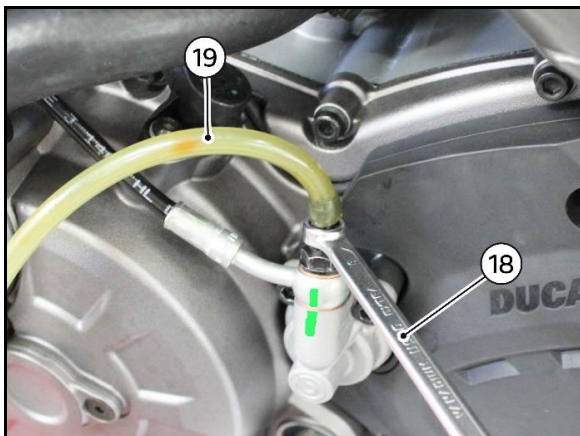
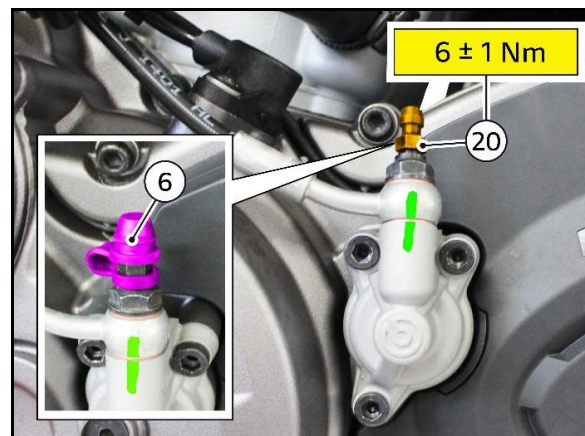
21.1 Insert the *wrench (18)* in the bleed valve and fit the *hose (19)* of the bleeder vessel on the bleed valve of the clutch actuator unit

21.2 Slacken the bleed valve and pump the clutch lever, while progressively filling the reservoir with DOT 4 so that the fluid level never goes below the half of the reservoir. Pump the clutch lever until you no longer see air bubbles entering the bleeder hose from the clutch slave cylinder

21.4 Tighten the *bleed valve (20)* to 6  $\pm$  1 Nm and fit the *bleed cap (6)*

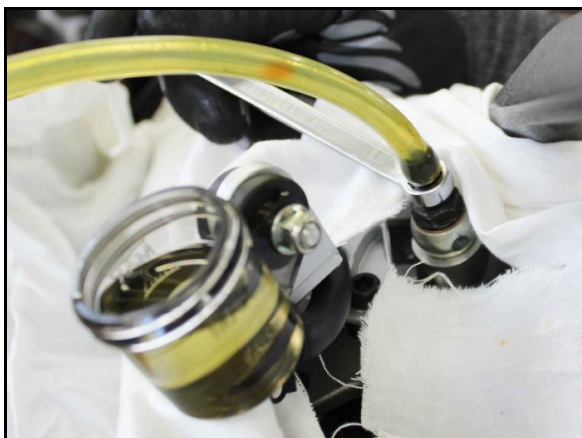
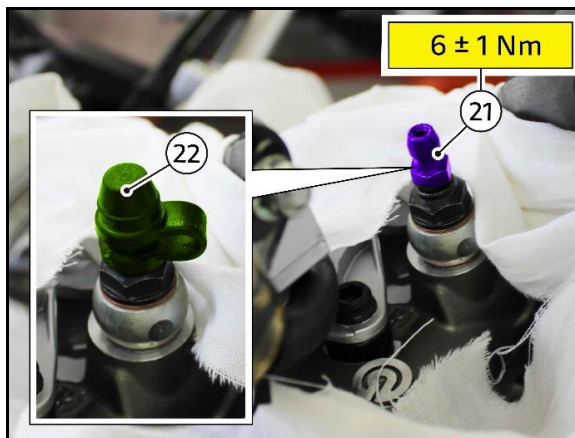
22. Repeat the bleed procedure from 21.1 - 21.4 at the *clutch master cylinder bleed valve (21)*
23. Tighten the *bleed valve (21)* to  $6 \pm 1 \text{ Nm}$  and fit the *bleed cap (22)*

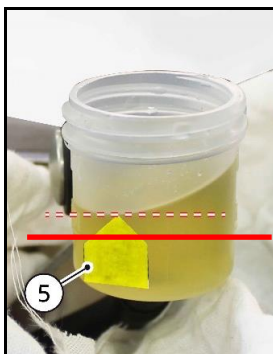
24. Top up the clutch fluid reservoir with DOT 4 until reaching the level indicated by the reference *arrow (5)*, then remove the adhesive tape arrow

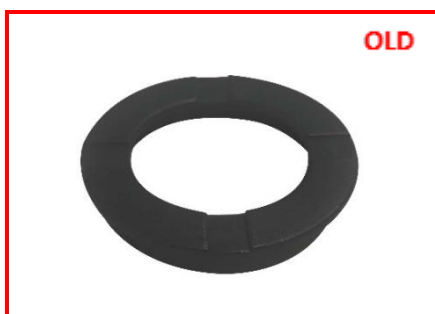
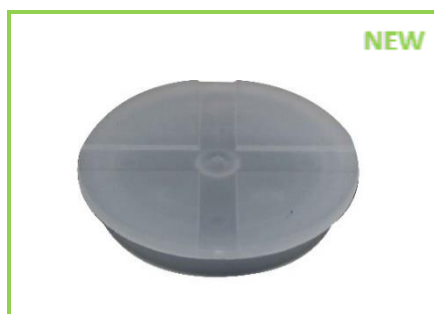
25. Flush the diaphragm and the clutch fluid reservoir cap with WATER ONLY, and dry with compressed air
26. Locate the new clutch fluid reservoir baffle, part no. 61241211A

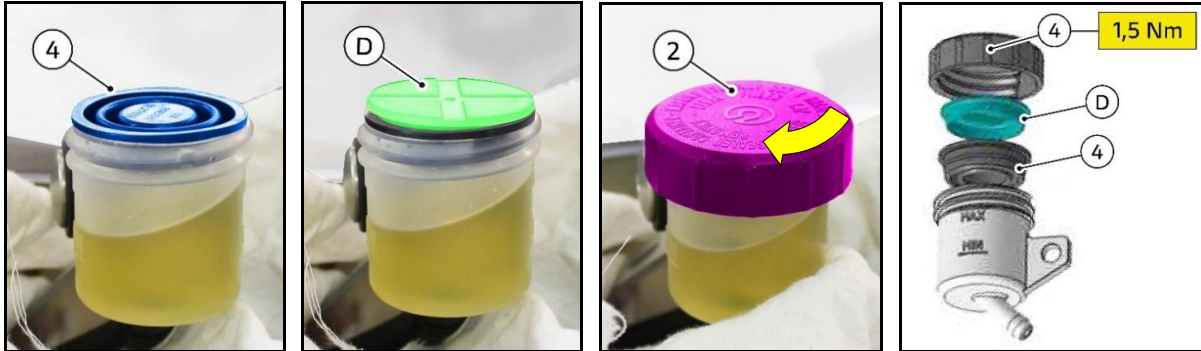
27. Install in the following sequence:

27.1 Insert the **diaphragm (4)** aiming it as shown in the figure

27.2 Insert the **baffle (D)** aiming it as shown in the figure

27.3 Screw the **cap (2)** clockwise and tighten it to **1.5 Nm**

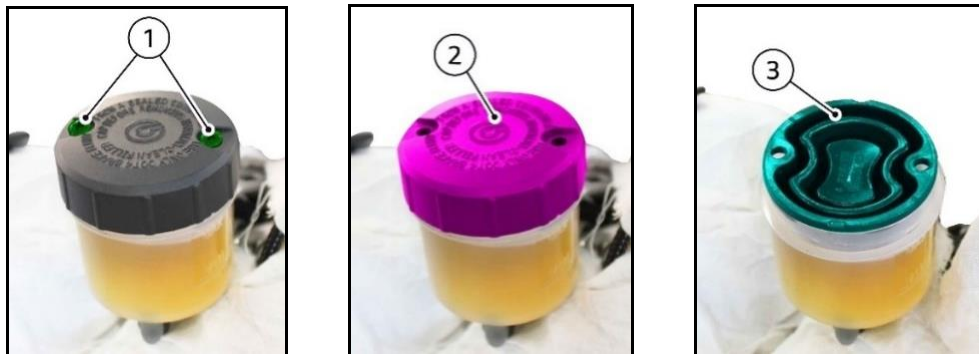
29. Use a cloth to protect the parts near and under the front brake fluid reservoir, as shown in the figure

30. Remove the **2 screws M4x45 (1)** and slide **plug (2)** out of the front brake fluid reservoir without removing the diaphragm (3)

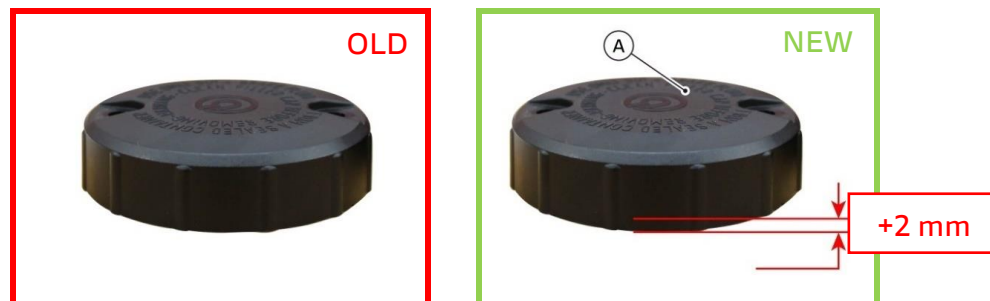
31. Locate the new **plug (A)** part no.89340291A for front brake fluid reservoir

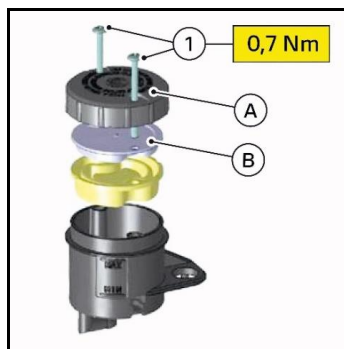
32. Locate *baffle (B)* part no.61241201A

33. Install *baffle (B)* aiming it as shown in the figure and then the new *plug (A)*

34. Tighten the 2 M4x45 *fastening screws (1)* to 0.7 Nm
