Bulletin No.: PIC6337

PIC6337 Rattle Noise from Exhaust

Brand:	Model:	Model Years:	VIN:		Engine:	Transmissions:
			from	to		
Chevrolet	Camaro	2018	All	All	LGX	All

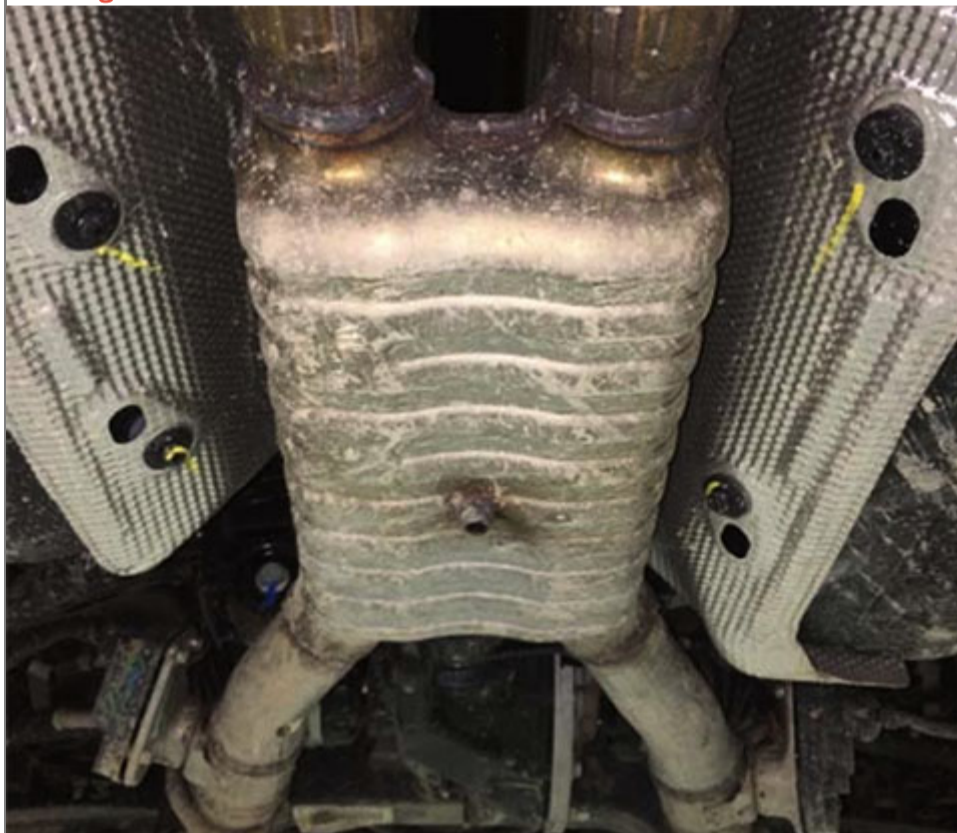
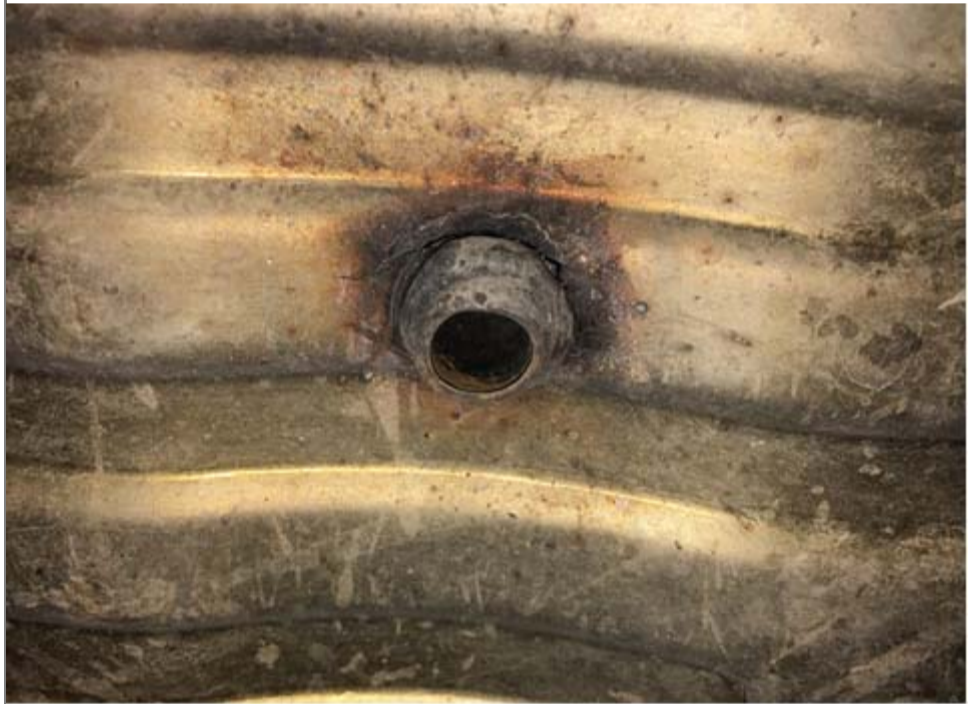
Some customers may comment about an exhaust rattle coming from the vehicle. Many technicians will automatically look at the exhaust valves for noise concerns. Before any repair is made, dealership technicians should also look at the resonator for the source of this concern. There is a tube that is located in the center of the resonator that can be seen in the first photo below. This is NOT a drain tube for condensation inside the exhaust system. This pipe is actually a structural component of the resonator that stiffens the upper and lower halves of the assembly. The welds holding this tube in place may crack, resulting in a rattle noise that can be heard by the owner of the vehicle. This will be most noticeable when starting the engine / applying the throttle.

Note: Corrosion alone will not cause this concern. The quality of the actual welds is the issue. Dealership technicians are to inspect both the lower weld on the bottom of the resonator, as well as the upper weld on top of the resonator for signs of cracking.

If the concern listed above has been found, dealership technicians are to replace the rear portion of the exhaust system.
