SERVICE BULLETIN

Classification: BT17-003a	Reference: NTB17-023a	Date: July 11, 2018
------------------------------	--------------------------	------------------------

2017-2018 ARMADA; OUTSIDE MIRROR(S) LOOSE AT BASE

APPLIED VEHICLES: 2017-2018 Armada (Y62)

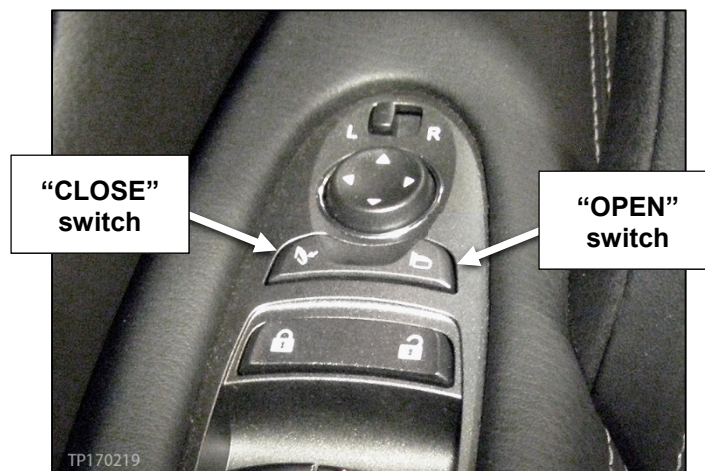
Figure 1

If the power foldable outside mirrors are manually folded/unfolded or bumped, the mirror body can become loose at the pivot point.

If this occurs, the mirrors should be adjusted again electrically before driving.

To readjust the mirrors, press the “CLOSE” switch (see Figure 1) until the mirrors are fully folded in, and then press the “OPEN” switch until the mirrors are fully open.
