## Volvo Models

**Title** Volvo Chassis - Seat Belt Alarm Stays On After The Seat Belt Is Fastened - **Model Year 2008 And Newer**

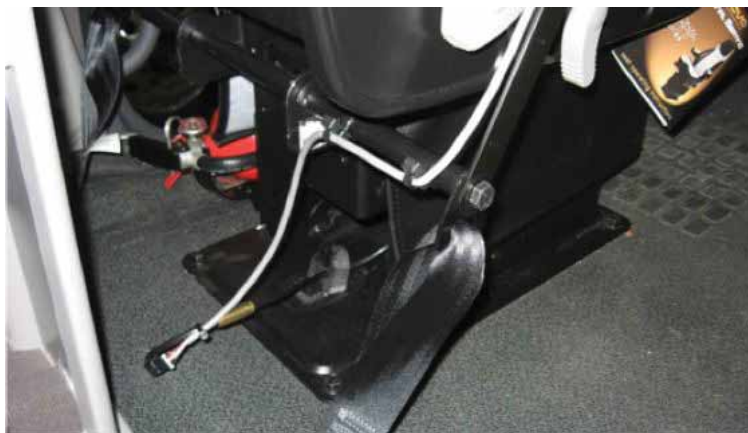
**B. Check that the connector is positioned correctly and is not corroded (Section A checks confirm poor or open connection in the harness, connector, or buckle)**

- The connector needs to be tied to the seat airline and remain above the floormat as shown above.

- Positioning the connector below the floormat can lead to corrosion.

- Check that the wiring is clipped properly to the seatbelt bracket and is not pinched.

- Double-headed cable ties should be used to prevent pinching and chafing against the bracket.
