## SERVICE BULLETIN

**APPLICABILITY:** 2017-2018MY Impreza  
 2017-2018MY Crosstrek

**NUMBER:** 02-175-18

**SUBJECT:** PCV Valve- Design and Material Change

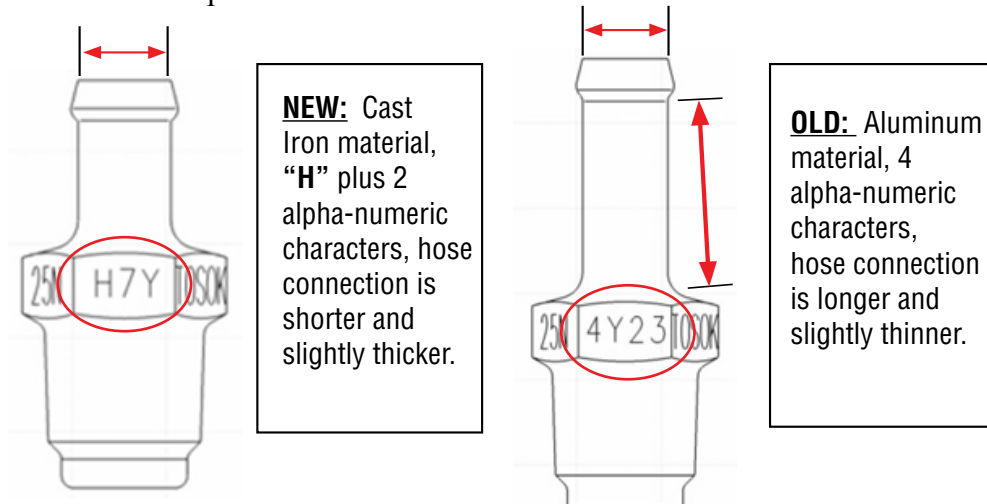
The part number for new PCV valve is: **11810AA190**. The new valve is made from cast iron instead of aluminum. In addition, the length of the hose connection portion is now shorter and slightly thicker as shown in the comparison illustrations below.

**VERY IMPORTANT:** Whenever installing this new-type PCV valve, the PCV valve hose, p. n. **99081AA450** **must** also be replaced with it (as a set) due to the thicker connection portion and to eliminate the chance of leaking crankcase vapors.
