Front Suspension Height Low Due to Air Strut Leak

Service Category Suspension

Section Front Suspension

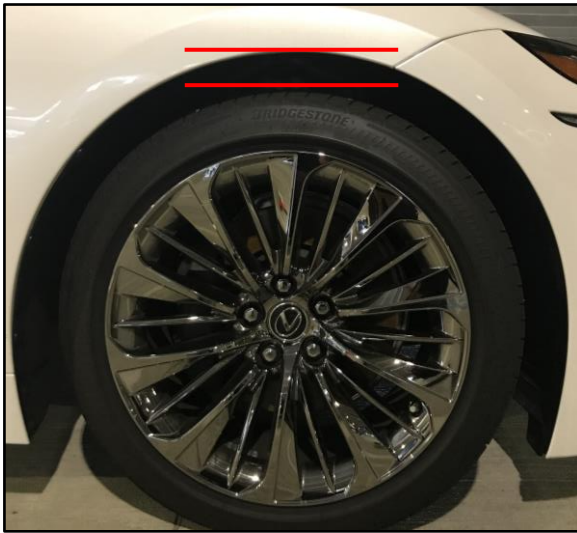
Figure 1. Good Condition

1. Does the vehicle exhibit low suspension height in the front or rear when compared to the front or rear with normal height appearance?
 - **YES** — Continue to step 2.
 - **NO** — This bulletin does NOT apply. Continue diagnosis using the applicable Repair Manual.

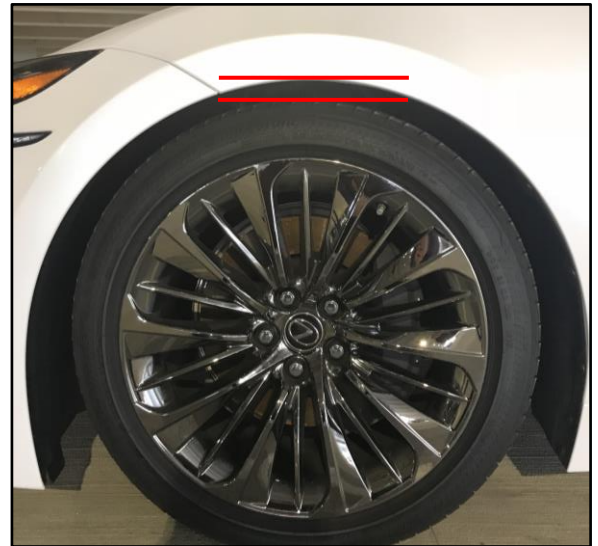
Figure 2. Bad Condition

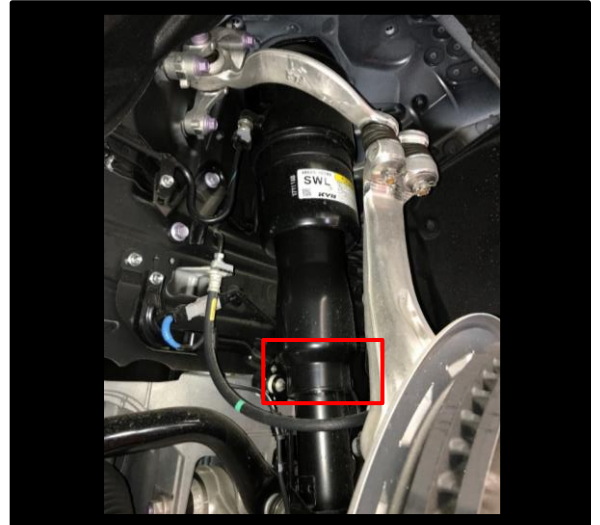
Figure 3.

6. Check the front struts for air leaks by spraying them with soapy water.
 - A. Spray soapy water on the area shown (360° around the pressed-on ring) and check for bubbles.

7. Replace the strut.

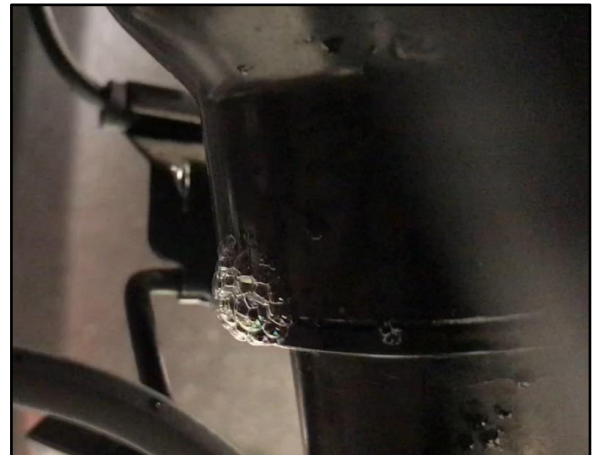
Figure 4. Example of Results if Leak is Present
