Technical Service Bulletin

Subject: FRONT BRAKE SQUEAK DURING LIGHT BRAKING	Bulletin No.: 04-006/18
	Last Issued: 07/30/2018

2016-2018 CX-9 vehicles with VINs lower than JM3TC*****231530 (produced before Apr. 27, 2018)

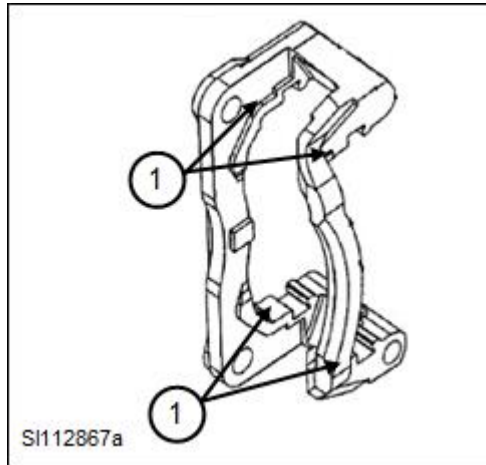
3. Clean the mounting support areas (1) with brake cleaner.

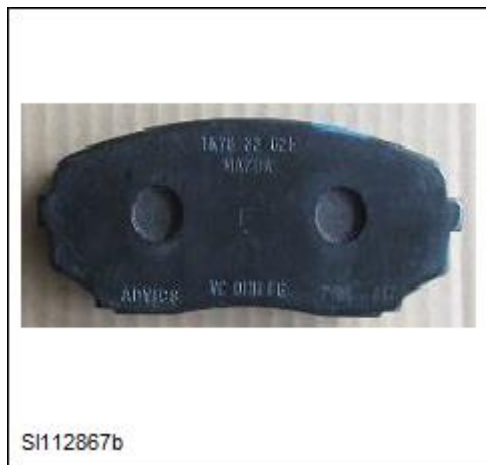
6. Evenly apply the white grease between the pad and shim (as shown below).

- Use a half packet of white grease for the pad and shim (one (1) packet for one (1) side of the vehicle).
- Do not apply the white grease to the pad surface or disc plate.
- Wipe off any excess grease coming out of the applicable areas.
- Do not mix white grease with black grease.

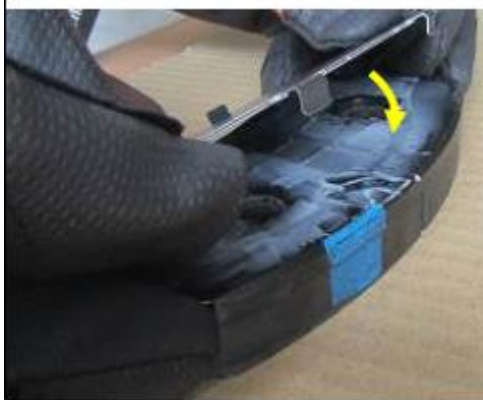
SI112867e

7. Attach the shim as shown.

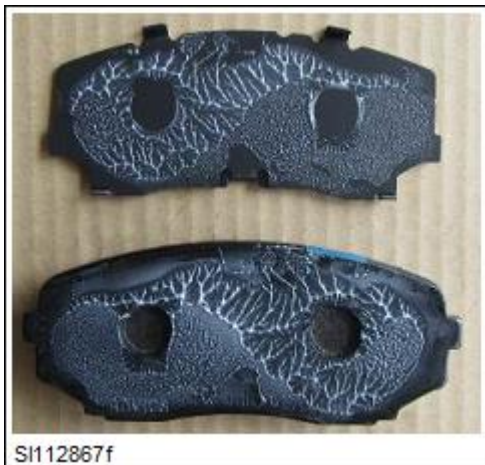
8. Remove the shim and confirm the grease has been applied evenly (as shown below).

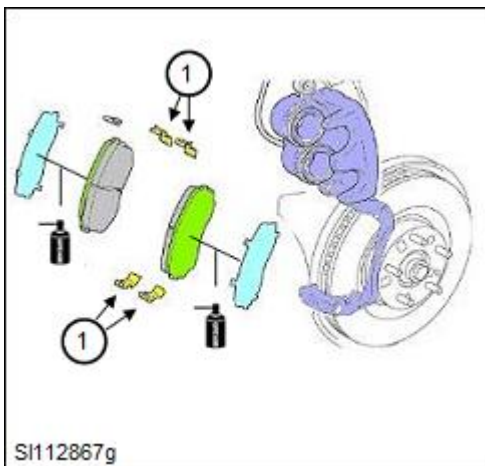
NOTE: Replace the guide plates (1) with the new ones included in the shim set.
