Driver's Side Rear Door Molding End Is Loose?

Year	Model	Trim
2019	RDX	ALL

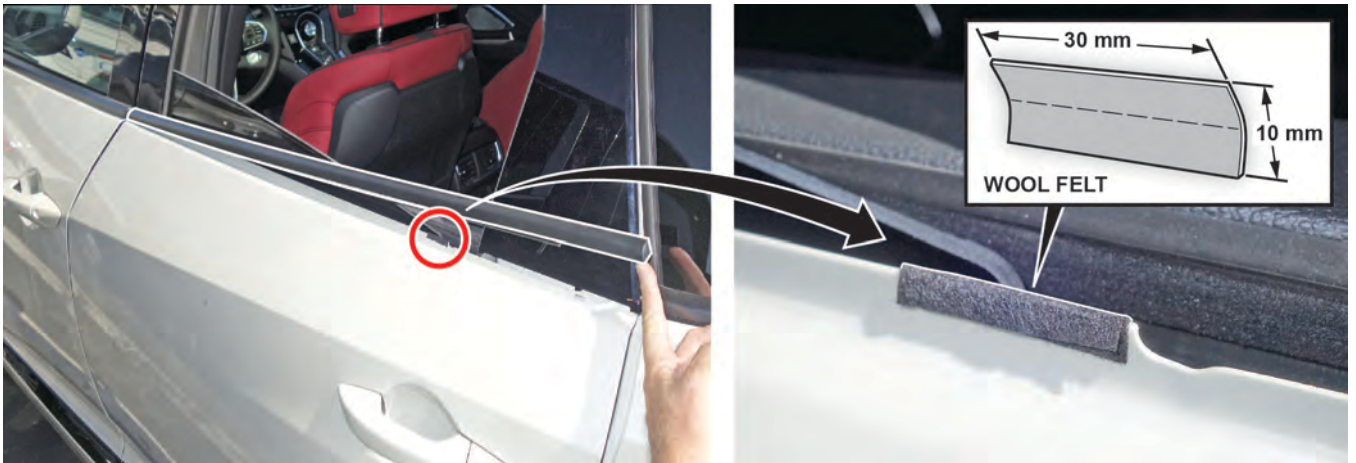
1. Remove the rear door molding.
2. Cut a 10 mm x 30 mm piece of wool felt (must be 0.5 mm thick), and wrap it around the door edge as shown. Make sure 5 mm is hanging down evenly on both sides.

We're getting reports that the door molding on the driver side rear door starts to come loose at the back end. From our investigation, this issue may result from the molding clip coming loose due to a curvature in the molding.

If you get a vehicle in with this issue, here's how you can fix it for now.

3. Reinstall the molding.
