Vehicle does not start

Topic number	LI54.00-P-067822
Version	1
Function group	54.00 General
Date	03-07-2018
Validity	smart electric drive
Reason for change	
Reason for block

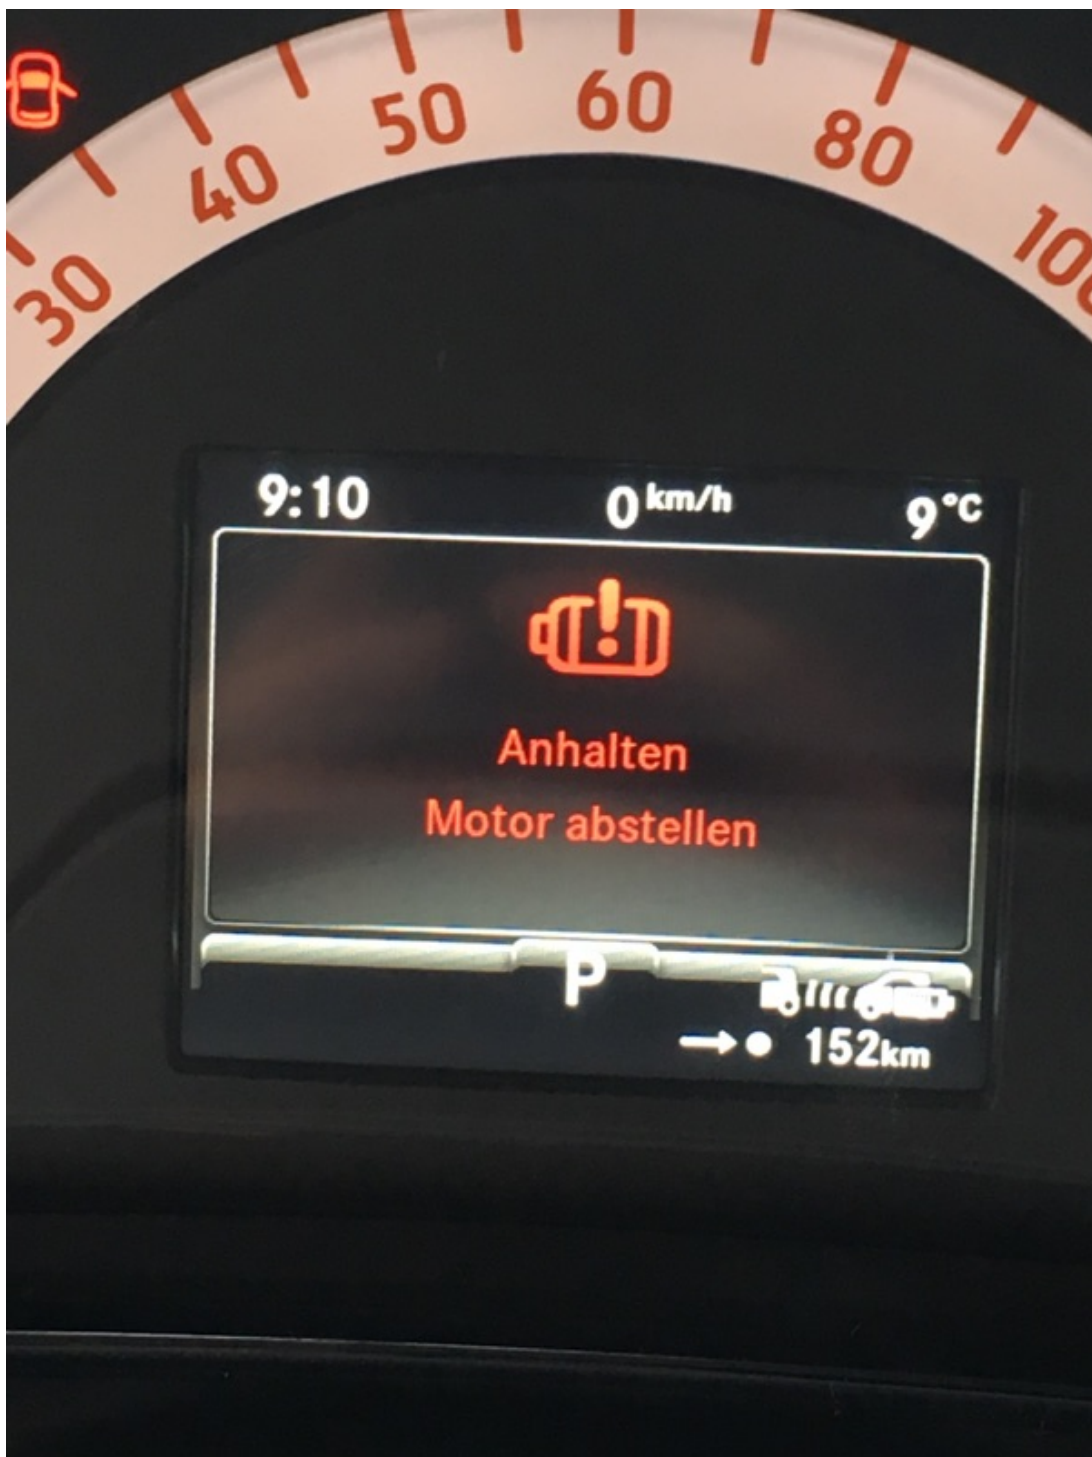
Bild vom Ki e smart.jpg:

HV fault message (see attachment) in instrument cluster.

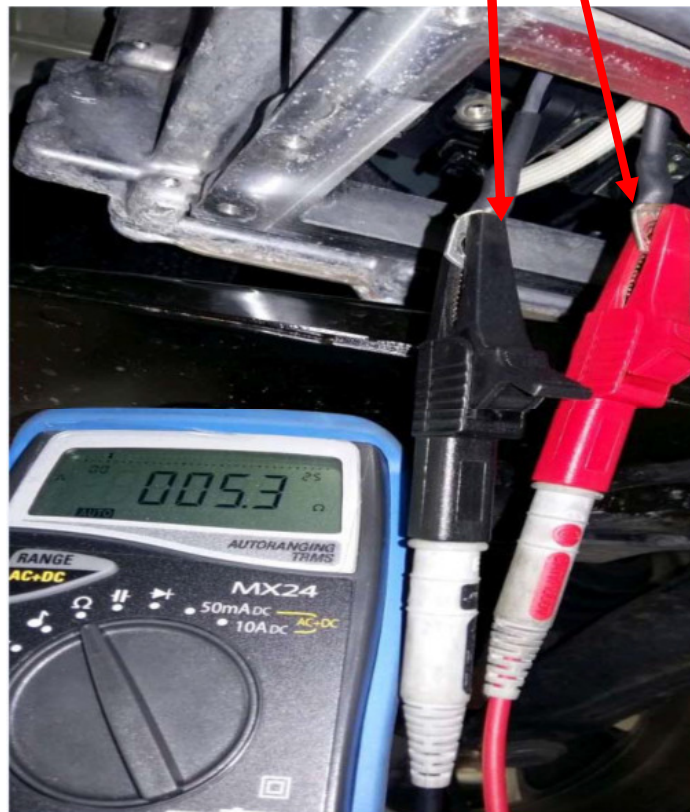
Measurement location of the excitation circuit

**Excitation Circuit Resistance should be approx.
(4.5 Ohms (left / Black Clip, E-) / 25 ohms (right / Red Clip, E+))**

Follow the XENTRY instructions for the fault code (perform resistance measurement on excitation winding/ insulation test).

- 1) If the measured resistance is outside the specified range, replace the electric motor.
- 2) If the measured resistance is within the specified range, visually inspect the threaded connection (picture in attachment).
- 3) If no faults are found, erase the fault memory, do not replace any parts, and release the vehicle to the customer.

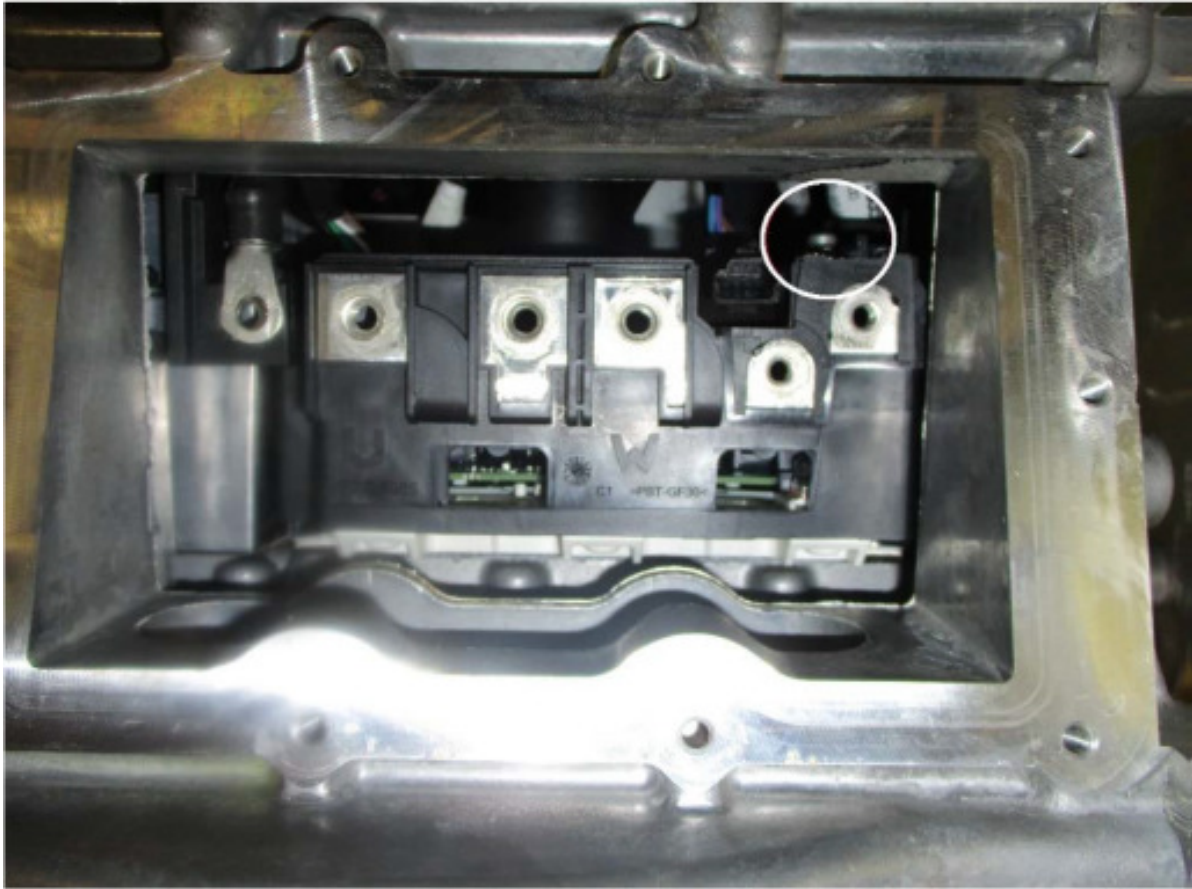
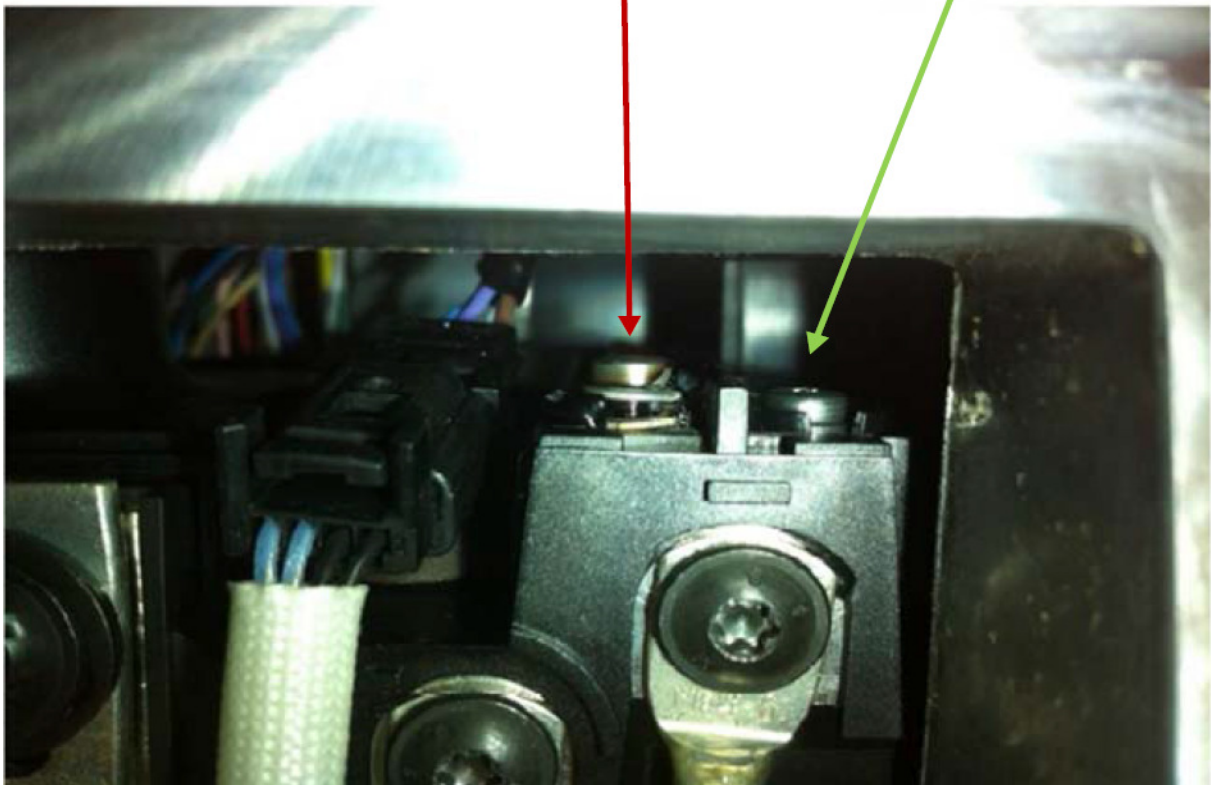
Visual verification of the clamping of the 2 excitation terminals on the PEC internal inverter module
