## Creaking noise on front seat when cornering

| Topic number | LI91.10-P-067955 |
| Validity | BR213 |

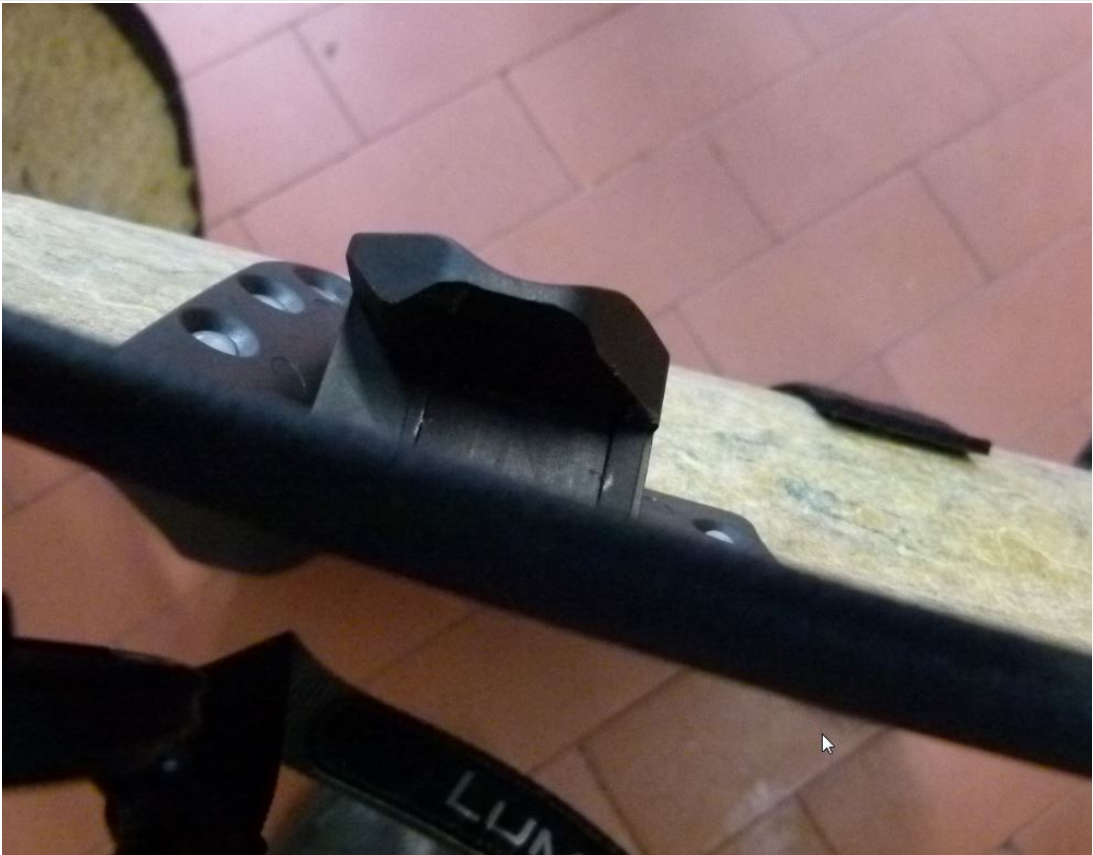
Pic1.JPG:

The fastening hooks (Pic 1) on the seat-back lining rubs up against the functional carrier hooks (Pic 3) and cause a noise

| Attachments | |
|---|---|
| Pic1.JPG | Fastening hooks on seat-back lining without felt |

1. Disassemble seat-back lining on front seat AR91.10-p-1910lw

2. Perform test drive without backrest seat-back lining.

3. Cut felt (A000 983 71 10) to size and attach as in Pic 2 to the two fastening hooks on the seat-back lining.

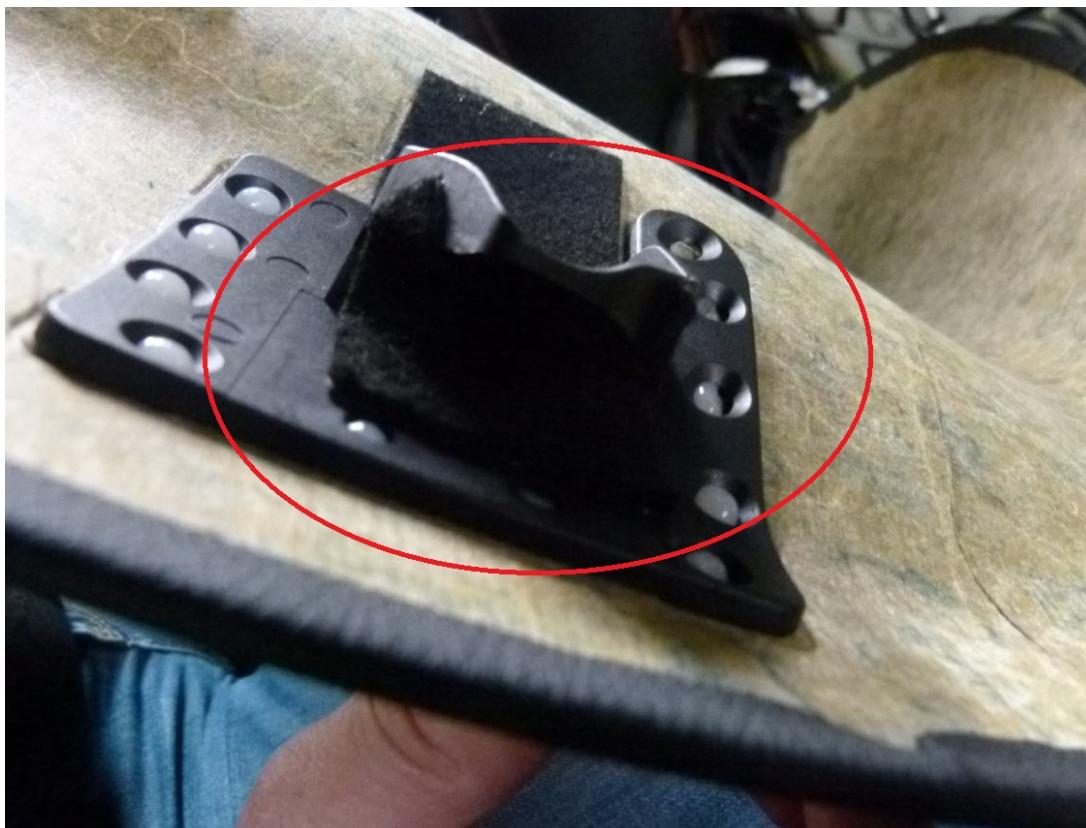
Pic2.JPG:

| Attachments | |
|---|---|
| Pic2.JPG | Fastening hooks on seat-back lining with felt |

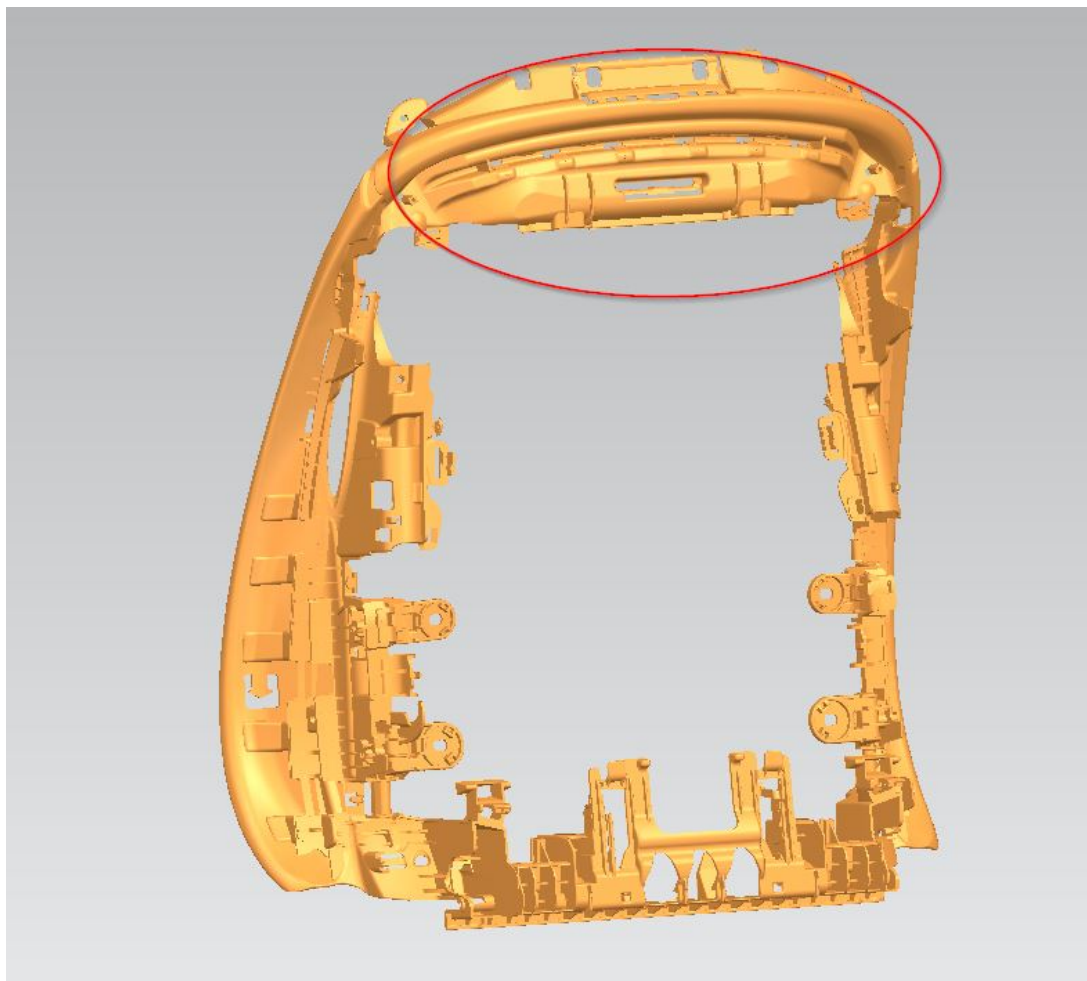
Pic3.jpg:

| Attachments | |
|---|---|
| Pic3.jpg | Functional carrier |
