MODEL
2017-2019MY
Sportage (QL)
2015-2018MY
K900 (KH)

NUMBER
PS578

SUBJECT: IDENTIFYING A SEIZED COMPRESSOR

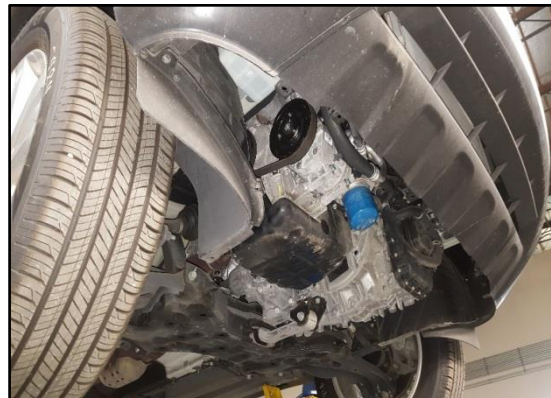
This Pitstop provides information regarding the diagnosis of an A/C related concern on 2017-2019MY Sportage (QL) and 2015-2018MY K900 (KH) vehicles that may have a seized compressor. To confirm the diagnosis of a seized A/C compressor, visually inspect for a paint mark (A) against the limiter in the center of the compressor. If the mark is no longer aligned (B), an internal disconnection of the limiter has occurred and the compressor assembly needs to be replaced.

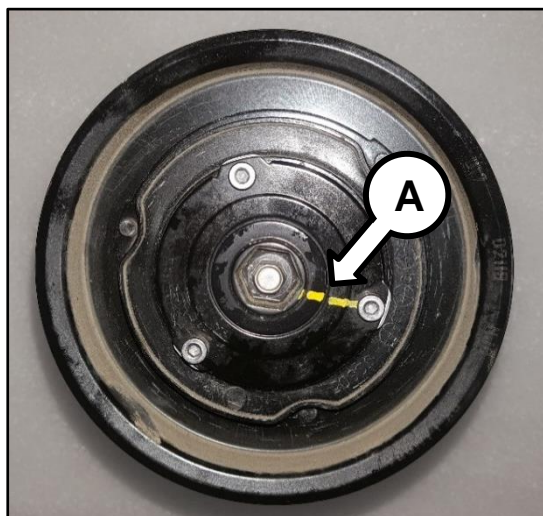
Marks **Aligned** (Not Seized)

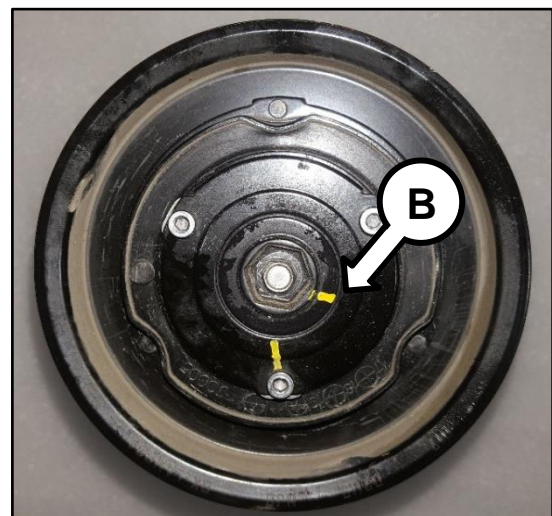
Marks **Not Aligned** (Seized)
