## Electrical fault in coolant pump

| Topic number | LI54.18-P-068180 |
| Validity | Model 205, 213, 253 with engine M274<br>except 180 kW variant |

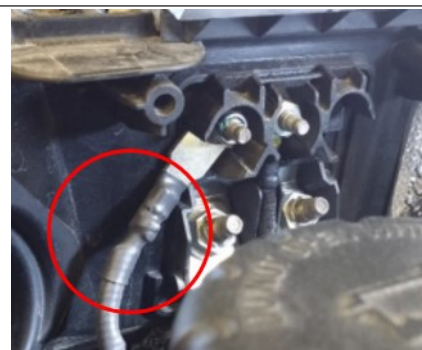
| Attachments | |
|---|---|
| Mögliche Bruchstelle.jpg | Picture 1 |

The wiring harness of the electric coolant pump (M75/11) could break at the cable lug of the connecting point (X244/16), see picture 1.

- Check line at connecting point X244/16.
- Check ground point (W46/1) of electric coolant pump.

If damage is found on the line to connecting point X244/1 just before the cable lug (picture 1), install the repair wiring harness (see "Parts") according to the specifications, see attachment.
