Model series 177: Dashes in total distance display in instrument cluster

Topic number	LI54.30-P-068183
Version	1
Function group	54.30 Instrument cluster, display instruments, hazard warning device
Date	06-01-2018
Validity	Model series 177
Reason for change	
Reason for block

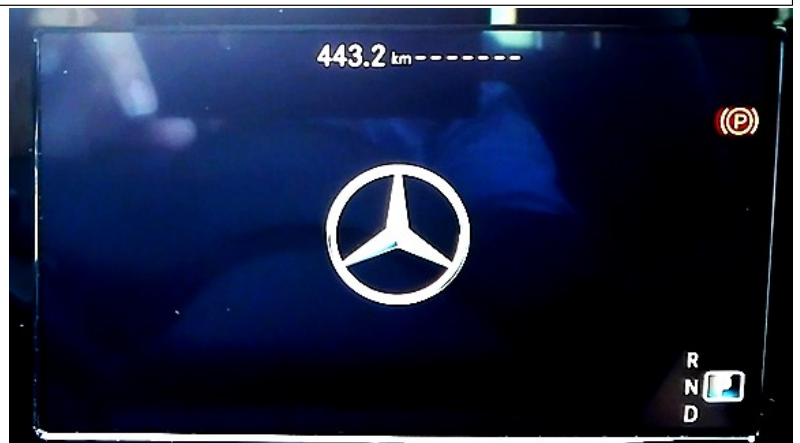
A.jpg:

Dashes are displayed in the instrument cluster in the total distance display (see attachment A).

The complaint occurs after six consecutive trips, each of 38 miles or more, without an ignition cycle. The dashes are seen at the next ignition cycle.

Communication error due to software release of electronic ignition lock N73.

The complaint can be rectified by switching off the ignition and then switching it back on after more than 30 seconds. The dashes disappear by themselves after approx. 90 seconds.

The final software remedy for the electronic ignition lock N73 is currently under development.

Note: Travel distances are not lost.
