TECHNICAL SERVICE BULLETIN

Technical Service Bulletin: 61-0847

Forest River is alerting you to an issue involving certain 2019 Prime Time – NAVI NVT16BH travel trailer recreational vehicles. Please see the information below which describes the issue and provides you with details on the steps you should take to have your vehicle repaired.

PRIME TIME – NAVI – T16BH WATER PUMP ACCESS REMEDY INSTRUCTIONS

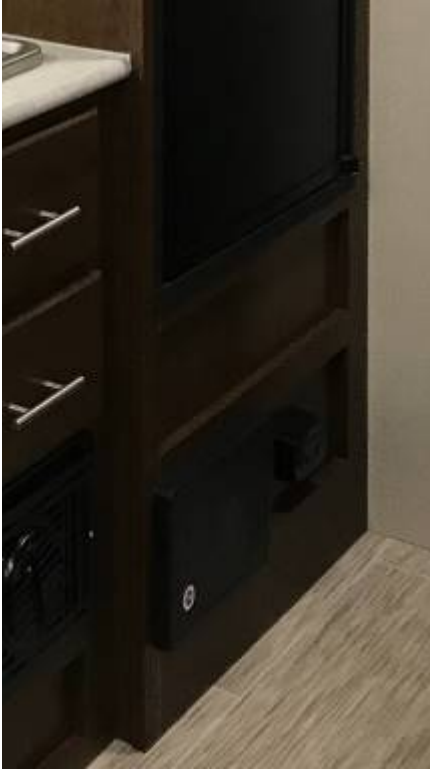
On certain NAVI T16BH, there is not an access panel for the water pump under the refrigerator.

Prior to moving CO2 detector then routing and installing access panel.

STEP 1: Move the CO2 detector to the panel below the refer

STEP 2: Route hole in the panel below to gain access to the water hose

STEP 3: Finally add an access panel over the bottom panel for easy winterization access

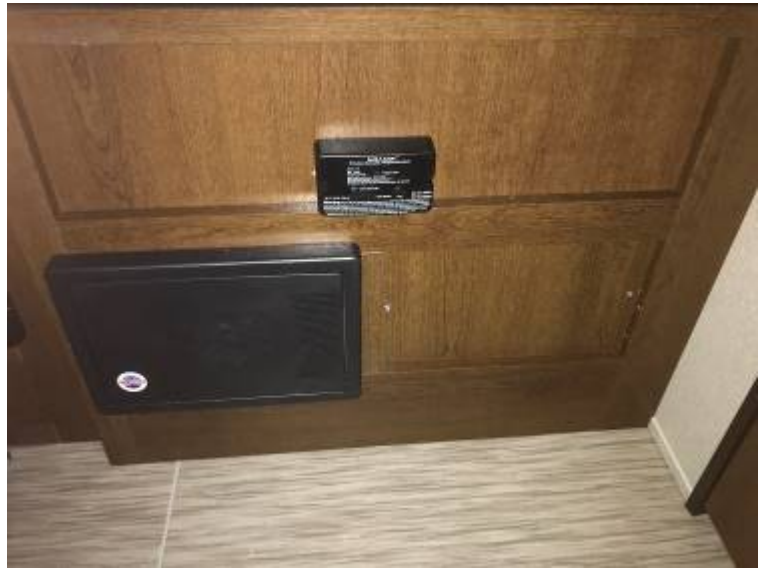
After moving the CO2 detector, routing the lower panel and installing the access panel.
