MODEL: Karma Revero**Date: August 2018****TITLE: EPB Harness Overlay Inspection and Adjustment**

PRIORITY: On complaint verify overlay install on provided list**APPLICABILITY:** MY18 Revero**MARKET REGION:** North America**PURPOSE:** Inspection of the EPB overlay harness for best installation. If the vehicle shows the DTC code (B1EEE) from EPB system, this bulletin will direct you to adjust harness install, and if needed replacement of select components on direction of TSS.

TB-18-60-01

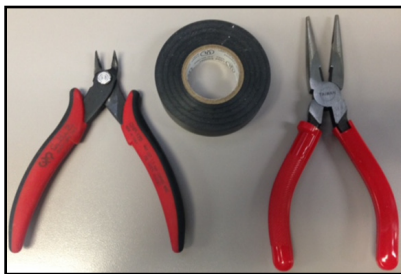
fig. 1a

- wire snips
- highest quality electrical tape (fig.1a)
- cable ties (fig.1b)

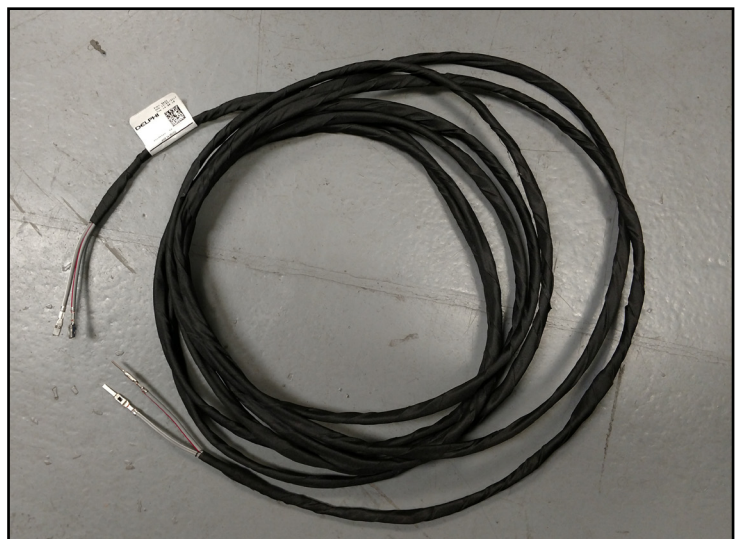
fig. 1c

The Overlay Harness Assembly (C161190100500, fig.1d) is installed on the affected vehicles. This previous repair was performed in CC-17-60-27 as a part of the BL1030 updates. order from Karma Automotive.

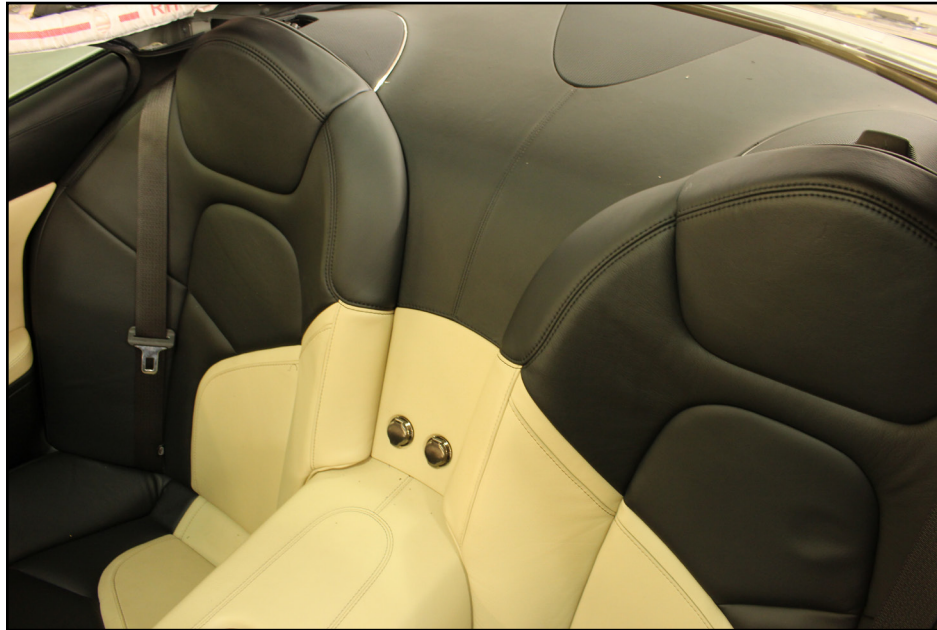
fig. 2a

2. Remove the rear seats and interior trim to access the harness overlay as installed. Reference the service manual if required (fig. 2a-2b).

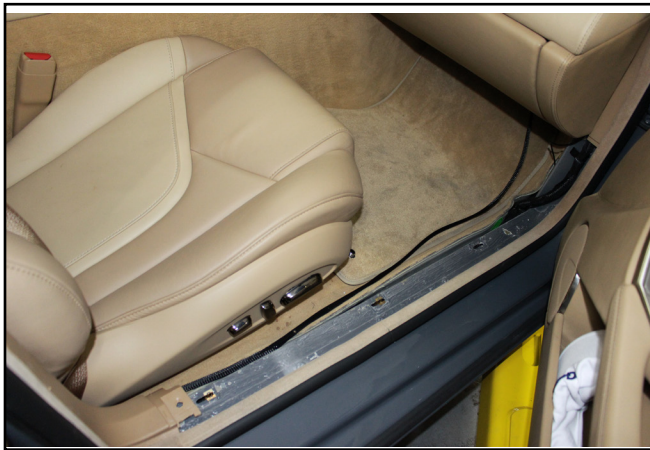
fig. 3a

3. Remove the RH sill plates and locate the overlay along the interior harness (fig 3a,3b). Remove the B-pillar trim and follow the harness to the EPB module. Remove connector D0310-1 and D0310-2.

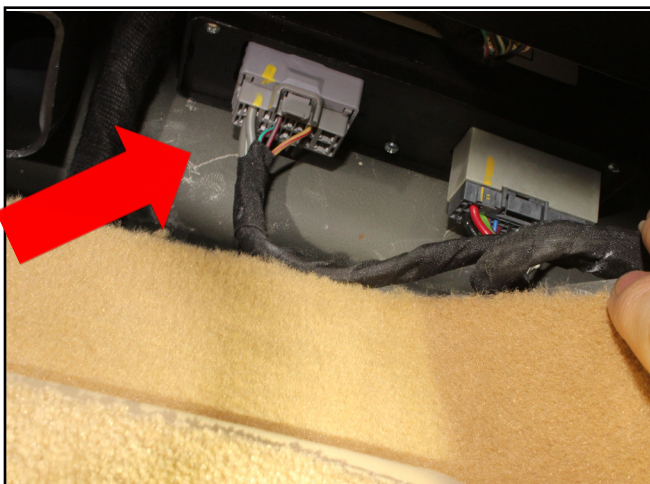
fig. 3c

4. Under the dash obtain access to the EPB module and disconnect the two connectors (fig 3c,3d) This will help in realigning the harness for the best install.

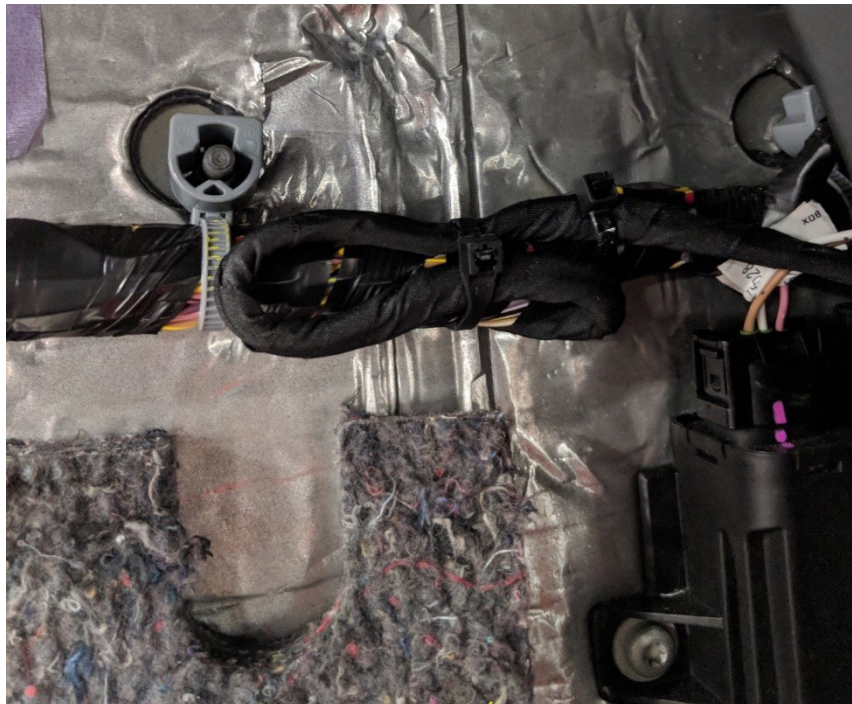
fig. 7a

9. The overlay harness will run as shown, and zip-tie along the existing interior harness (fig.7a) and route along the the trunk harness (fig.7a) every 12-inches is recommended.

Note how Overlay is bundled and secured with zip tie.
Any excess wire is bundled and “zip-tied” in this location
