## Airstream Service Bulletin 177 – AEU Models - Fresh Water Tank Drain Down connection

This service bulletin relates to European specification Airstream trailers, initially units built between June 2017 to present date.

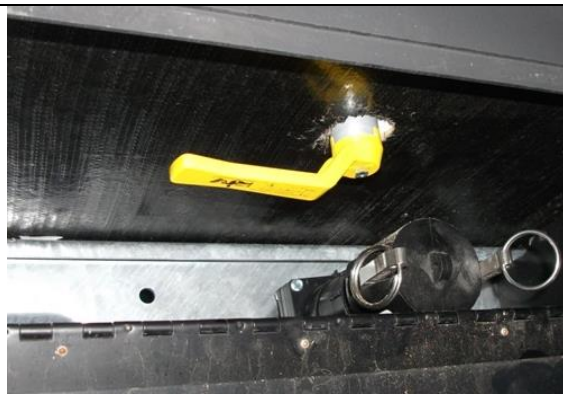
^ 684 model. Remove bolt from head of lever below floor, so handle and spindle extension can be removed.

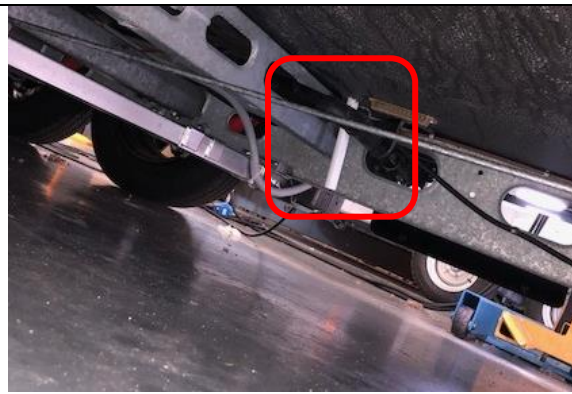
^ 684 model. Pull out bottom galley drawer to access fresh tank drain down piping.

Remove last 90 elbow and white section of pipe passing vertically down through floor (photo above).

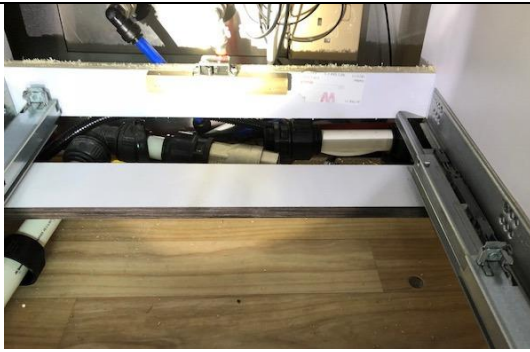
^ 684 model. When you have play in the 1" drain down piping assembly, undo the thread connection between the drain down valve and the white pipe nearest the water tank.

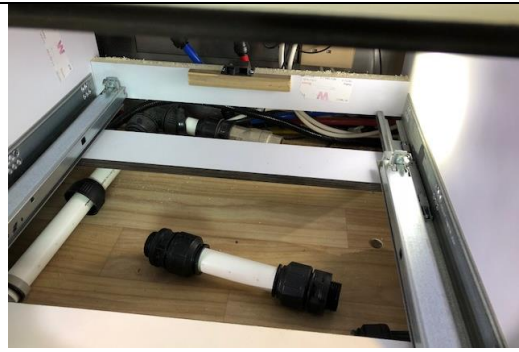
Unscrew the 1" female adaptor from the fresh water tank and remove this short assembly (photo above).

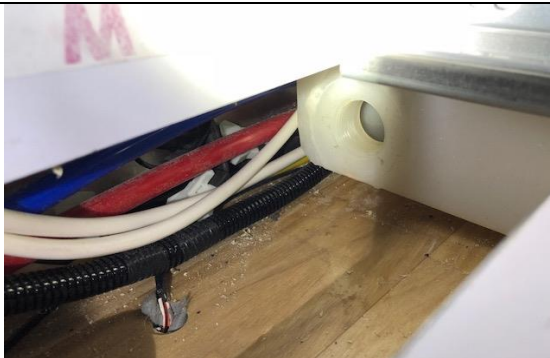
This allows inspection of the spun in 1" fitting to the tank.

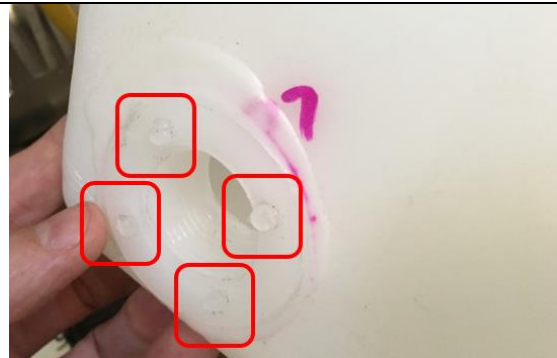
The photos below detail the requested work, to remove and refit the 1" drain down connection to the above floor fresh water tank. Nipples of plastic have been found on the spun in fitting on some tanks, preventing the 1" John Guest adapter fitting screwing in fully to engage the O ring seal against the tank side, resulting in a risk of leakage.

Inspect the spun in fitting closely for any projecting nipples of plastic, if there are any shave them off with a sharp knife/ chisel so the face of the tank is flat.

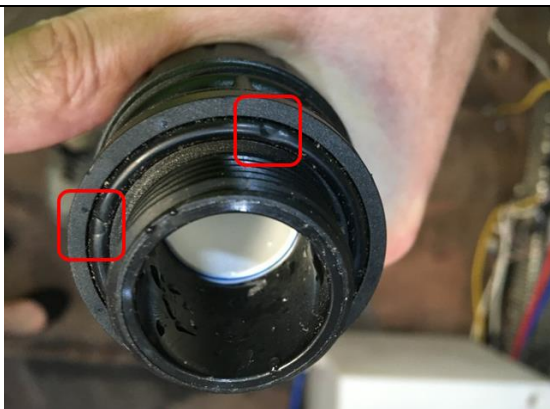
Check the O ring thread is present to the 1" John Guest fitting. This may have small indentations where it was in contact with the nipples of plastic.

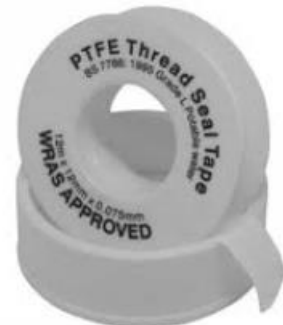
Apply PTFE tape (WRAS approved for potable water) around the male thread of the John Guest 1" adapter, then screw the adaptor back into the tank. Reassemble the drain down pipe fully.

> **On completion**, lay some paper towel under the connection off the fresh water tank, then fill the drain water tank fully and monitor for at last 1 hour, to verify the connection to the tank and valve are watertight.
