## Millimeter Wave Radar Won't Align; DTC P2583-76 Won't Clear

### AFFECTED VEHICLES

Year	Model	Trim	VIN Range
2017-18	CR-V	EX, EX-L, Touring	ALL
2018	Accord	ALL	ALL
2018	Accord Hybrid	ALL	ALL
2019	Insight	ALL	ALL
2017-18	Civic	With Honda Sensing	ALL

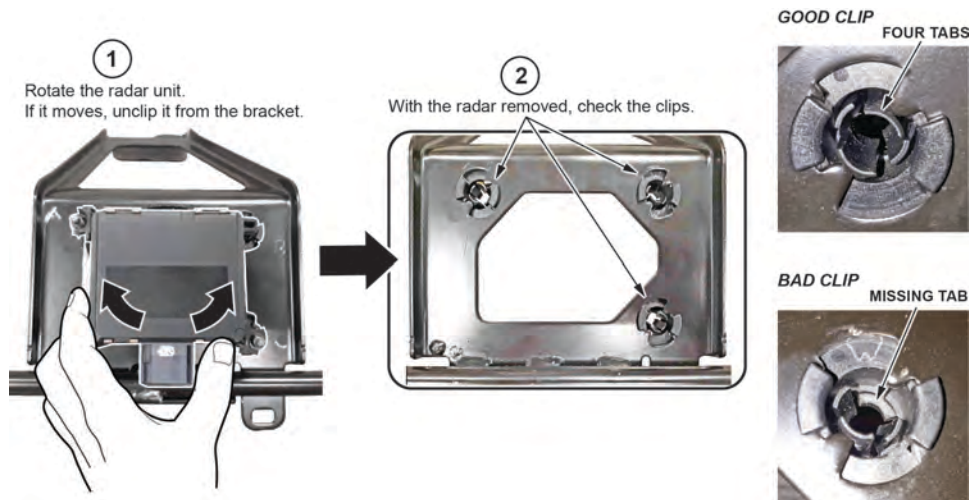
If you're having trouble aligning the front millimeter wave radar, or if DTC P2583-76 is present and does not clear after re-aiming, inspect the radar mounting clips and bracket.

Check that the mounting bracket is not bent or out of shape. Check if the radar unit for play by trying to twist it. If there is play, remove the radar unit and check each mounting clip for damage. Replace all clips that have damage or missing tabs.

These items should be checked first before replacement of the radar unit. If you are still having issues after following this, then replace the radar unit.
