# Warranty Field Campaign

| <b>Campaign Number:</b><br>c2046 | <b>Revision:</b> | <b>Released Date:</b> 14-Aug-2018 |
| <b>X15 CM2350 X114B/X116B Turbo Actuator Water Intrusion Correction Campaign</b> | | <b>Expiration Date (U.S. and Canada):</b> 01-Aug-2020 |

### **Campaign Service Step By Step Repair Process**

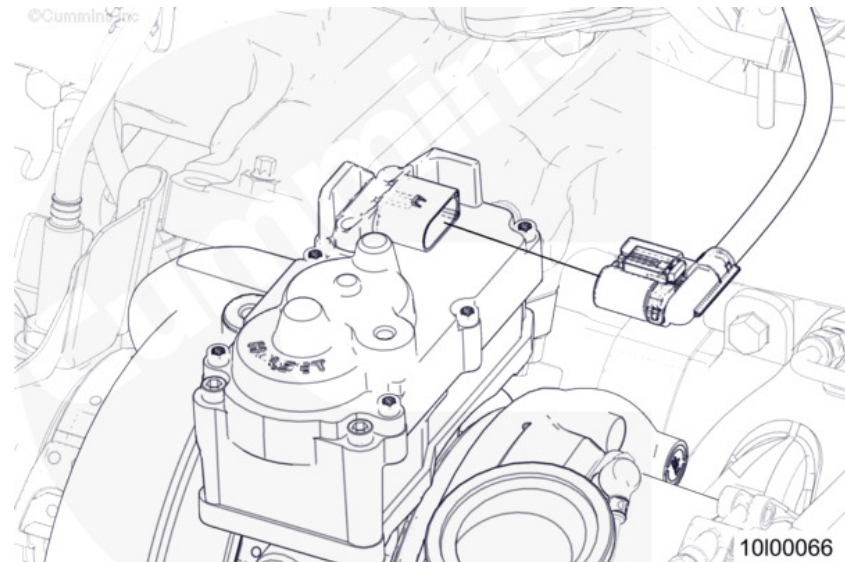
- Review Quickserve document 204-006 General Safety Instructions
  - <https://quickserve.cummins.com/qs3/portal/service/manual/en/5411186/>
- Turn key switch OFF. Disconnect the VGT actuator from the engine harness.

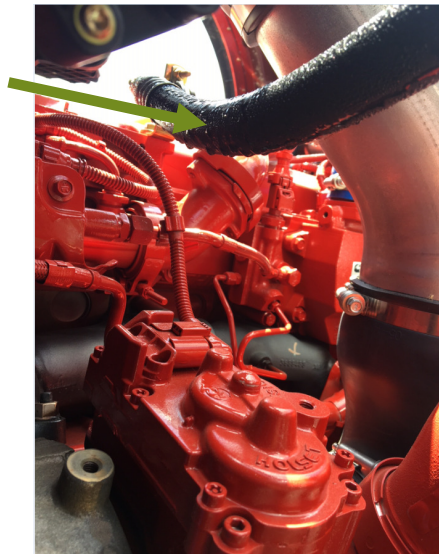
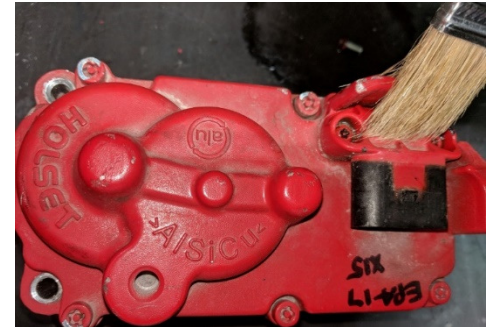
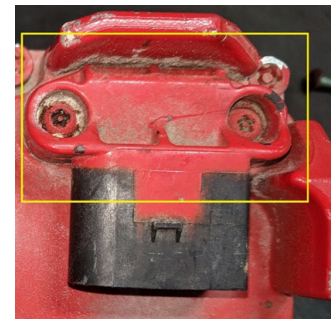
- Wipe the AC line to remove moisture on it
  - Ensure water does not drop on the actuator while cleaning
  - Remove loose dirt and debris from around the VGT Actuator with a brush as shown
  - Use shop air to remove any loose debris
  - Apply QD Contact Cleaner (Cummins PN 3824510) and use a brush around the connector removing as much oil and dirt as possible.
- 
- **DO NOT SPRAY THE QD CONTACT CLEANER ON THE TURBINE HOUSING WHEN IT'S HOT!!**

Area of connector requiring a detailed cleaning

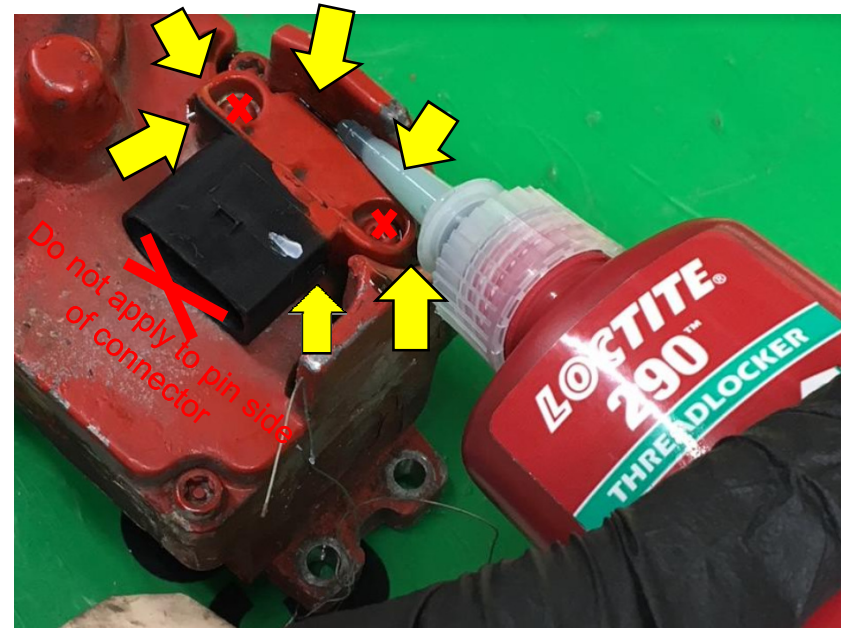
1. Apply a liberal amount of Loctite 290 around the entire black plastic connector body where it meets the aluminum actuator cover.
- DO NOT APPLY TO THE PIN AREA OF THE CONNECTOR.
  - TRY TO AVOID LOCTITE ON THE CAPSCREWS OF THE CONNECTOR.
  - There is time to clean up any excess.
  - The Loctite 290 will wick under the plastic cover and fill any gaps that may lead to a leak path.

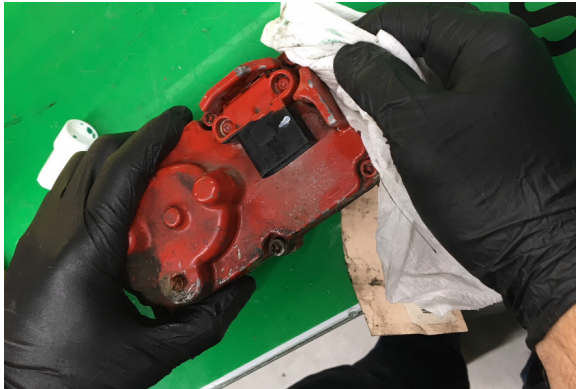
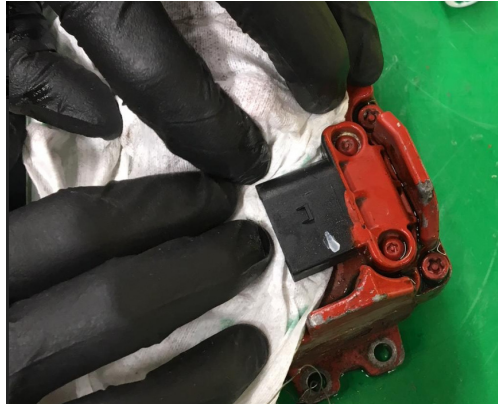
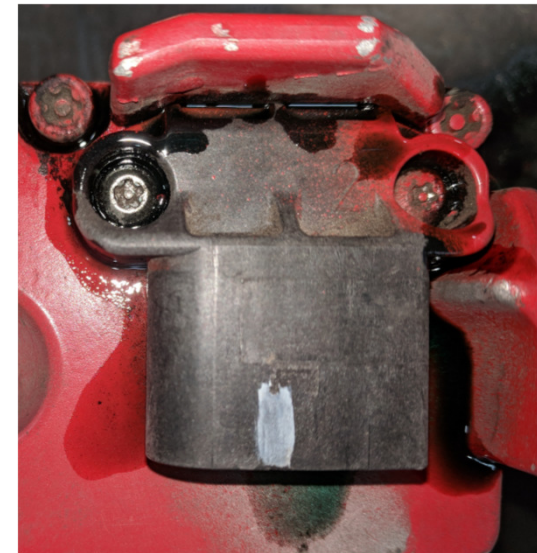
1. Check for Loctite 290 around the entire plastic connector body
2. Wait for 5 minutes to allow Loctite 290 to wick into the hidden crevices
3. Wipe away excess Loctite 290 from the connector and actuator with a lint free cloth.

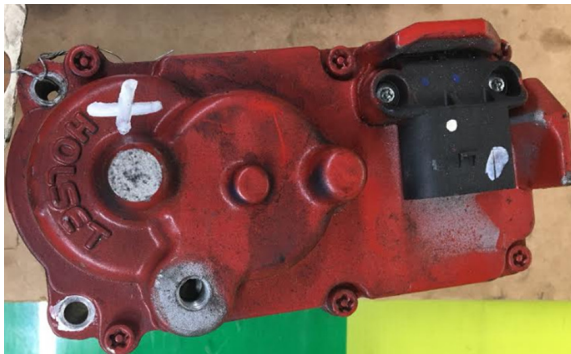
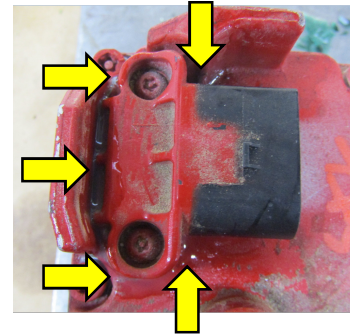
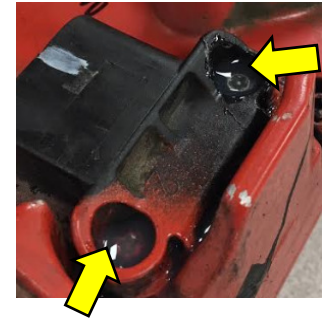
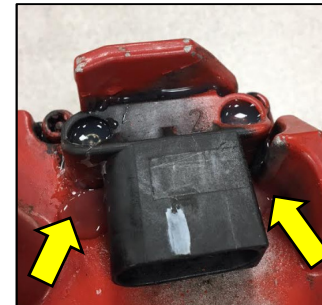
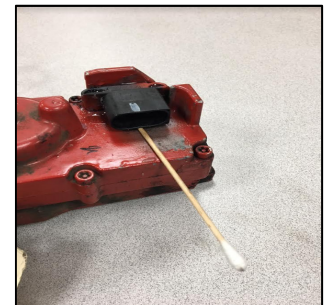
- Apply Permatex silicone around the plastic connector body as shown by arrows
- Apply on the top of the connector mounting screws
- Apply silicone on the edges shown as shown and using a swab stick to smear the silicone underneath the connector to make a thin layer at the VGT actuator connector interface
- Using a white paint marker, apply a witness mark “X” as shown in the picture
- Witness mark confirms the repair has been applied to this actuator

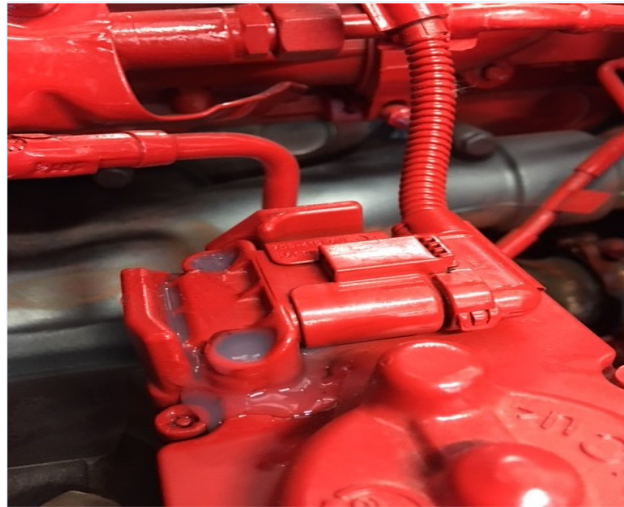
- Expect the Loctite to cure in 2 hours after the vehicle returns to service
- Expect the Permatex silicone to be tack-free in 1 hour
- Full cure of Permatex within 24 hours after application

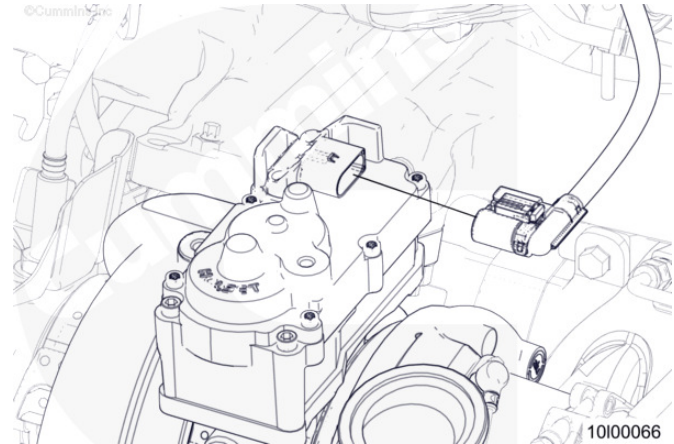
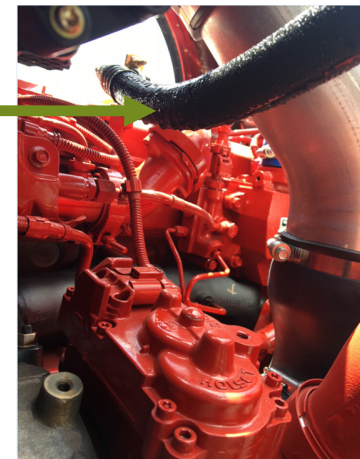
- Reinstall engine harness connector to the Variable Geometry Actuator.
- Reinstall any clips or wire ties that were disturbed.
- To enable optimum curing, we recommend you do not idle the engine with AC ON after application of Loctite/Permatex
- Wipe the AC line to make sure it doesn't have moisture on it
- **Complete the AC Line Wrap with Insulating Foam tape & Reflective tape as describe in page 13.**
- Return to service as soon as possible after Loctite and AC Line Wrap repair is completed

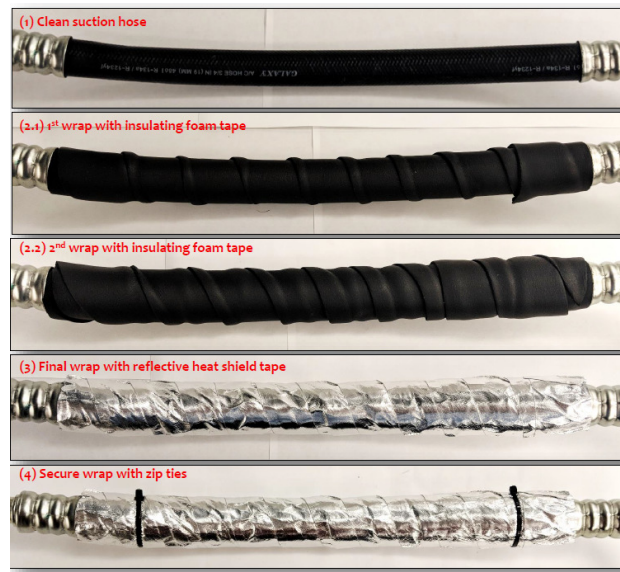
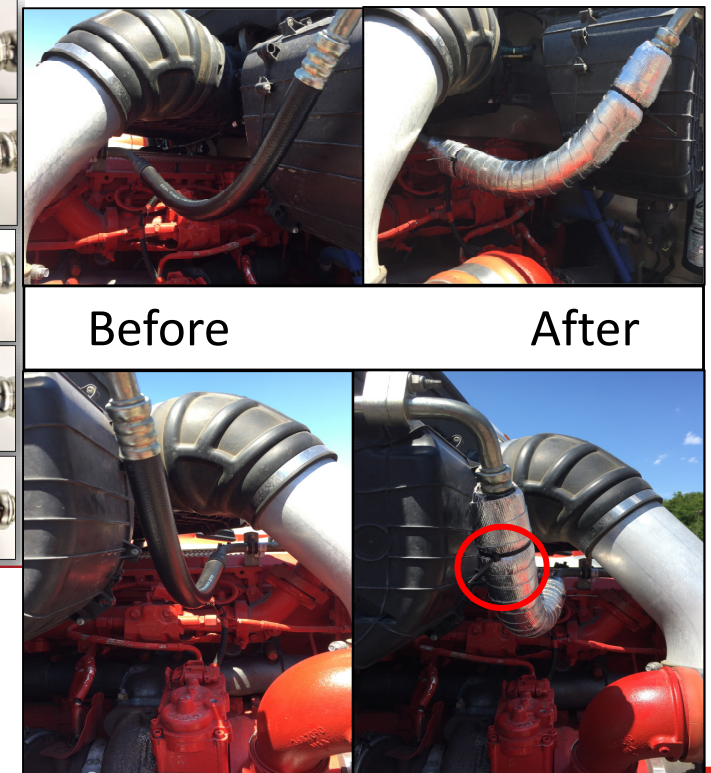
1. Clean Hose – Remove any oil/dirt
2. Wrap Suction Hose with two layers of cross-linked polyethylene insulating foam tape
  - Target 15' (2 ~7.5' sections) of Insulation tape
3. Apply Final wrap to the suction hose with a reflective heat shield tape
  - Target 10' of Thermo-Shield Wrap
4. Secure the wrap in place using two zip ties on each end of the wrap
  - Target 2' inches from the end
5. Make sure the tail of the zip tie is pointed towards the ground as pointed out
