## Subject: Checking 488 Challenge Intercooler Efficiency

# Ferrari North America

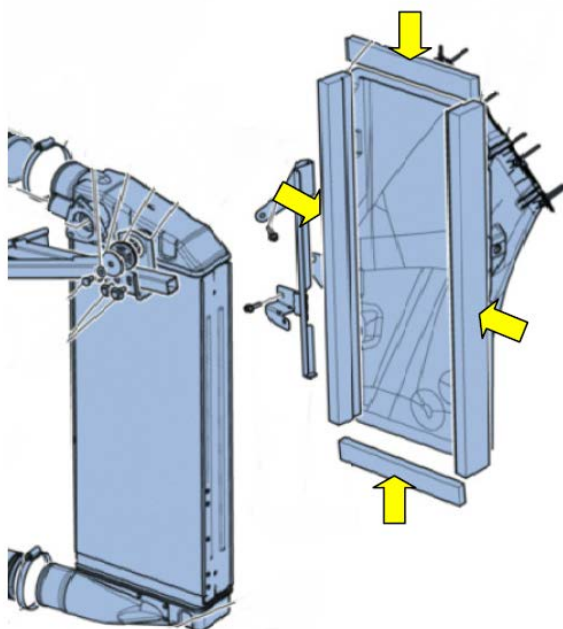
Figure 1

The sponges (See yellow arrows in figure 1) around the perimeter of the intercooler must always be correctly installed. Any gaps between the shroud (Figure 2) and the intercooler could allow air leakage and compromise the ability to reduce the charge air temperature.

We would like to remind you the importance of maintaining the sealing between the intercooler and its cooling duct.

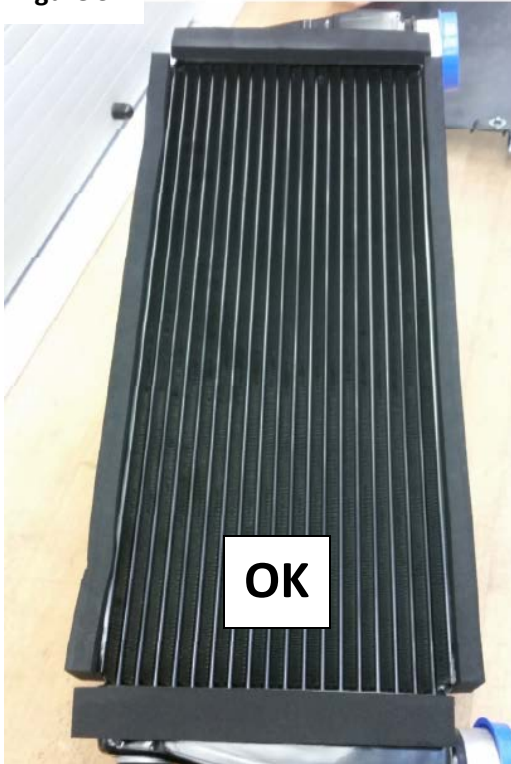
Figure 3

Furthermore, it is important that the intercooler must be in good condition without any damage to the plate fin surfaces. (See Figures 3 and 4.)

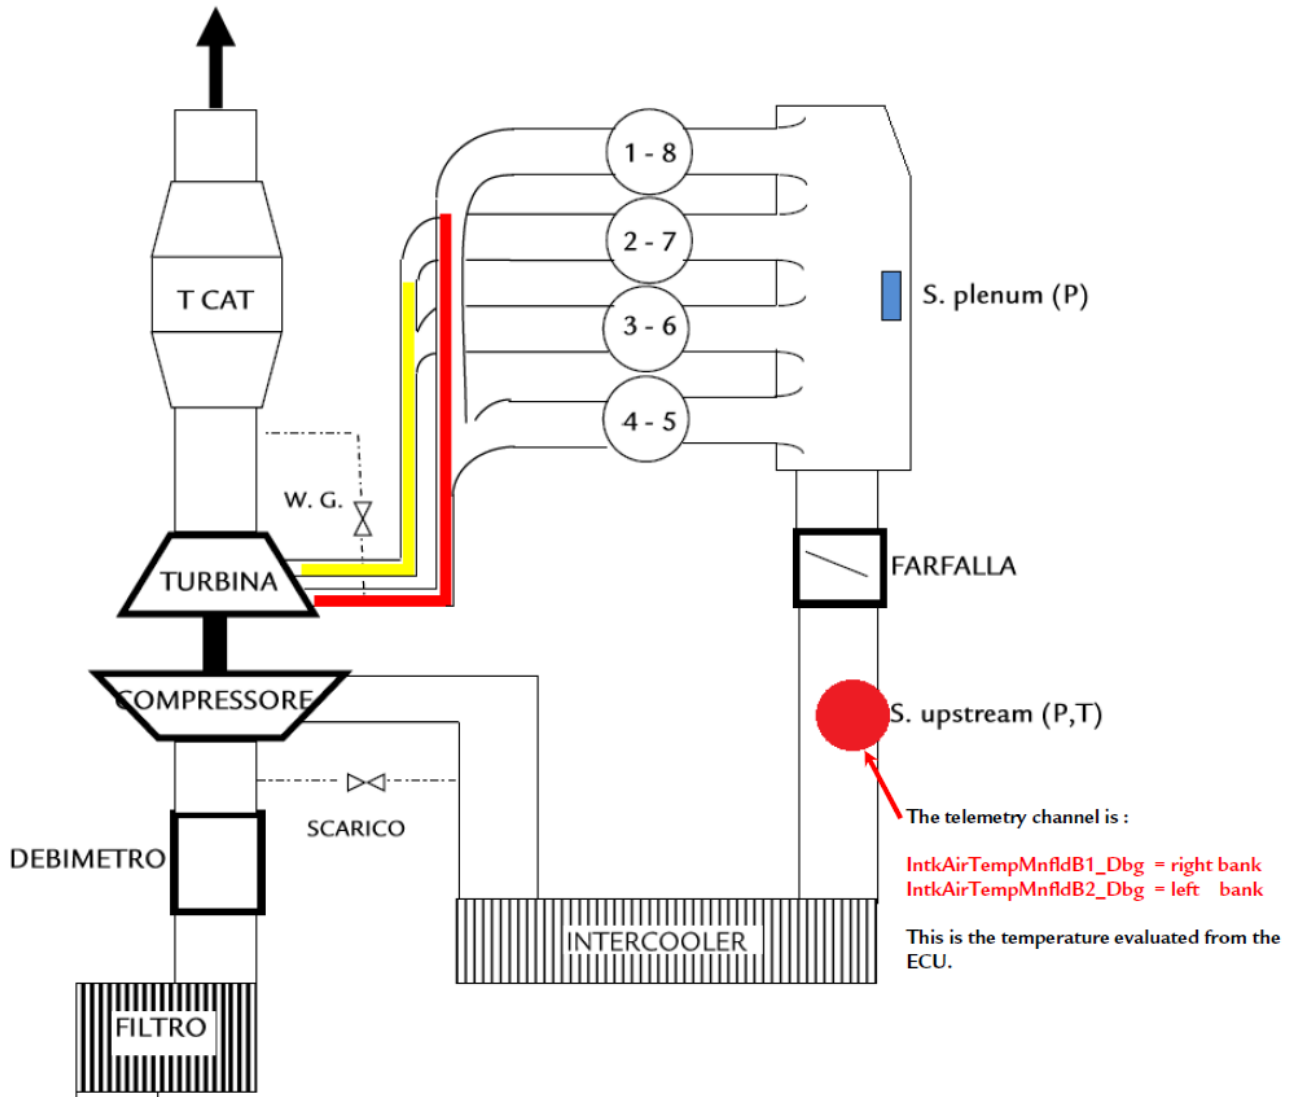
Fig. 5

These conditions must be met in order to help keep the air temperature below the threshold of triggering recovery by the engine ECU. The engine ECU will significantly reduce the boost pressure if the temperature is over the limit. (see Figure 5 for system overview)
