SERVICE BULLETIN

Classification: AT15-003f	Reference: NTB15-037f	Date: August 10, 2018
------------------------------	--------------------------	--------------------------

VERSA SEDAN, VERSA NOTE, AND SENTRA; CVT VALVE BODY REPLACEMENT WITH CONFIRMED DTC

APPLIED TRANSMISSION: CVT (RE0F11A)

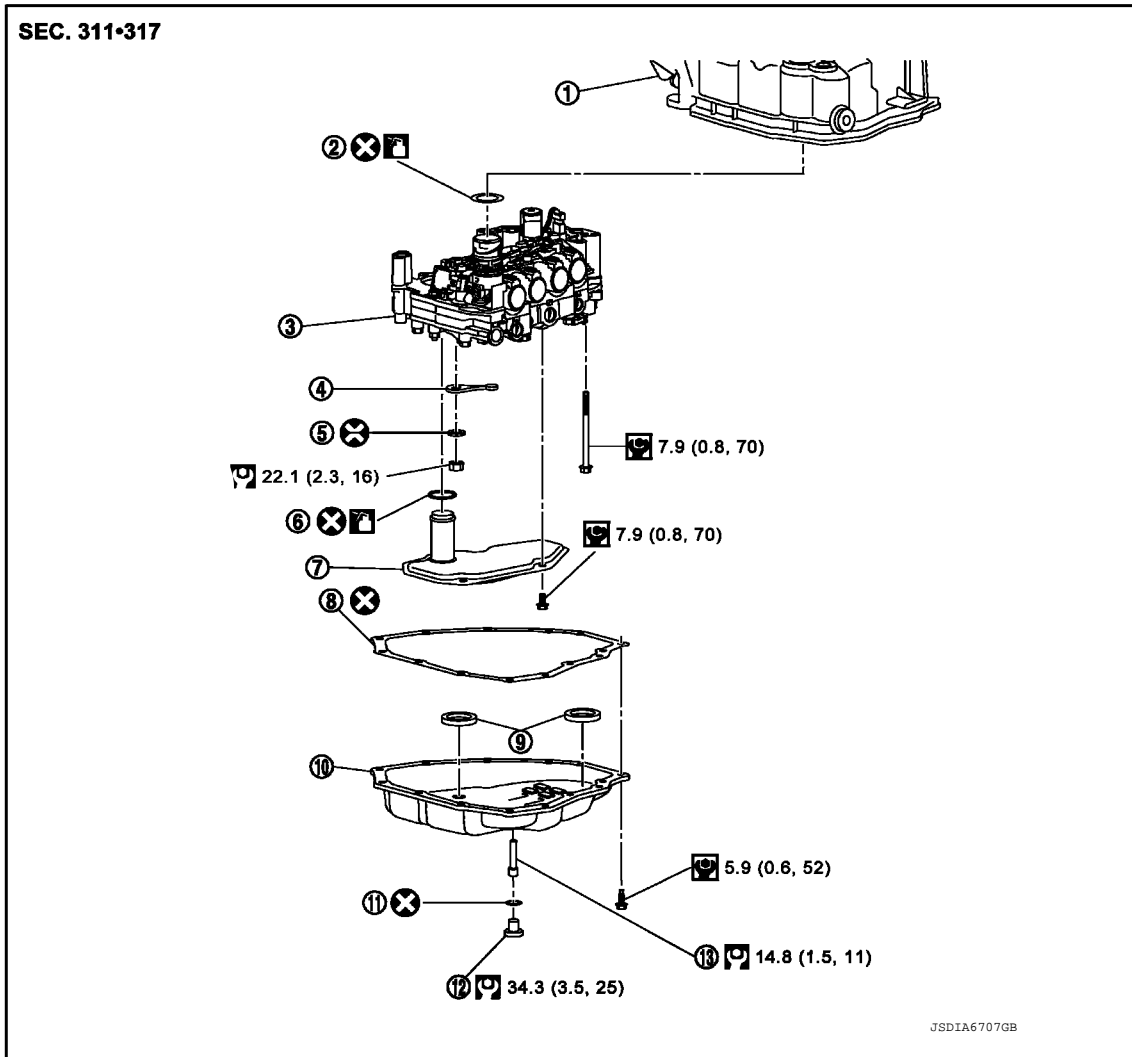
Exploded View

| 1. Transaxle assembly | 2. O-ring | 3. Control valve |
| 4. Manual plate | 5. Washer | 6. O-ring |
| 7. Strainer | 8. Oil pan gasket | 9. Magnet |
| 10. Oil pan | 11. Drain plug gasket | 12. Drain plug |
| 13. Overflow tube | | |

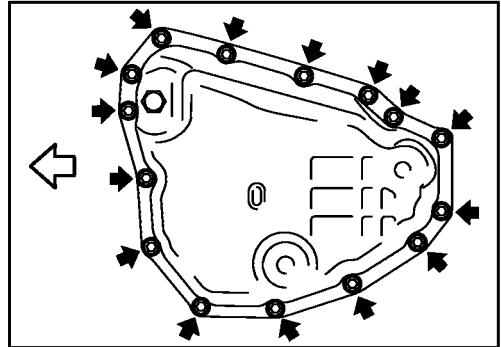
5. Remove the drain plug gasket from the drain plug.
6. Remove the oil pan mounting bolts (←), and then remove the oil pan and oil pan gasket.

← : Vehicle front

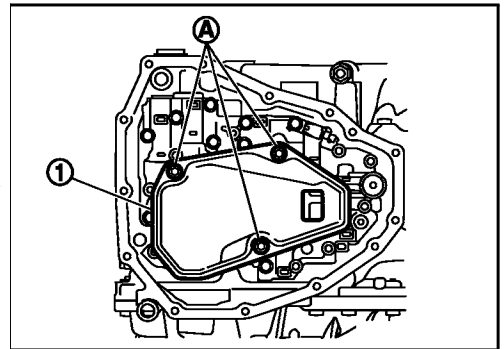
8. Remove the strainer bolts (A), and then remove the strainer (1) from the control valve.

- Discard the strainer. A new one will be used during assembly.

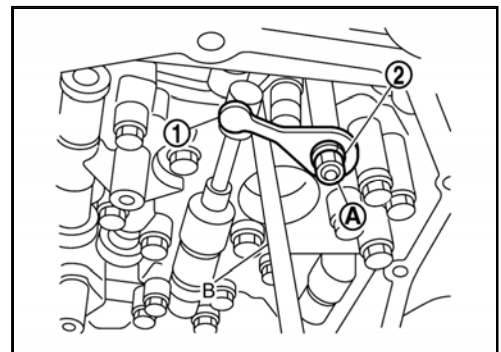
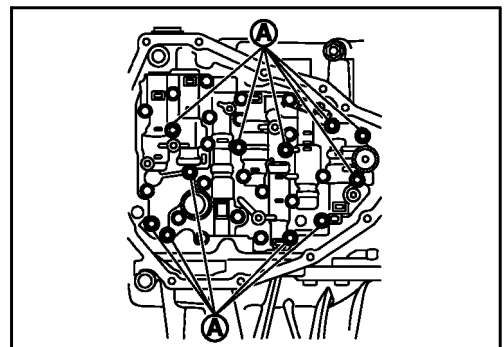
9. Remove the nut (A) and washer (2), and then remove manual plate (1).

To remove nut, fix manual plate with flat-blade screwdriver (B).

11. Remove the control valve bolts (A), and then remove the control valve from the transaxle case.

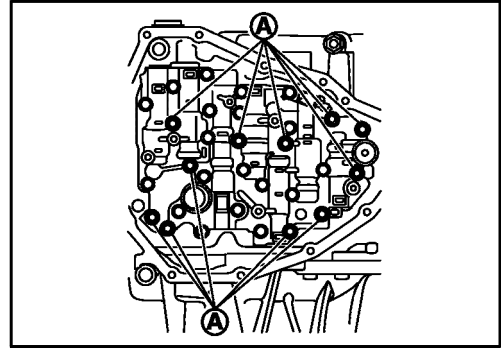
1. Install the control valve, and then tighten control valve bolts **A** to the specified torque.

- Never pinch the harness between the control valve and the transaxle case.
- Never drop the control valve and manual valve.

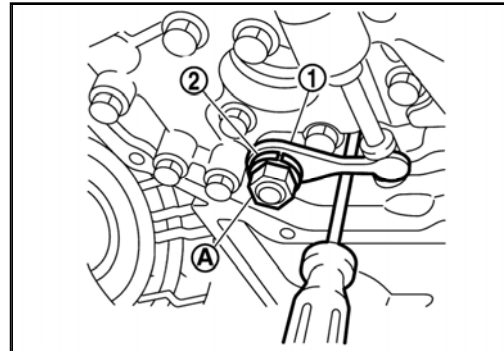
2. Install the manual plate **1** and washer **2**, and then tighten nut **A** to the specified torque.

- Reassembly Torque: 22.1 N•m (2.3 kg-m, 16 ft-lb)

3. Install the new strainer **1**, and then tighten the strainer bolts **A** to the specified torque.

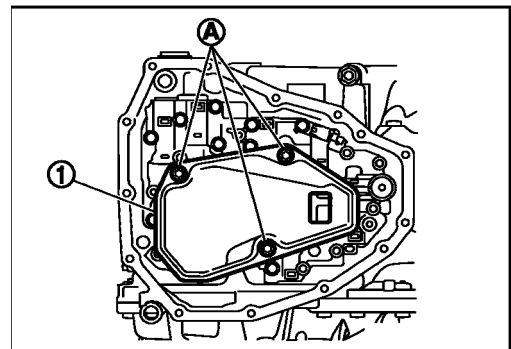
4. Install oil pan (with oil pan gasket) to transaxle case and temporarily tighten oil pan bolts (**←**).

← : Vehicle front

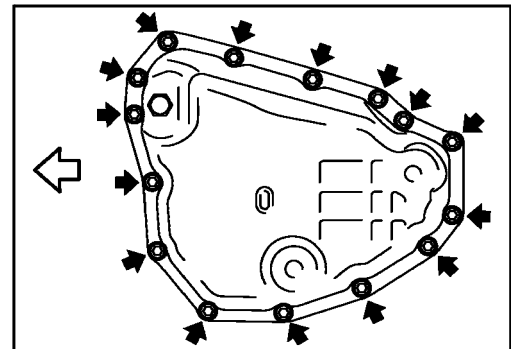
5. Tighten the oil pan bolts to specification in the order shown.

← : Vehicle front

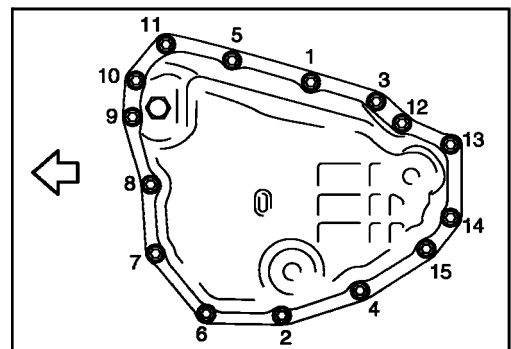
7. Connect the CVT unit harness connector.
8. Connect battery negative terminal.
9. Fill with CVT fluid from overflow tube to the specified level. Refer to ESM for further information.
10. Install the drain plug and drain plug gasket to oil pan.

Never reuse drain plug gasket.
