SERVICE INFORMATION BULLETIN

APPLICABILITY: 2018MY Crosstrek
 2017-18MY Impreza

SUBJECT: Door Opening Body Flange Weatherstrip- Design Change

NUMBER: 12-233-18R
DATE: 02/19/18
REVISED: 08/15/18

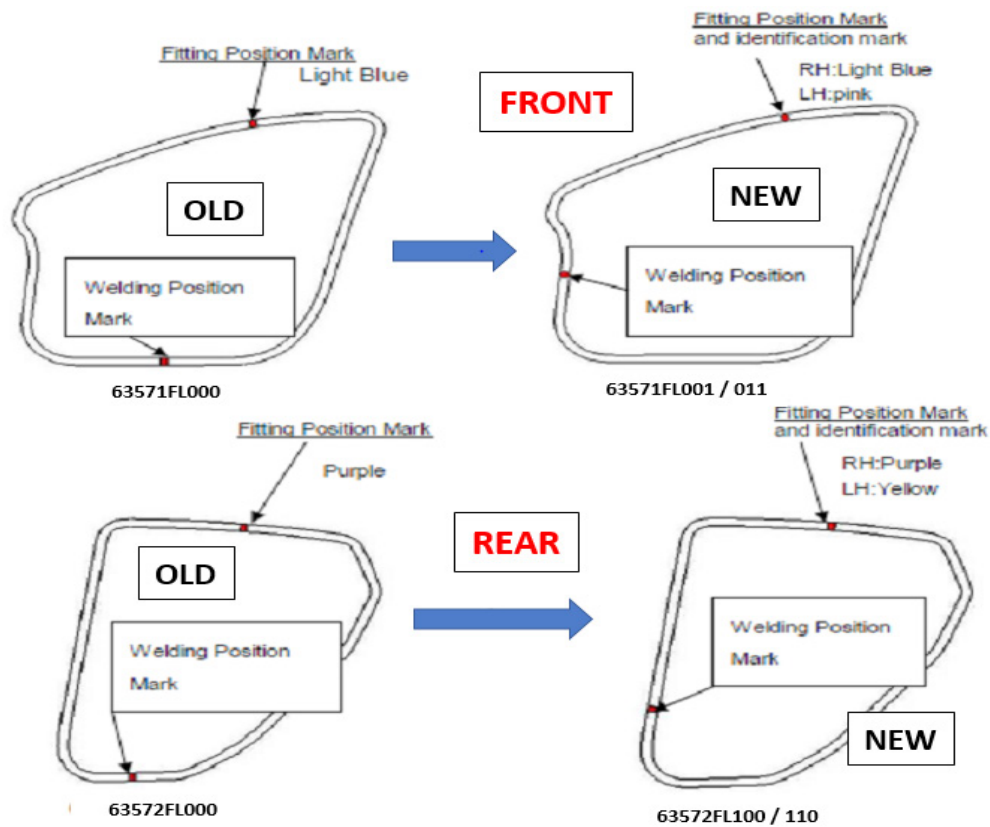
The previous versions of these weatherstrips were the same part number for the left and right. The new parts are made individually for each door opening flange (R/F, L/F R/R and L/R). The differences between the old and new parts are provided in the illustrations below.

IMPORTANT: Always confirm the Fitting Position Marks are installed in their proper positions as shown in the illustrations above.
