## TECHNICAL SERVICE BULLETIN Poor Air Conditioning (A/C) Performan

21 August 2018

#### Model:

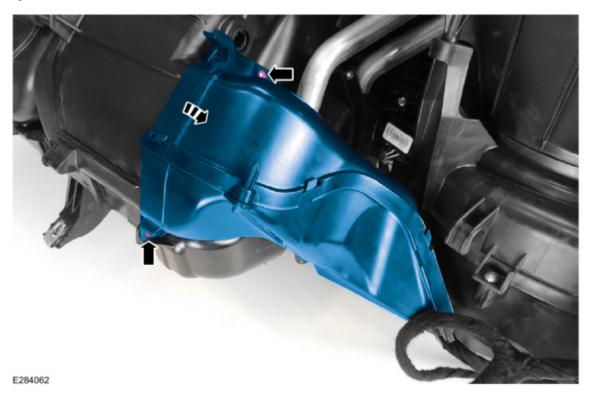
**7.** Remove the 2 footwell duct to climate control housing fasteners and remove the footwell duct. (Figure 6) Figure 6

- 27. Install the footwell duct to the climate control housing and install the two fasteners. (Figure 6)
- **28.** Install the upper plenum housing to the climate control housing and position the bulkhead insulator back on. (Figure 5)

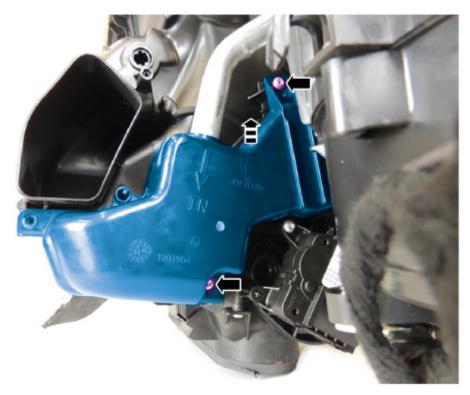
Figure 7

**8.** Remove the 2 heater core outlet pipe cover fasteners from the climate control housing and remove the cover. (Figure 7)

- 25. Install the 2 climate control housing perimeter fasteners. (Figure 8)
- 26. Install the heater core outlet pipe cover and the 2 fasteners in the climate control housing. (Figure 7)

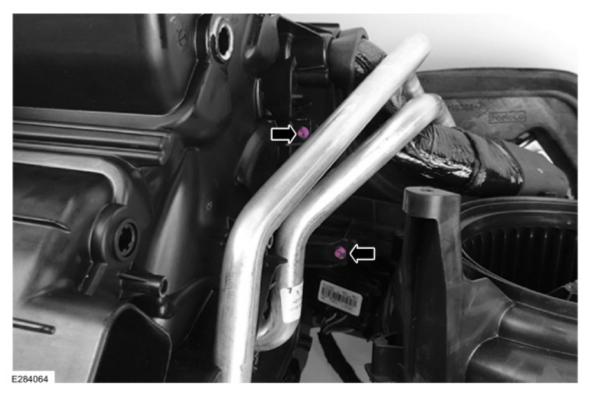
**9.** Remove the 2 climate control housing perimeter fasteners. (Figure 8) Figure 8

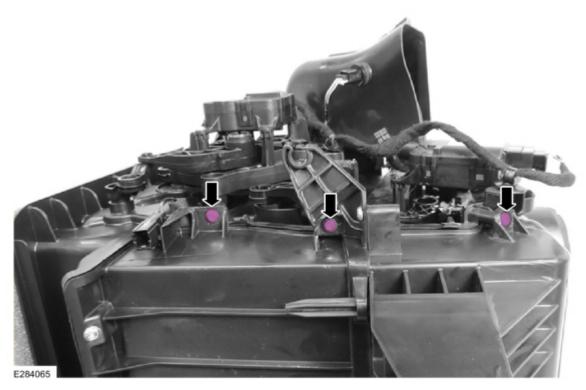
**10.** Remove the 3 climate control housing perimeter fasteners. (Figure 9) Figure 9

- 21. Install the bulkhead insulator over the TXV. (Figure 12)
- 22. Install the 4 climate assembly perimeter fasteners. (Figure 11)
- 23. Install the 4 climate control housing lower perimeter fasteners. (Figure 10)
- 24. Install the 3 climate control housing perimeter fasteners. (Figure 9)

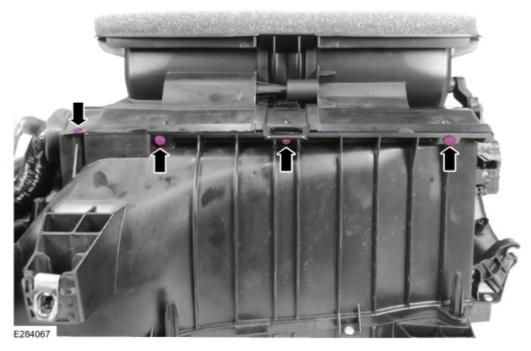
**12.** Remove the 4 climate control assembly perimeter fasteners. (Figure 11) Figure 11

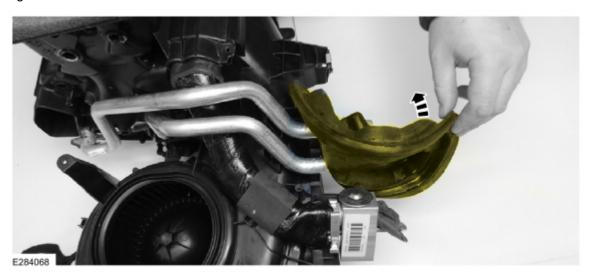
**13.** Position the bulkhead insulator over the thermostatic expansion valve (TXV). (Figure 12) Figure 12

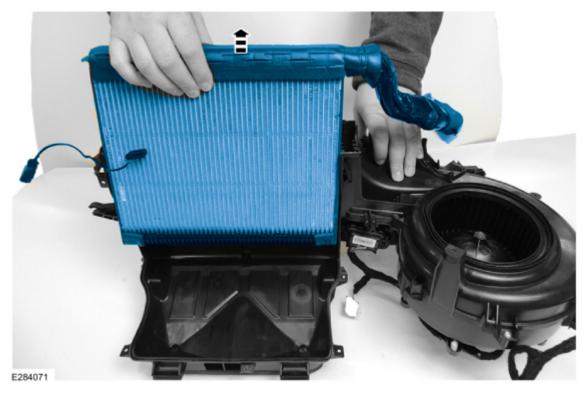
**16.** Remove the evaporator core from the climate control housing. (Figure 15) Figure 15

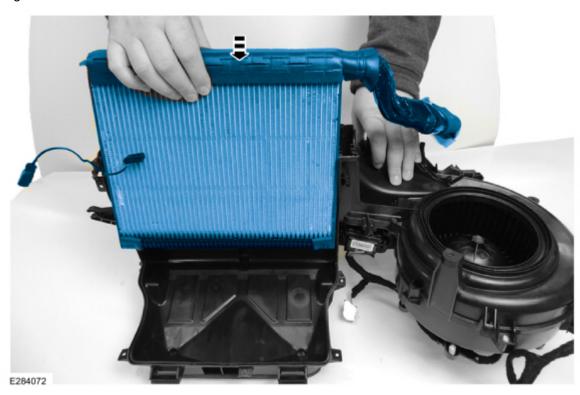
Figure 16

**17.** Install the new evaporator core. Push down on the evaporator core firmly to make sure it is fully seated in the climate control housing. (Figure 16)

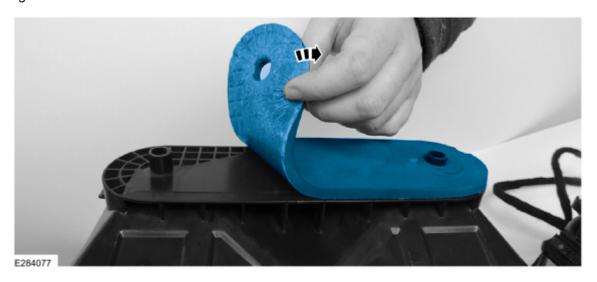
**34.** Remove the old climate control housing assembly foam isolator and apply the new foam isolator. (Figure 21) Figure 21
