Technical Service Bulletin

91 Apple CarPlay: No audio when listening to SXM, FM, or AM

91 18 97 2051241/1 May 4, 2018.

Model(s)	Year	VIN Range	Vehicle-Specific Equipment
All	2017 - 2020	All	With Audi Smartphone Interface (ASI)

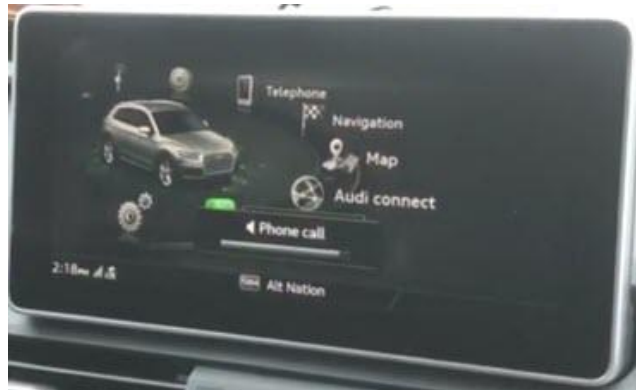
The customer states while listening to SiriusXM Satellite Radio, FM Radio, or AM Radio, there is no audio heard after ending a phone call when connected to Apple CarPlay. When adjusting the volume the customer sees a message on the MMI screen of “Phone call”, which indicates the phone call audio is still active even after the call has ended (Figure 1).

Figure 1. “Phone call” audio control with no sound.

- Once the condition is present, the customer can resume audio from SXM/FM/AM by switching to Apple CarPlay and playing audio from any music source within Apple CarPlay. For instance, start a song using the Apple Music App, Spotify, or Pandora. The customer can simply start and stop the song. Doing so allows CarPlay to properly release the audio to the MMI. From there the customer can switch back to the MMI radio source they were originally listening to (SXM/FM/AM).

- The customer must disconnect and reconnect the USB cable and then can they select SXM/FM/AM and continue listening to the original radio source. This should only be done under safe conditions, or by a passenger, and should never be performed while driving.
