Incorrect Vehicle Emission Control (VECI) Information Label

Reference: PC641
Date: August 16, 2018

PC641 – (Z52) MURANO EMISSION LABEL

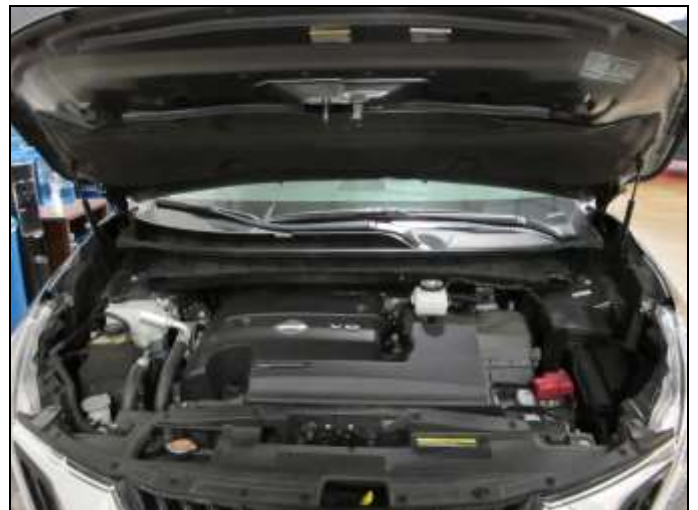
Figure 2

2. Open the hood (Figure 2).
 - Pull Hood Release lever
 - Release Hood Latch
 - Raise Hood

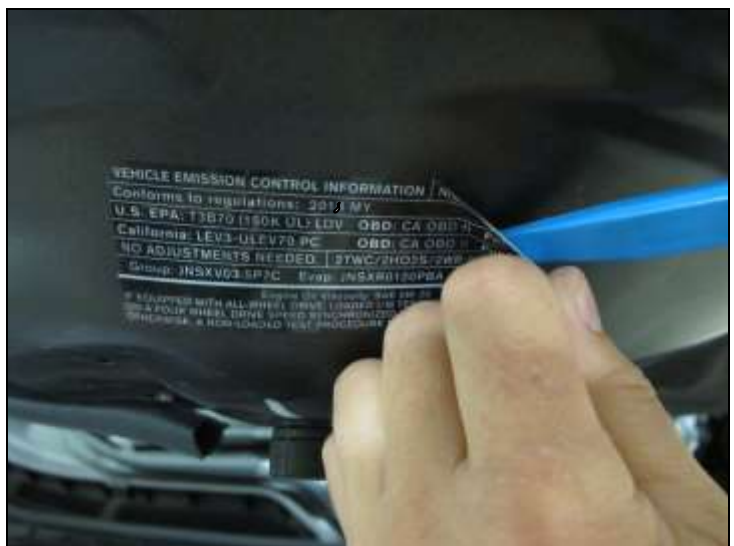
Figure 5

5. Using a suitable tool remove the "No-Good" Emissions Certification label (Figure 5).

Important: Note original placement of emissions label.

Note: Be careful not to scratch under-hood paint.

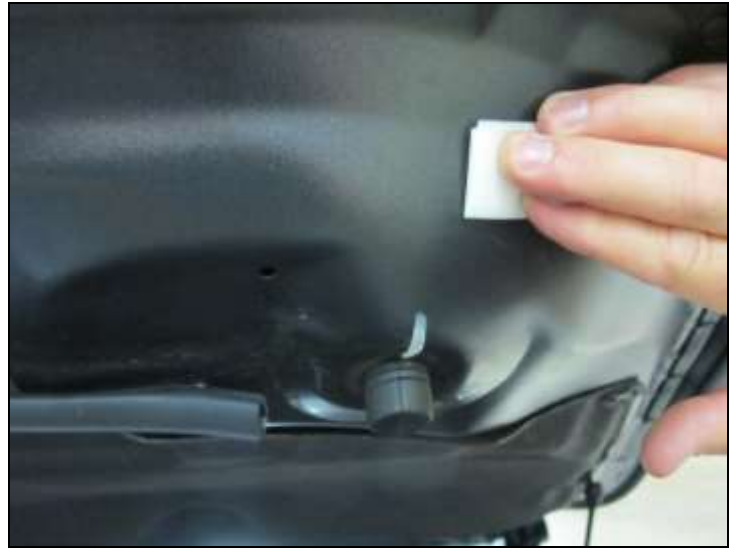
Figure 6

6. Clean the area where the Emissions Certification label adheres to the hood (Figure 6).

- Using the Nissan Supplied Alcohol Prep Pad, clean area where the old label was located
- Let alcohol completely dry

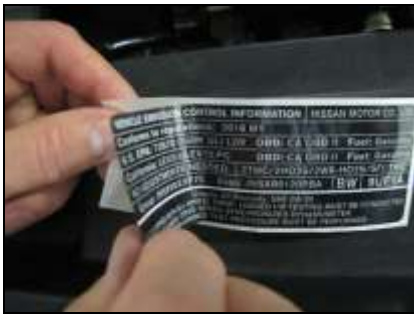
Figure 7

7. Apply Nissan supplied Emissions Certification label in applicable hood area.

- Peel backing off supplied label (Figure 7)
- Carefully align label and adhere (Figure 8)
- Press firmly to ensure contact

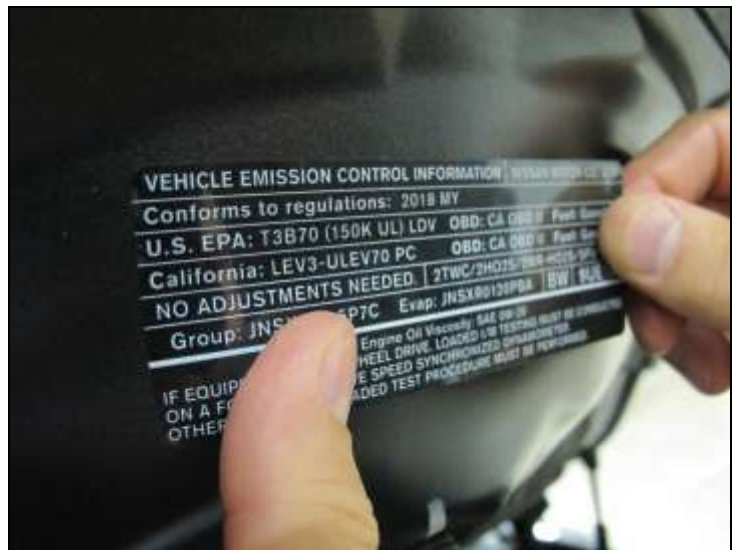
Figure 8

NOTE: The label cannot be removed and reused once applied (One-Time Use).

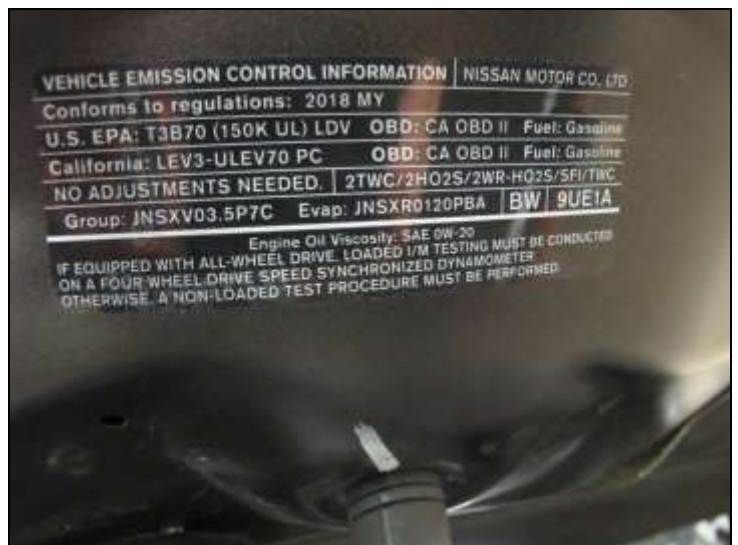
Figure 9

8. Confirm that Emission Certification label has no bubbles or damage (Figure 9).
