| Topic | Trim Strip For Rear Panel Brake Light - Blackware - Paint Adhesion (SC18/05) |
| Campaign number | EB02 |

Bentley Continental GTC / Supersports GTC

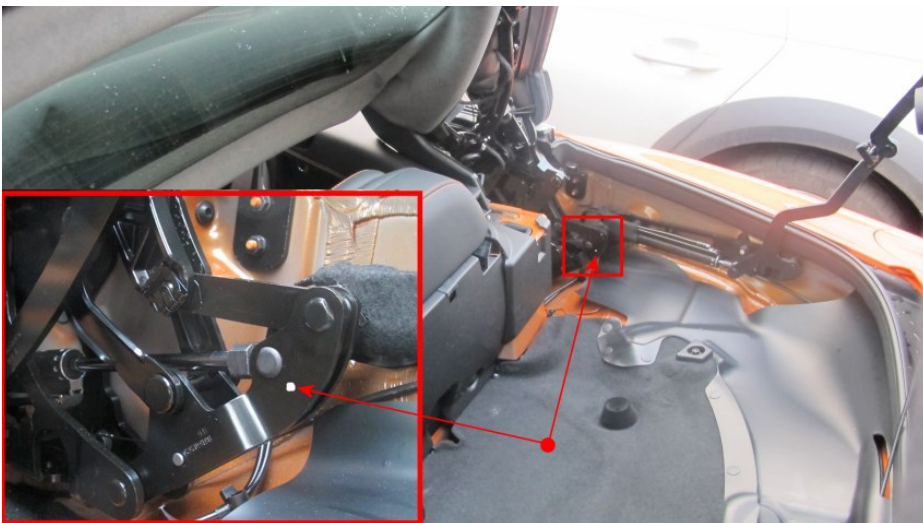
Figure 1

Upon completion apply a white campaign identification mark on the convertible roof mechanism - see Figure 1.
